CK-2235

SCUZZY CREEK 6.6km

2018 Inspection

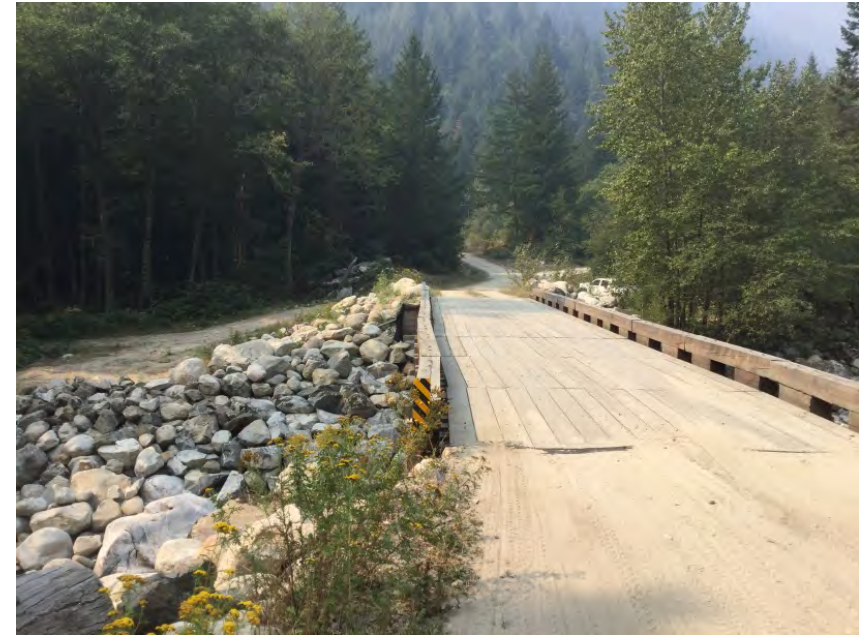
The riprap is starting to scour at the upstream right bank and downstream left bank (structure is skewed to stream). The riprap consists of large diameter round rock that does not appear to have been appropriately tied below thalweg elevation. The riprap condition should be monitored following high flow events. The modular deck panels are misaligned but appear to have been installed that way.

Deck panels misaligned

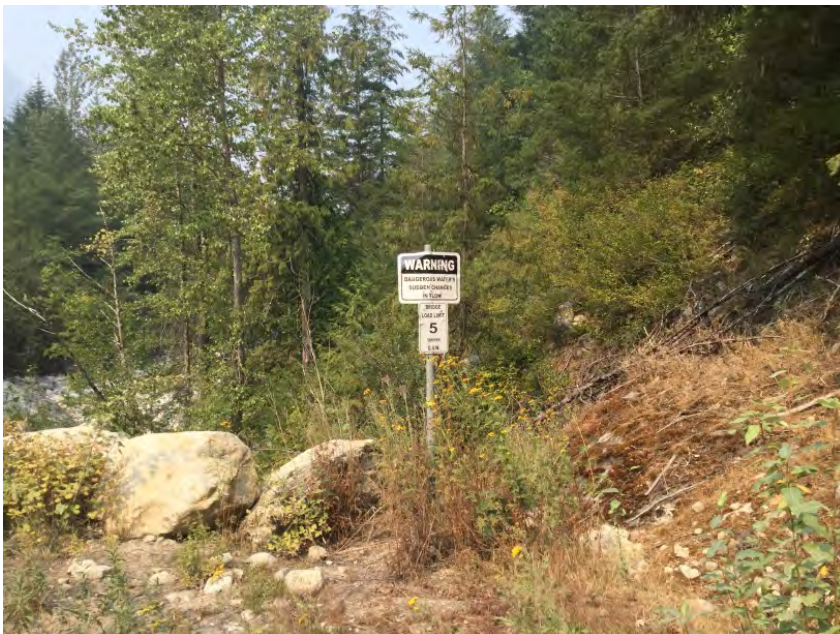
Load Rating Sign

Post bridge ahead signs and update load rating signs. Monitor the riprap scour. Current load rating of L75 or 68 tonnes to continue.

| Repair Item | Priority | Repair Description |
|---|---|---|
| 1 | Low | Update load rating sign and post bridge ahead signs |

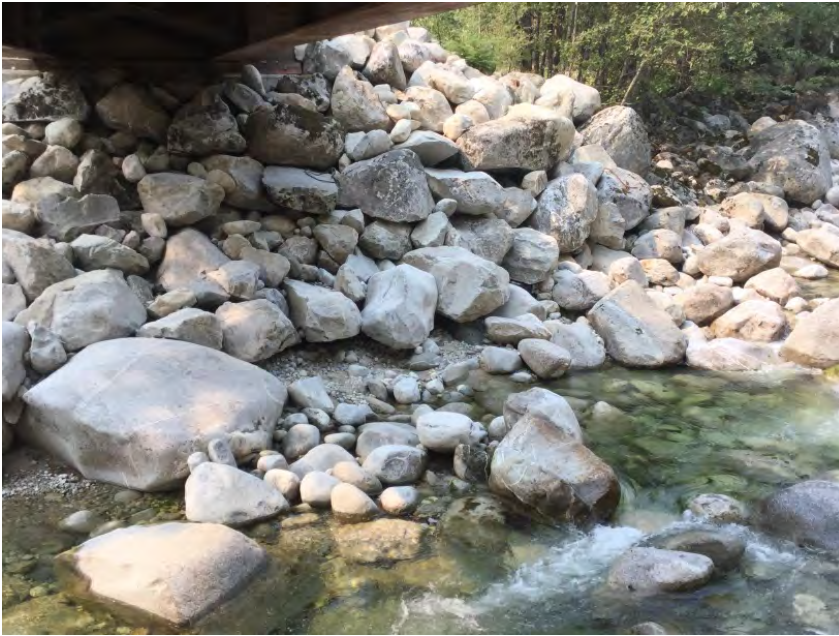
Riprap Fair

Scour evident

Upstream right bank riprap scour

| Item | Monitor Description | Frequency |
|---|---|---|
| 1 | Riprap condition | Routine Inspection |

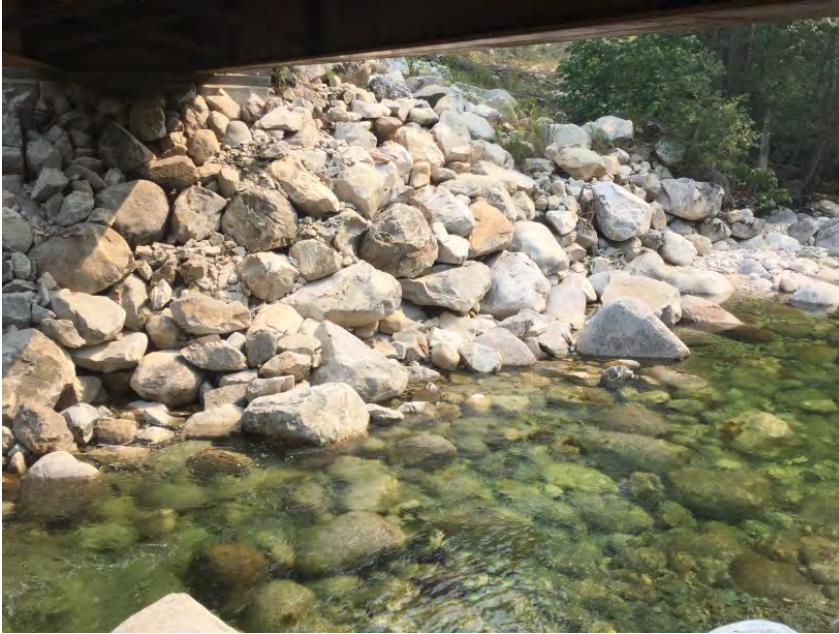
Downstream left bank riprap scour
