CK-2239

SOWERBY 6.5km

2018 Inspection

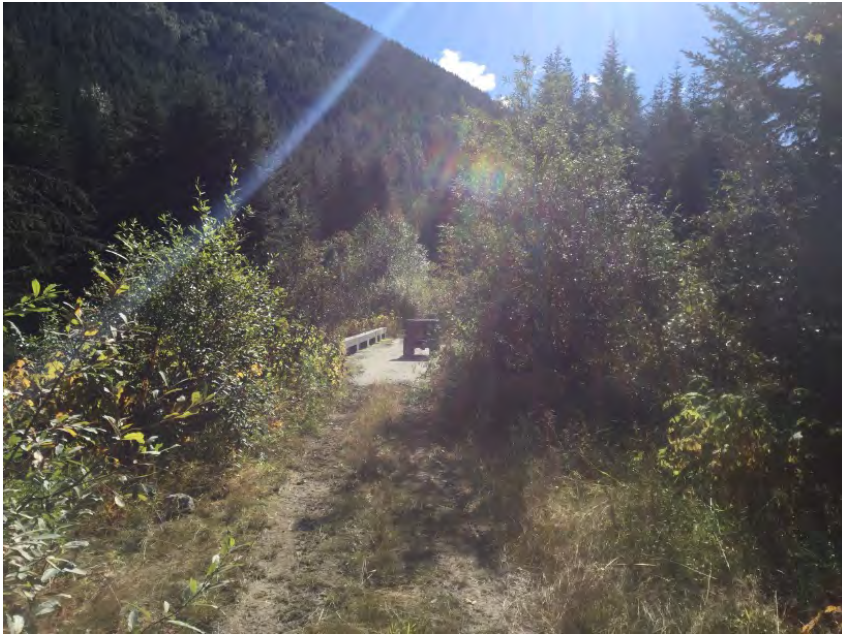
Approach from Left Bank when facing downstream

The road has been eroded in a number of locations and in some instances there isn't any road ballast remaining. The road will require extensive work prior to industrial activity. Only accessible by off road vehicles

Road Surface Poor Eroded in many locations

| Repair Item | Priority | Repair Description |
|---|---|---|
| 2 | Low | Brush approaches and place fenders prior to activity |

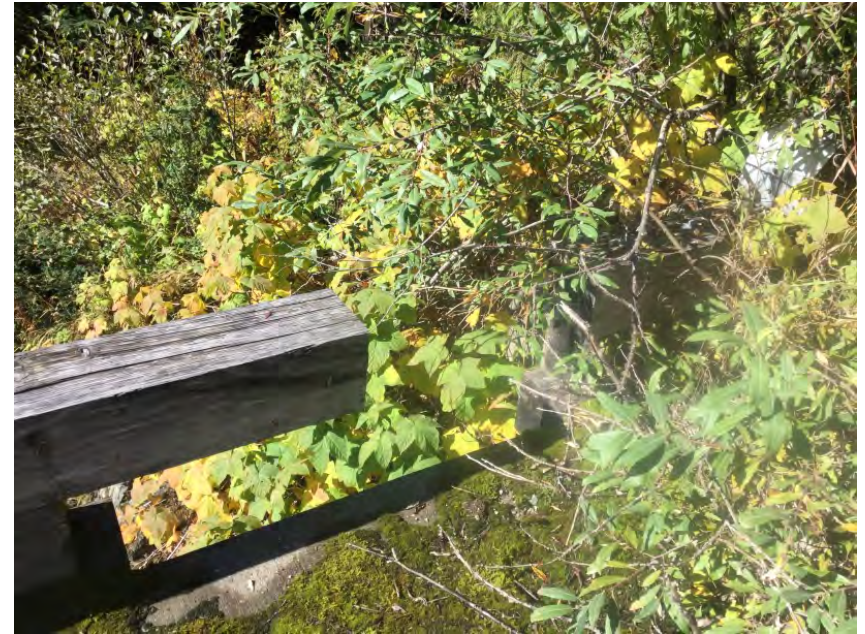
Poor

Rotten

Missing guardrail

| Repair Item | Priority | Repair Description |
|---|---|---|
| 1 | Low | Replace guardrail, risers and blocks prior to activity |

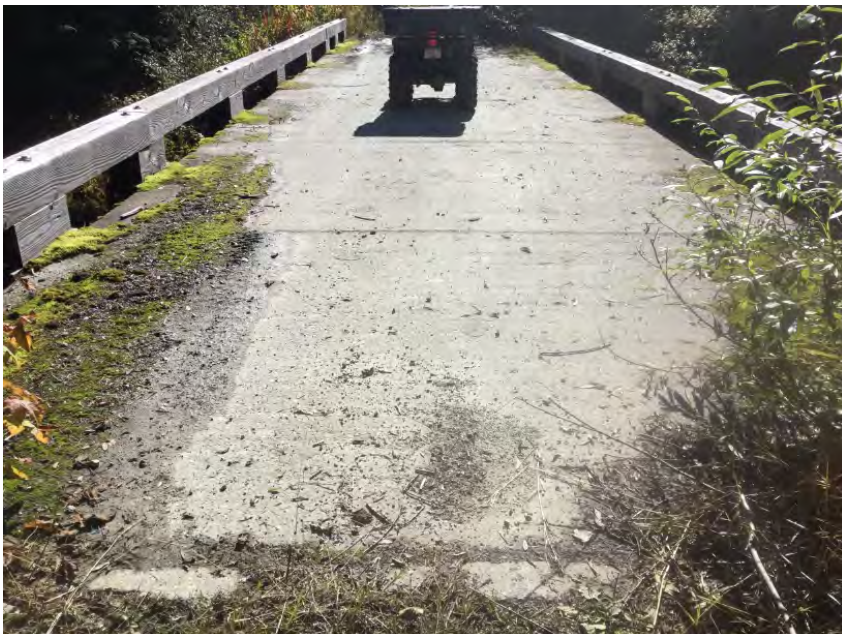
Deck

Eroded in many locations

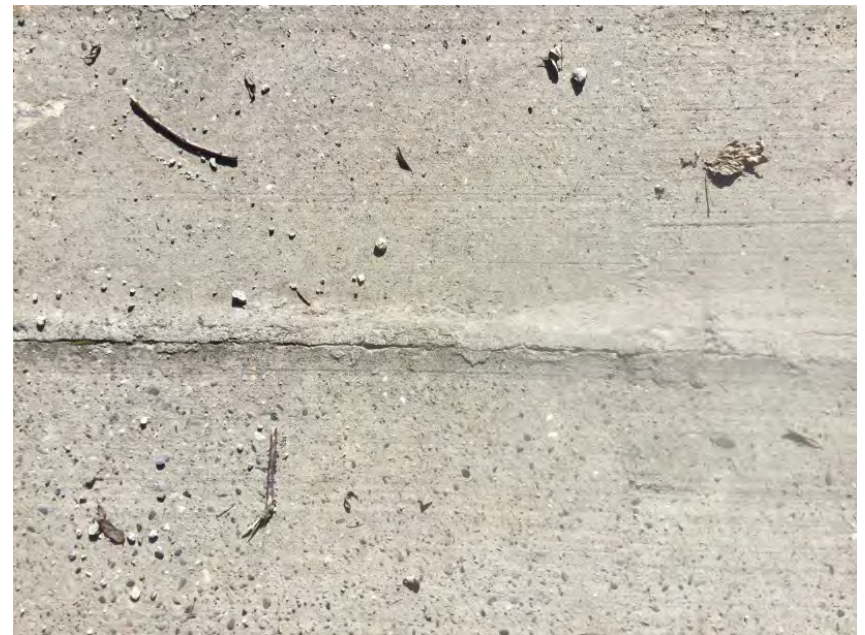
Hairline cracks noted on surface of all joints

Hairline cracks noted at surface in all deck joints
