CK-2260

STAVE 3.5km

2018 Inspection

| Crossing Name | Roaring Creek | | |

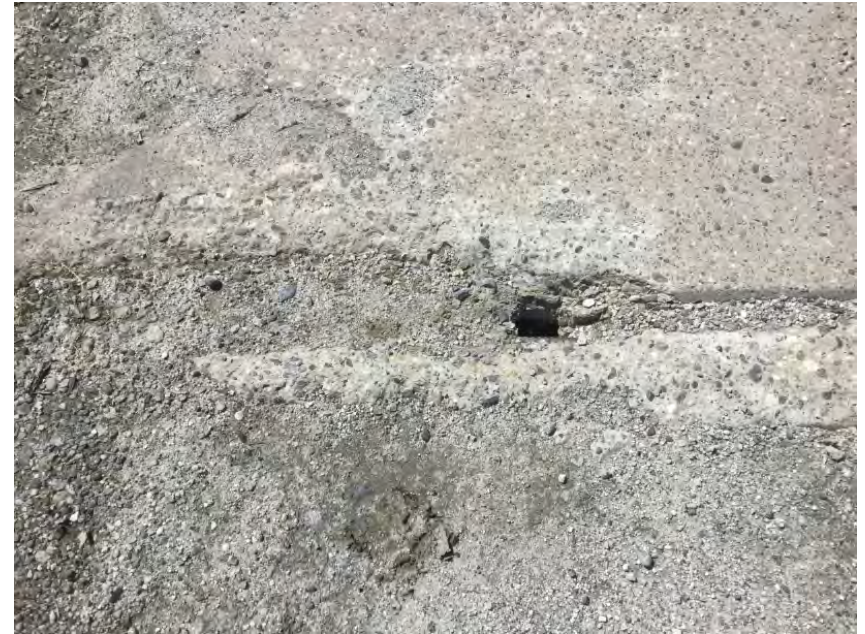
Ballast Wall Fair Damage noted to top of both

Damage noted to top of right ballast wall

| 2 | Medium | Repair damage to ballast walls and deck panels |

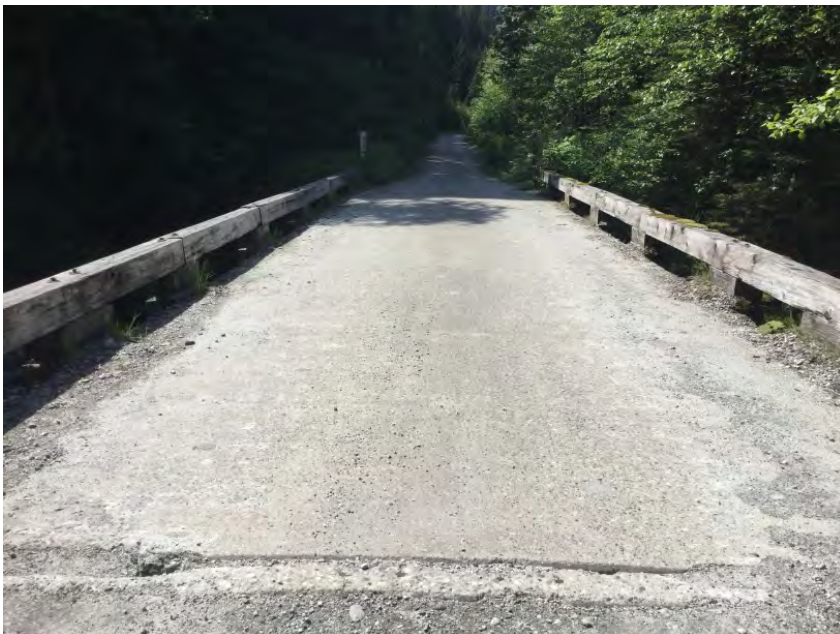
Concrete Deck      **Fair**      Damage noted to wheel path most likely attributed to tracked machinesGrout Pockets      **Good**Deck Joints      **Good**

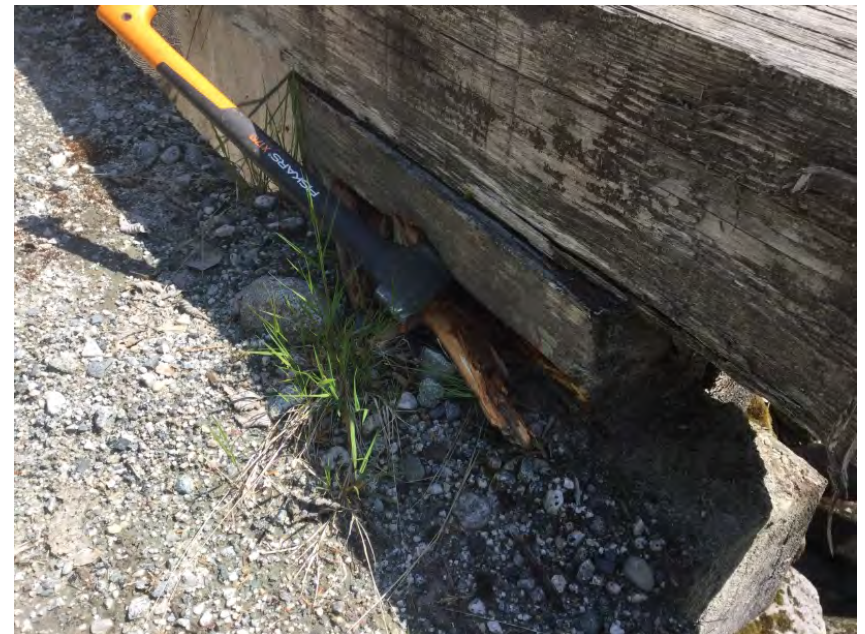
Curb Rail/Blocks/Posts      **Poor**      Rotten

Hardware      **Poor**      Loose rail boltsOverall Deck Condition      **Poor**      Due to rail condition

Guardrail condition

| 1 | Medium | Replace guardrail, risers and blocks |

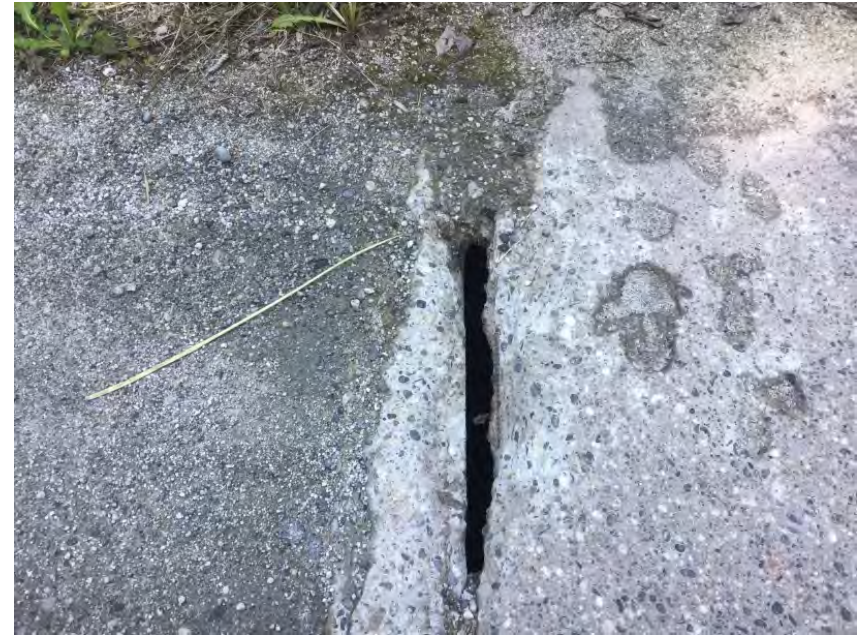
Damage noted to left ballast wall and panel 1

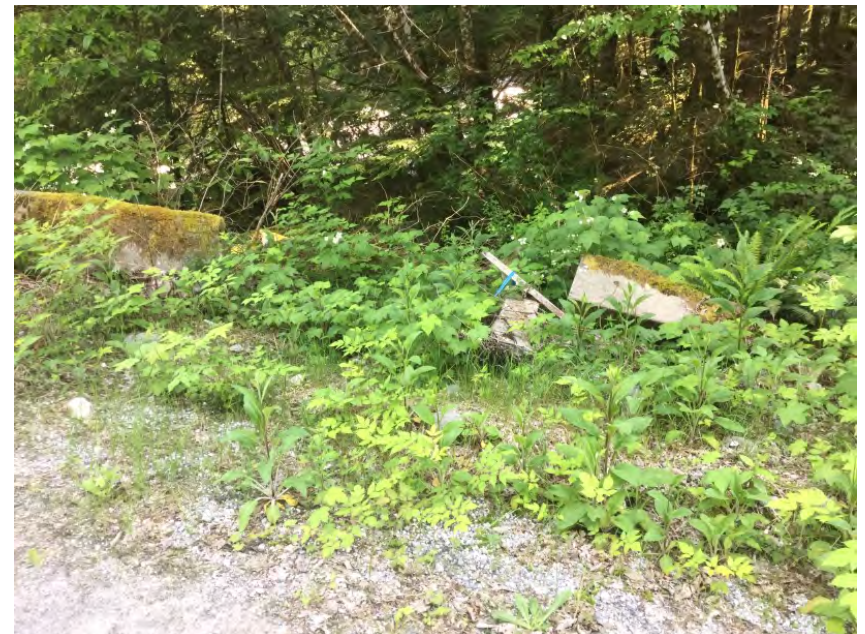
Upstream left approach bullnose not attached

Replace guardrail, risers and blocks. Repair damage to ballast walls and deck panel. Brush approaches, post bridge ahead signs, and reattach bull nose to upstream left approach barrier. Present load rating of L75 or 68 tonnes to continue.
