## Bridge Inspection Report

| Structure #: | CK-2261 | Site #: | CK-2261 | Road Name: | STAVE | Inspection Date: | 2018/06/06 |
| KM: | 8.50 | User km: | 7.50 | Crossing Name: | Winslow Creek | Next Inspection Date: | 2019/09/14 |

STAVE 7.5km

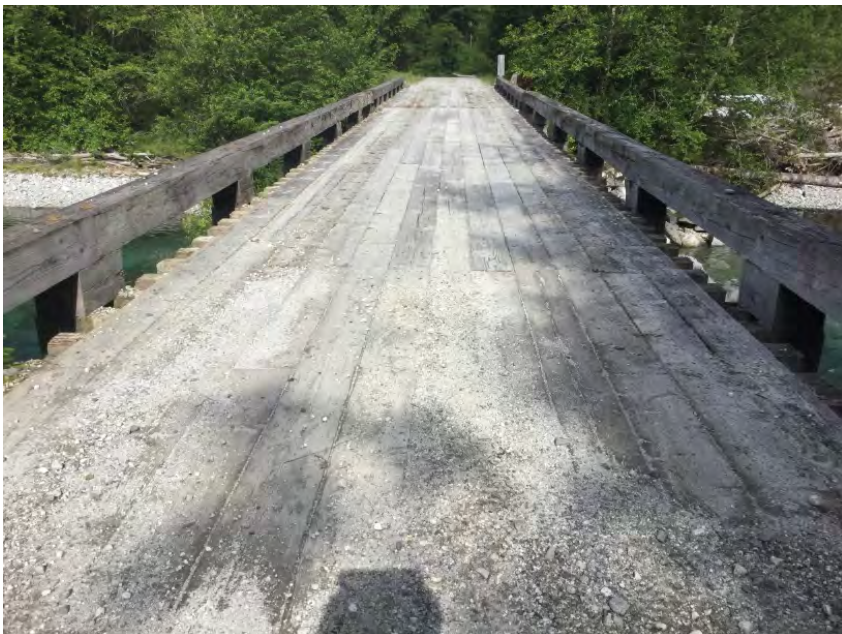
| Running Planks | Poor | Rotten and holes starting to show |

Left bank deck

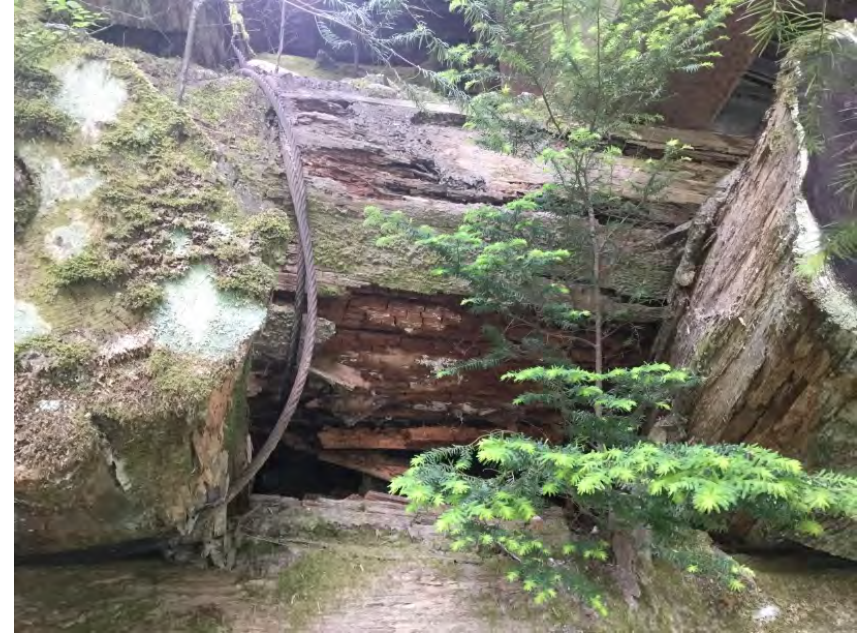
| Log/Timber Crib | Poor | Rotten |

Top crib log on left abutment

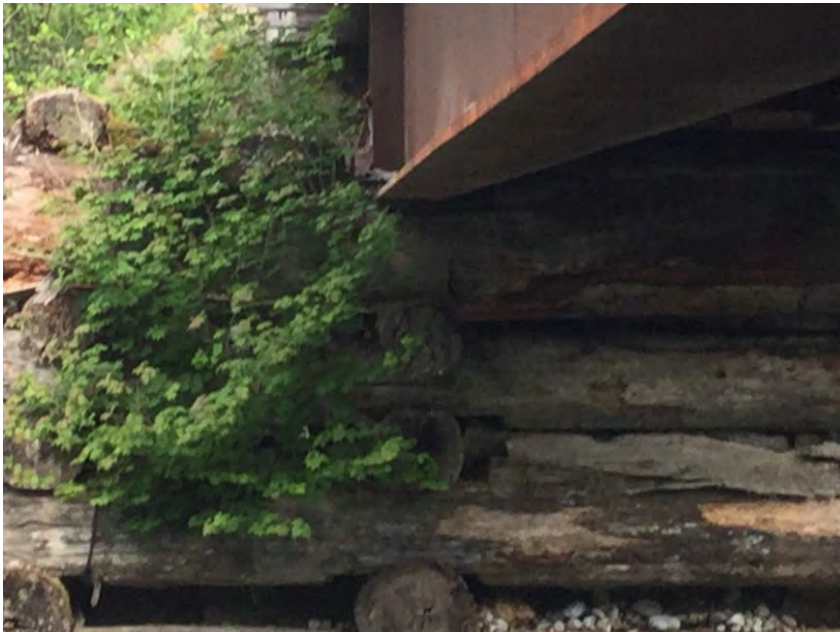
| Bearings | Poor | appears to be settling on the downstream left span side |

**PEng's Comment:** The entire structure is in poor condition. The top crib log at the downstream left side of the pier is in poor condition and the bridge appears to be settling at this location. Continue to monitor the condition of the log and the corresponding settling of the girder and deck. The present load rating of 30 tonnes can continue; however the road users need to be aware of the issue and I recommend the users complete periodic inspections while using the bridge to ensure no further deterioration of the substructure. If further deterioration of the substructure has been determined please contact the Coast Engineering Group. Post load rating sign and plan to replace the entire structure soon. Monitor debris accumulations at the inlet.

Top crib log on left side of pier in poor condition and downstream left span girder 55mm lower than right span

| | 1 | substructure condition, especially the pier | | | | | | | | |

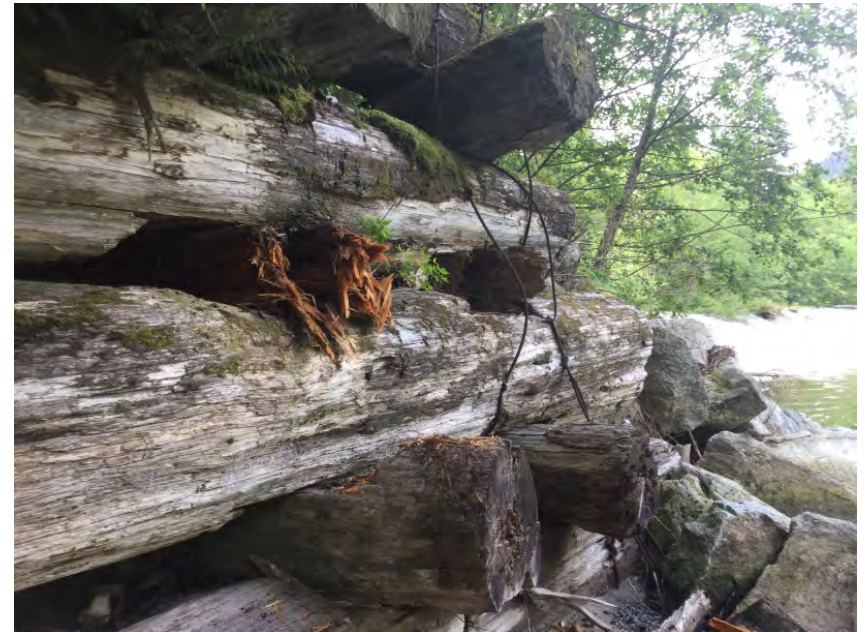
| Tie-backs | Poor | Ends are splitting and rotten |

Tieback condition on left abutment

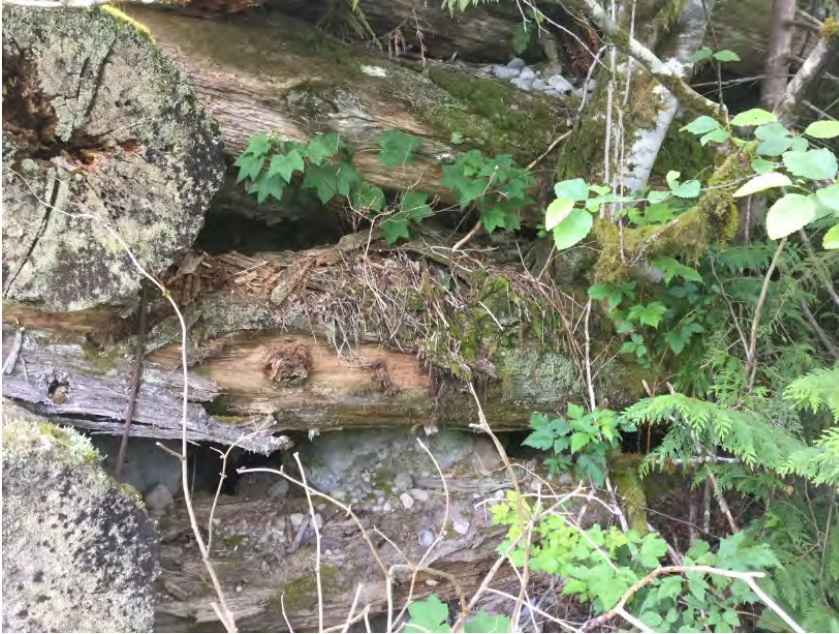
| Wing Wall | Poor | Rotting, settling and alder growing from within |

Downstream left bank wingwall

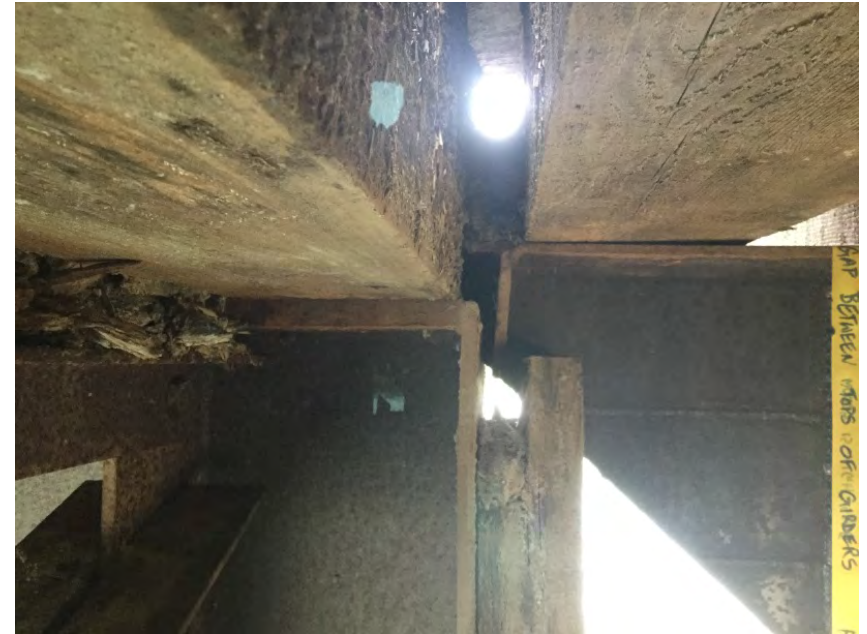
Left span girder 55mm lower than right span at downstream location

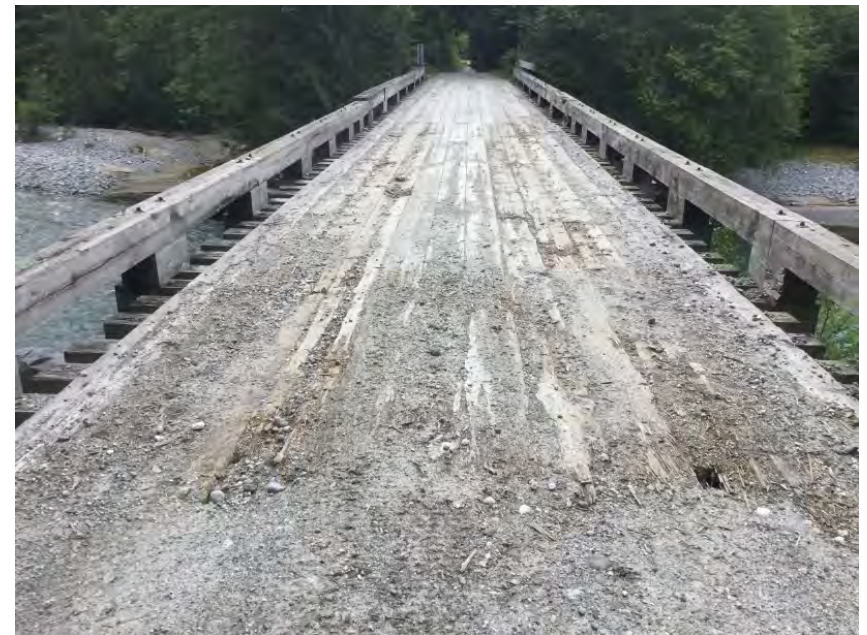
| Running Planks | Poor | Rotting |

Right span deck condition

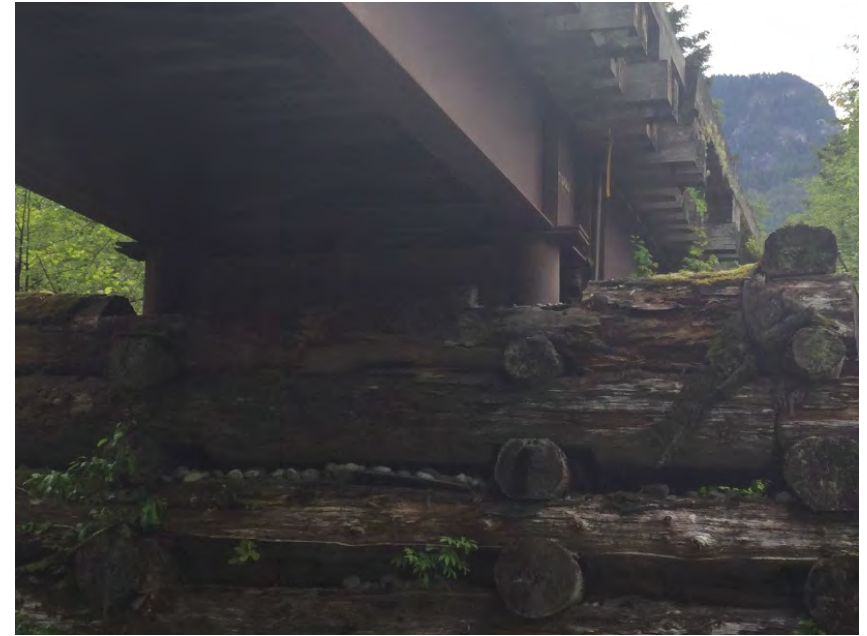
Top log condition on right side of pier

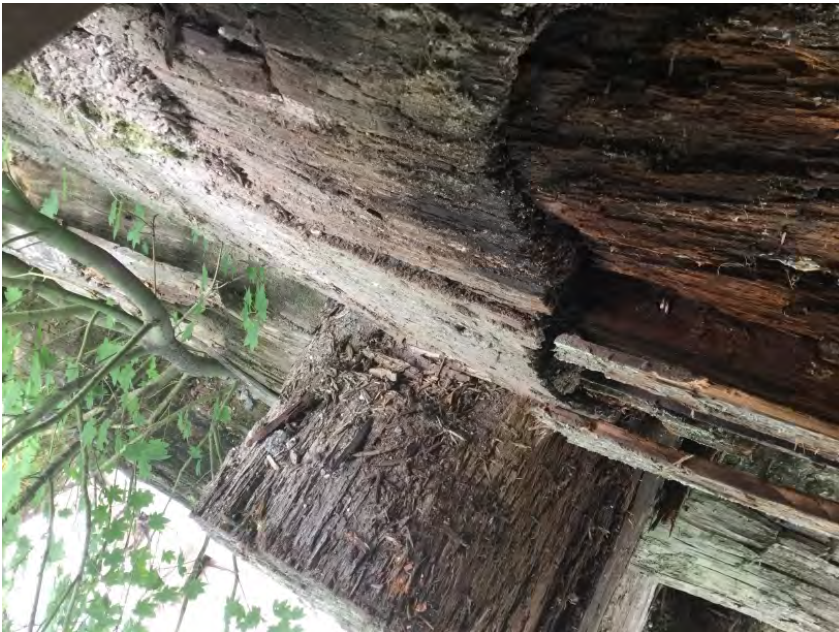
Poor condition of top crib log at downstream left side of pier
