CK-2263

STAVE 10.3km

2018 Inspection

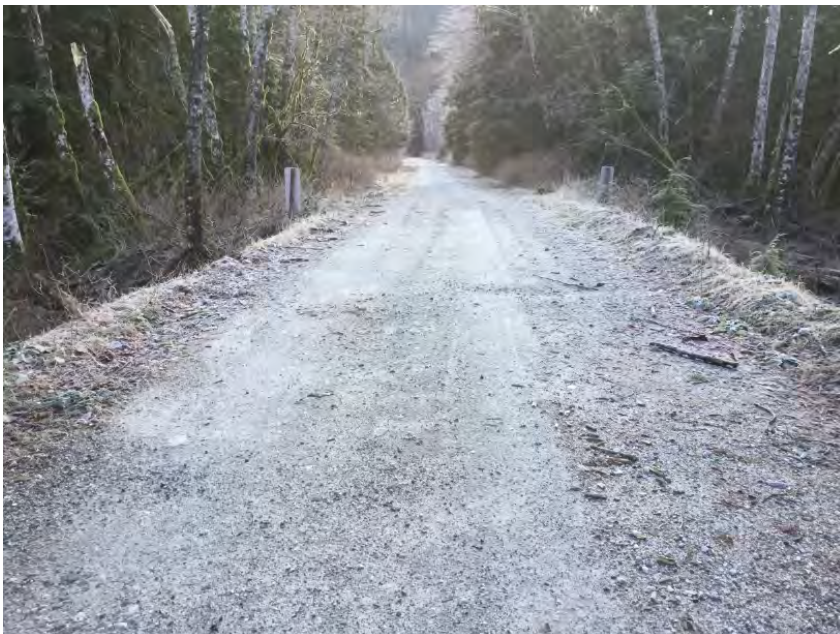
Curb Rail/Blocks/Posts Poor None

Overall Deck Condition Poor Due to curbs

| 2 | High | Place curb logs |

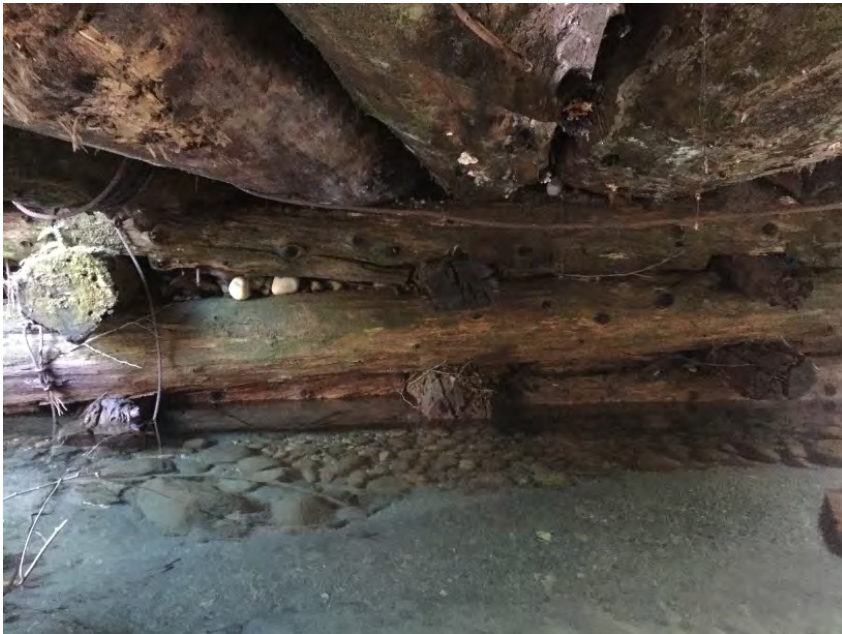
Log/Timber Cribs Poor Cracked top face log on left bank with 150mm of settlement

Bearings Poor Top face log settling with uneven bearing

Top face log on left abutment cracked and settling
