CK-2264

STAVE 11.9km

2018 Inspection

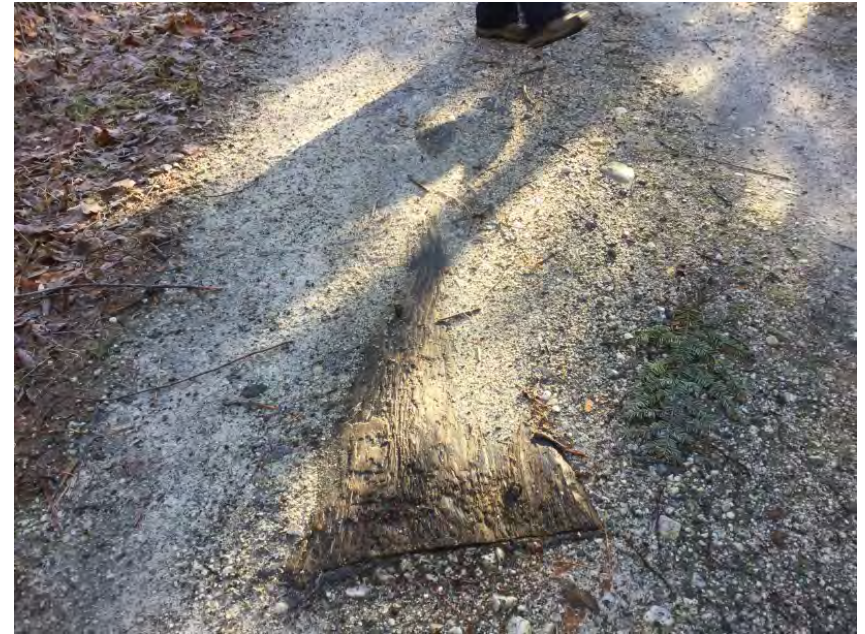
Gravel Surface    **Poor**    Top layer of stringers exposed on wheel path

Gravel Depth (mm)    100    Top layer of stringers visible on wheel path

Top stringers visible from surface

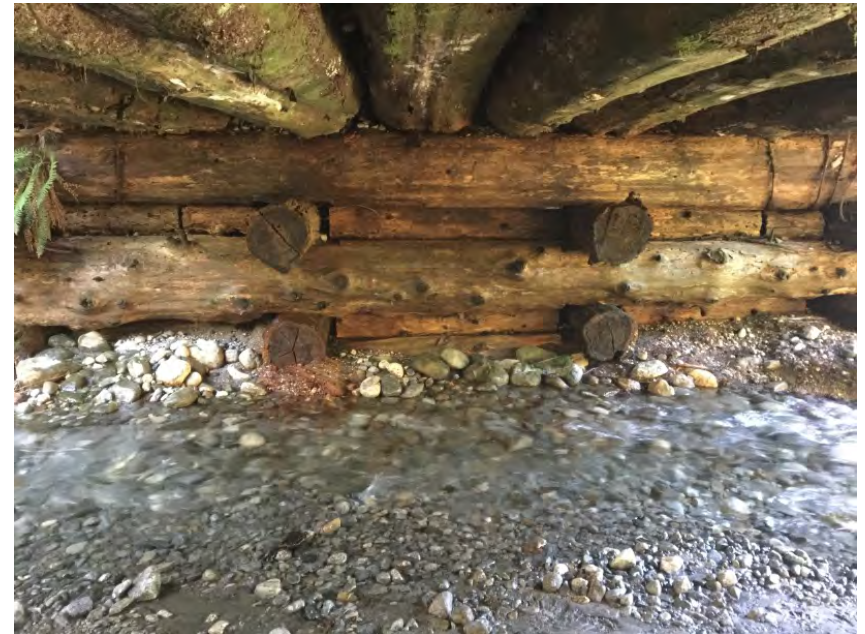
Left Bank Abutment when facing downstream

Log/Timber Cribs Poor 3 open face logs, old and rotting

Tie Backs Poor 4x, old and rotting/spilting

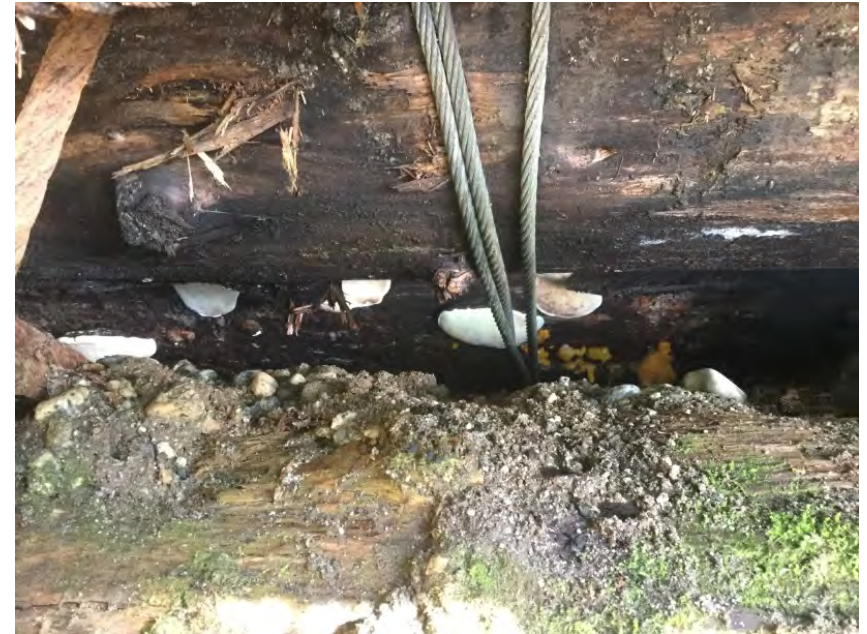
This structure has 2 layers of stringers. The top layer cannot be inspected as they are blocked from view on the top and bottom. The downstream outside top stringers have conk visible.

Fruiting bodies or conk are now visible on the outside top layer of stringers (visible on downstream end). Without the top layer of stringers being visible for a more thorough inspection all stringers are assumed to be degrading similar to that of the outside ones. Limit loading to 20 tonnes and plan to replace the structure soon. Post load rating signs.

Top layer of stringers have conk

| Item | Priority | Repair Description |
|---|---|---|
| 1 | High | Post load rating signs |

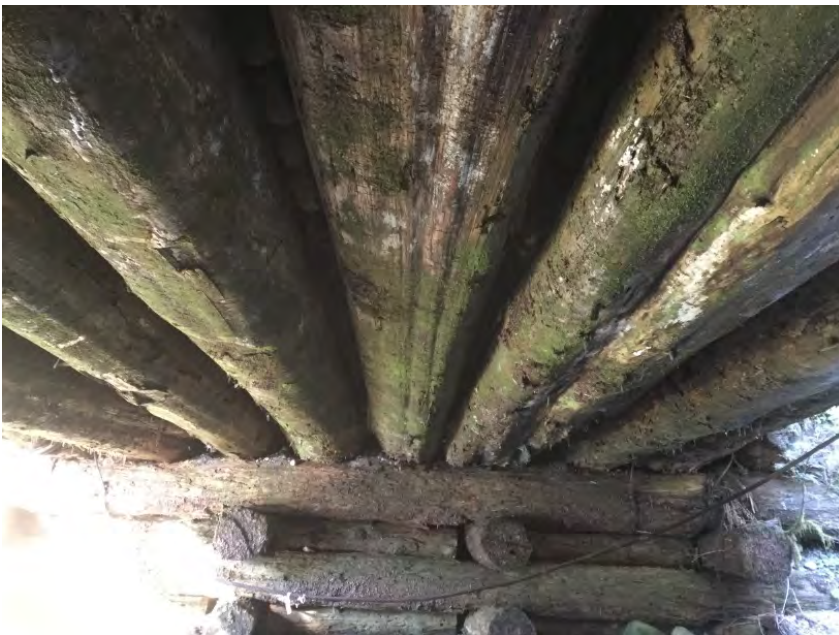
Stringers

These are the bottom stringers
