CK-2265

STAVE 12km

2018 Inspection

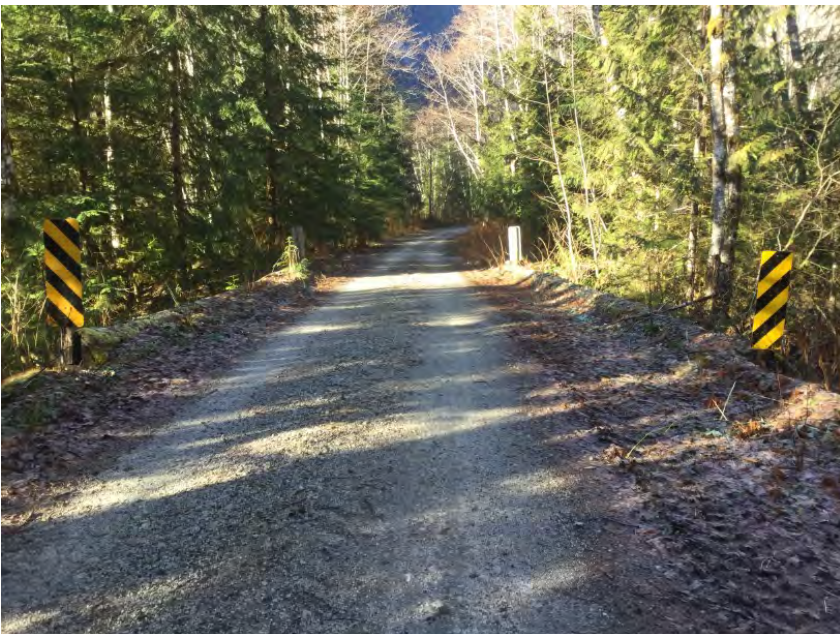
| Curb Rail/Blocks/Posts | Poor | Too low |

| Overall Deck Condition | Poor | Due to curb condition |

2    Medium    Place properly sized curb logs

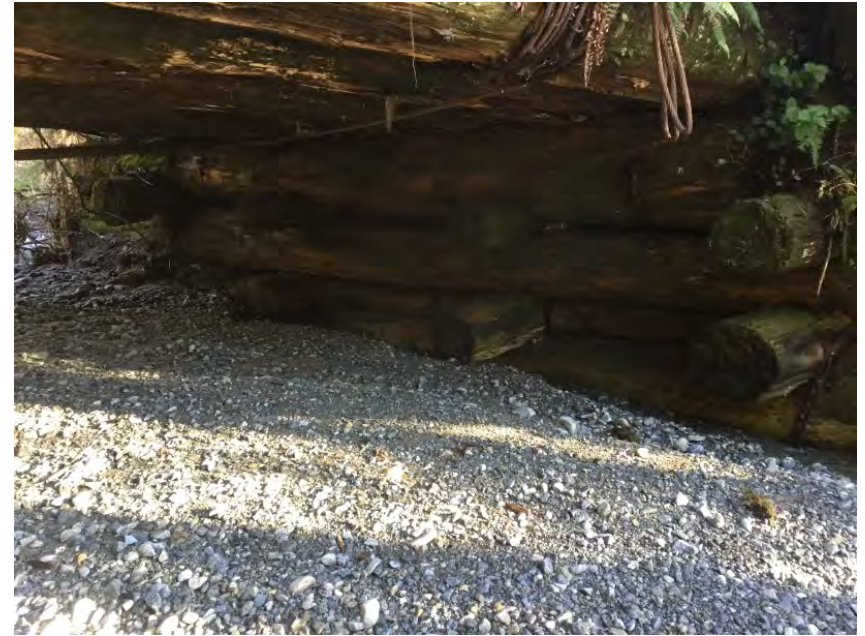
Left Bank Abutment when facing downstream

Log/Timber Cribs Fair 3x open face, old and rotting

Tie Backs Poor old and rotting/saturated

Hardware Poor Loose lashing

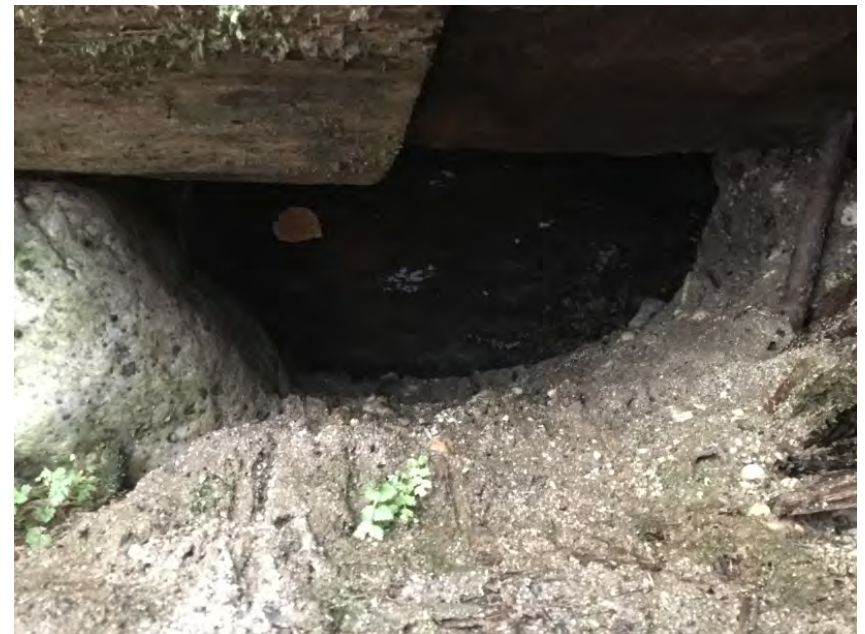
This structure has 2 layers of stringers. The top layer cannot be inspected as they are blocked from view on the top and bottom. The downstream outside top stringers have conk visible

Fruiting bodies or conk are now visible on the outside top layer of stringers (visible on downstream end). Without the top layer of stringers being visible for a more thorough inspection all stringers are assumed to be degrading similar to that of the outside ones. Current load rating of 10 tonnes to continue and plan to replace the structure soon. Post load rating signs and place properly sized curb logs.

Top layer of stringer have conk noted

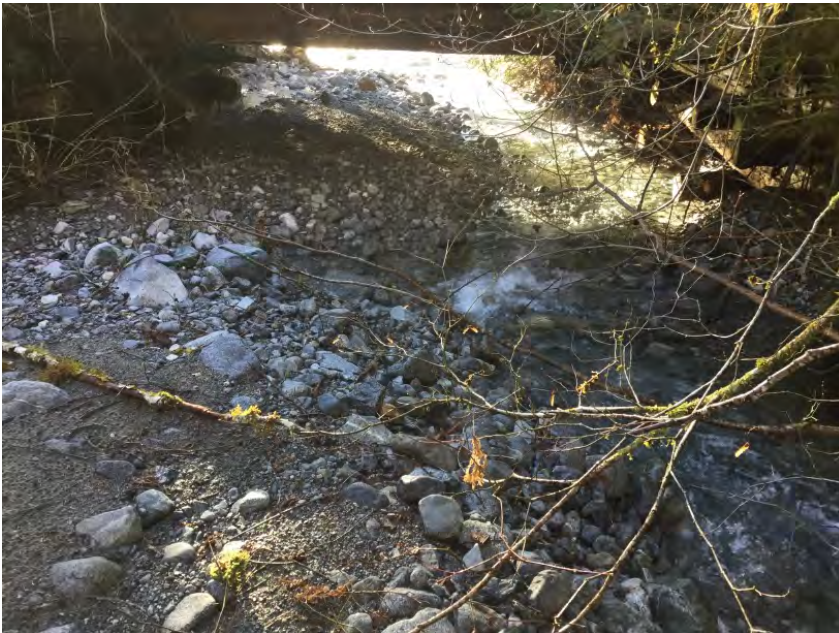
| Estimated Present Water Level Width (m) | 4.0 | Aggradation | <input checked="" type="checkbox"/> | Scour | <input checked="" type="checkbox"/> |

Aggradation
