CK-2266

STAVE 15.8km

2018 Inspection

| Crossing Name | Side Creek | | |

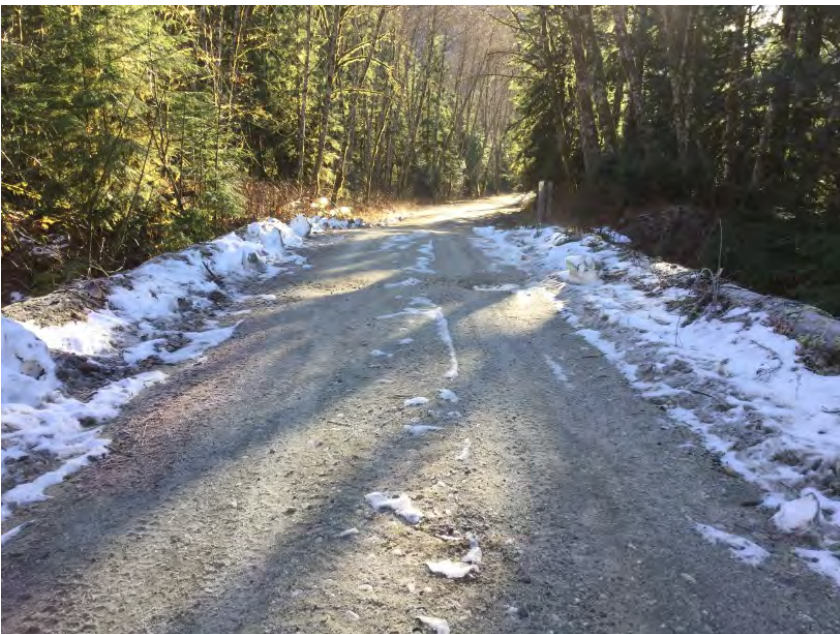
Gravel Surface      Poor      Stringer visible at the road surface

Overall Deck Condition      Fair

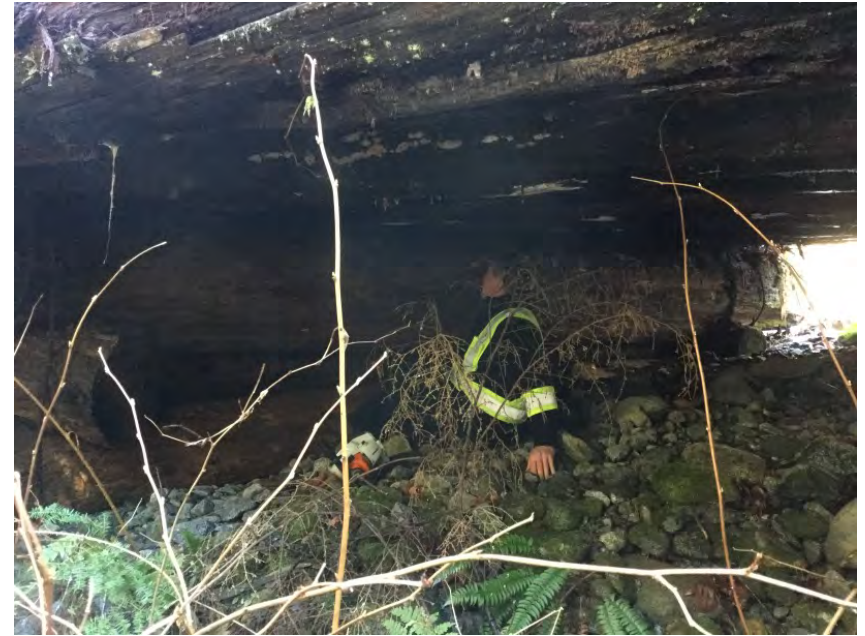
Right Bank Abutment when facing downstream

Fair to poor - 2 face logs, open face with up to 50mm sap rot

Fair to poor - 3x, end crack/splits

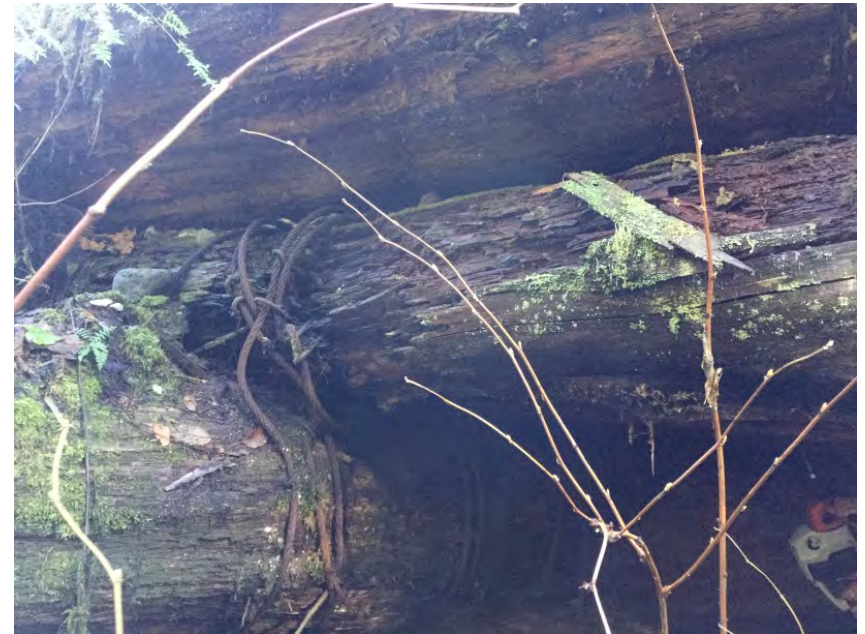
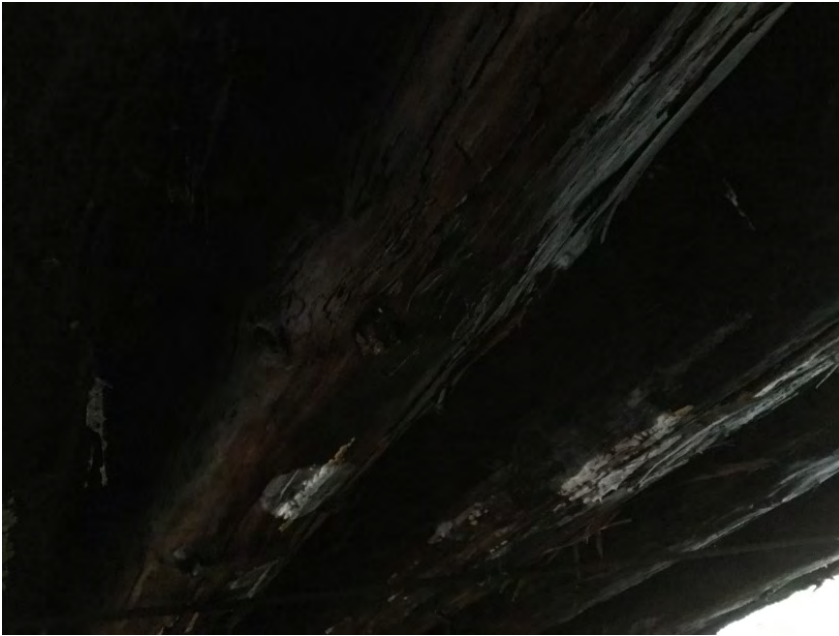
Stringers

This structure has 2 layers of stringers. The top layer cannot be inspected as they are blocked from view on the top and bottom.

| Stringer<br>Number | Species | Peeled | Diameter<br>(mm) | Rot Depth<br>(mm) | Condition | Comment |
|---|---|---|---|---|---|---|
| 1 | Fd | Y | 480 | 140 | Poor | Fruiting bodies |
| 2 | Fd | Y | 510 | 150 | Poor | rotten |
| 8 | Fd | Y | 730 | 60 | Poor | Fruiting bodies |
| 9 | Fd | Y | 630 | 100 | Poor | pocket rot detected |
| 10 | Fd | Y | 600 | 100 | Poor | pocket rot detected |
| 11 | Fd | Y | 560 | 180 | Poor | Fruiting bodies |

The current load rating of 30 tonnes can continue. Replace missing delineators. Post load rating signs and plan for a complete replacement soon.

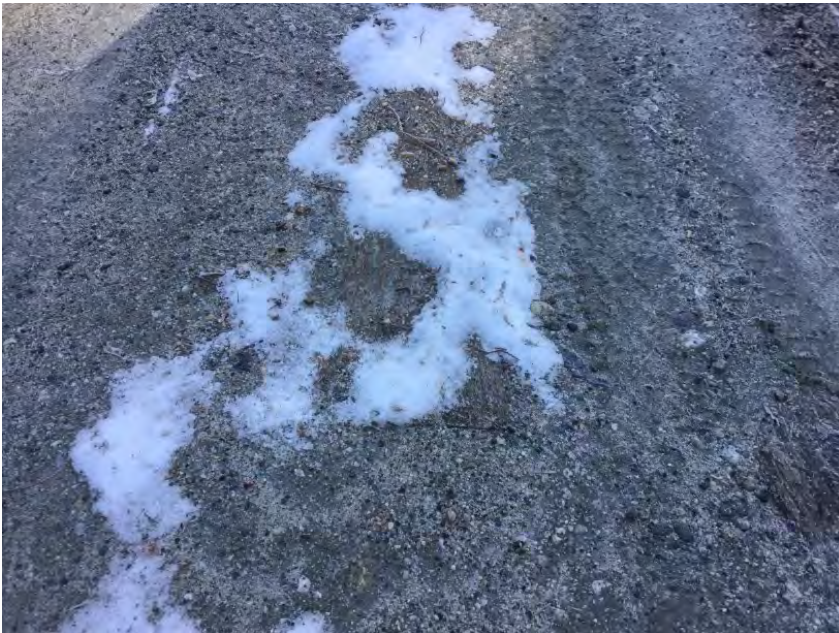
Top layer of stringers visible from surface
