CK-2267

STAVE 17.8km

2018 Inspection

| Crossing Name | Ole Creek | | |

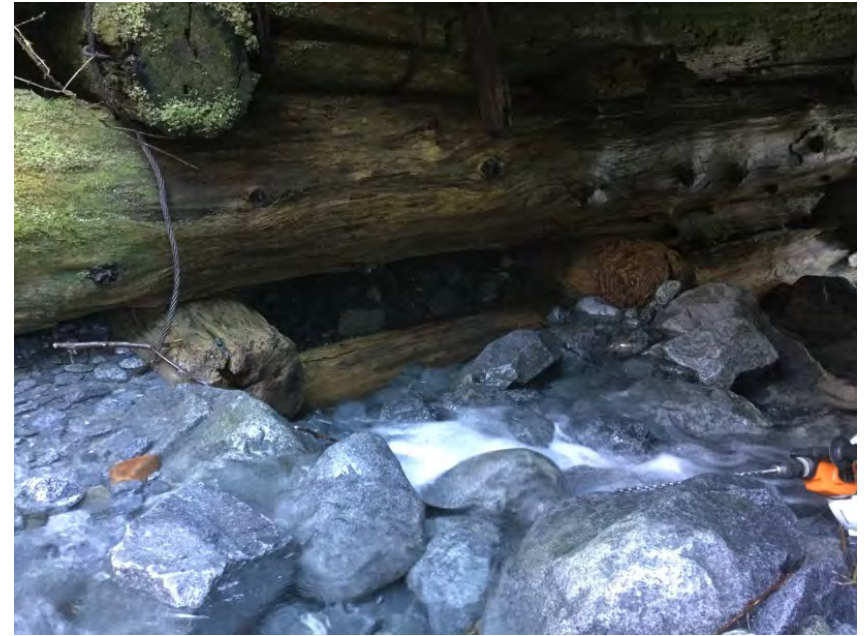
Left Bank Abutment when facing downstream

3 face logs left bank, 2 face logs right bank - collapsed top face log at left abutment

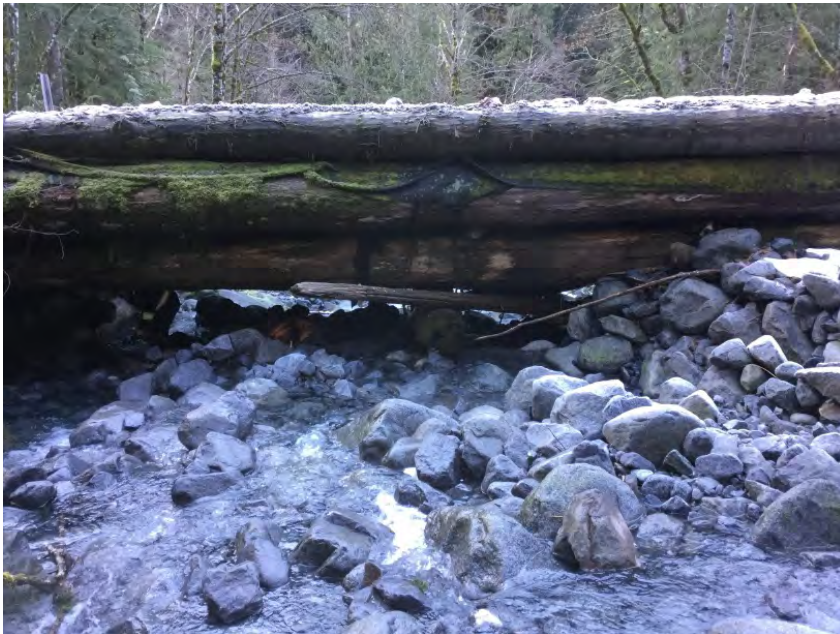
Inlet

Hydraulic capacity of structure limited due to bedload buildup at the inlet  
Structure 40 meters upchain recently blown out and now a ford - same stream

Top face log on left bank vertically and horizontally cracked

Current load rating of 10 tonnes to continue. Due to the poor condition of the structure monitor it while in use, and inspect after heavy precipitation events. Consider cleaning the inlet to increase hydraulic capacity. Post load rating signs. Plan to replace the structure soon.

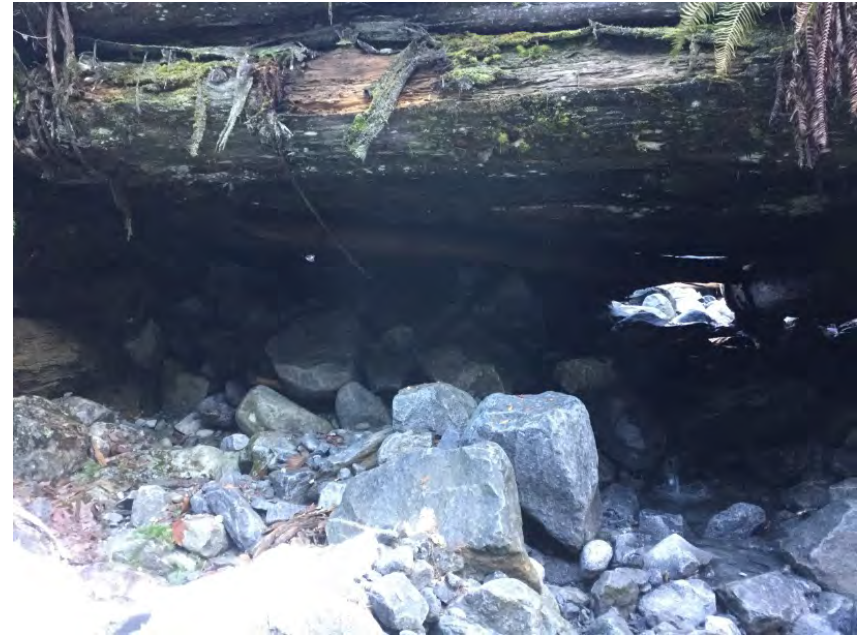
Bedload buildup on right side of structure between crib and needlebeam

Debris aggrading under bridge

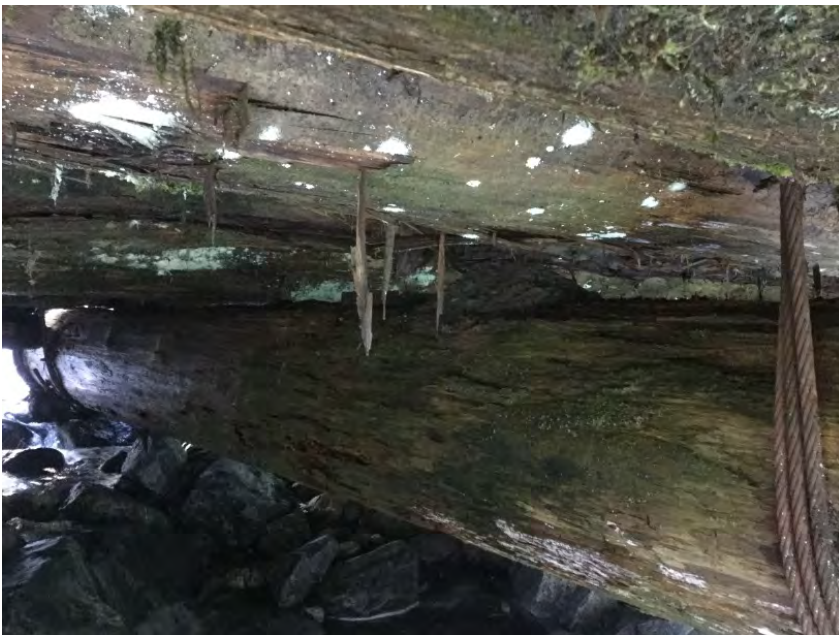
Needle Beam Poor Rotten and not shimmed tight to all stringers

Needle Lashing/  
Shimming Poor Loose lashing and shims missing

Non functional needle beam
