CK-2269

STAVE 20.3km

2018 Inspection

| Crossing Name | Stave River | | |

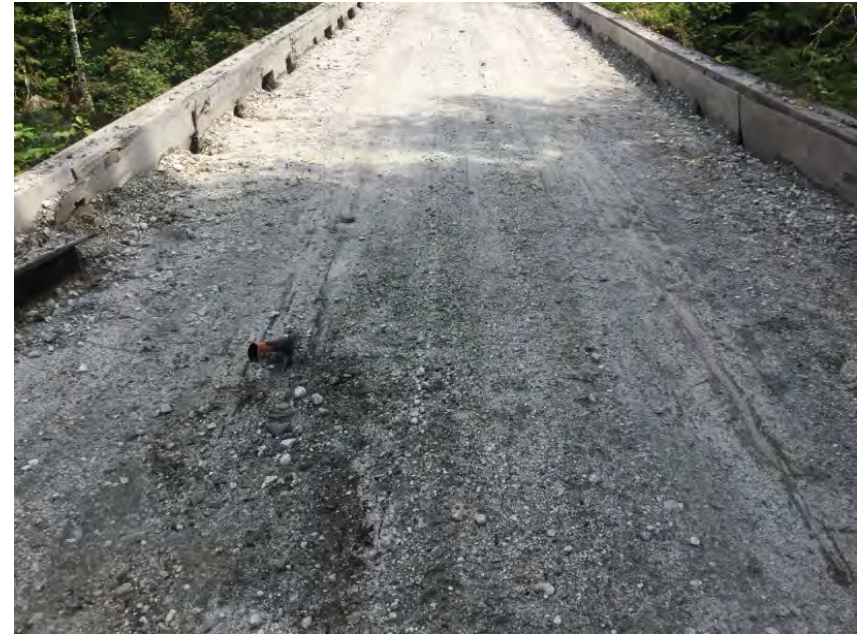
Deck

| Running Planks | Poor | Heavy wear in locations along wheel path |

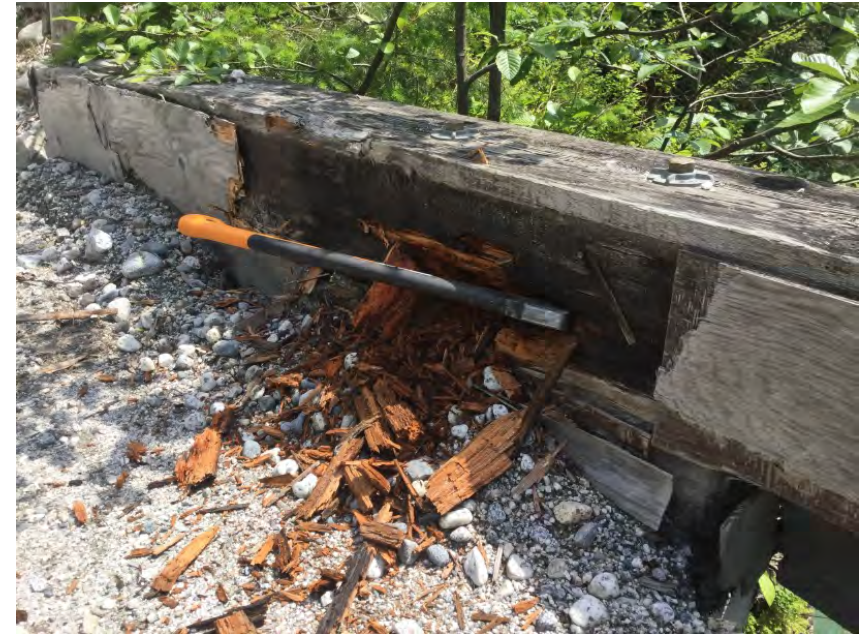
No posts all pushed off road with grader and should be reset

Guardrail condition at left approach

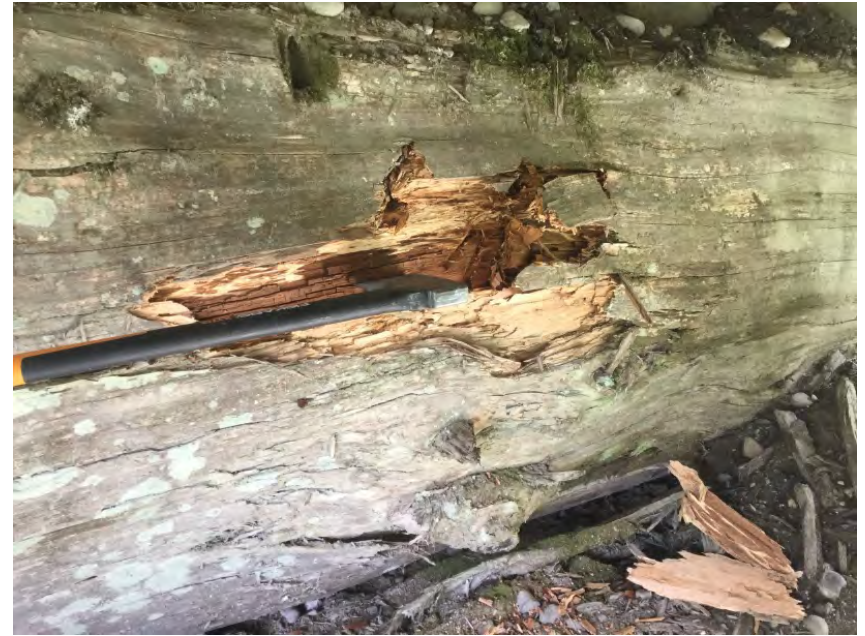
50-70mm sap rot in crib

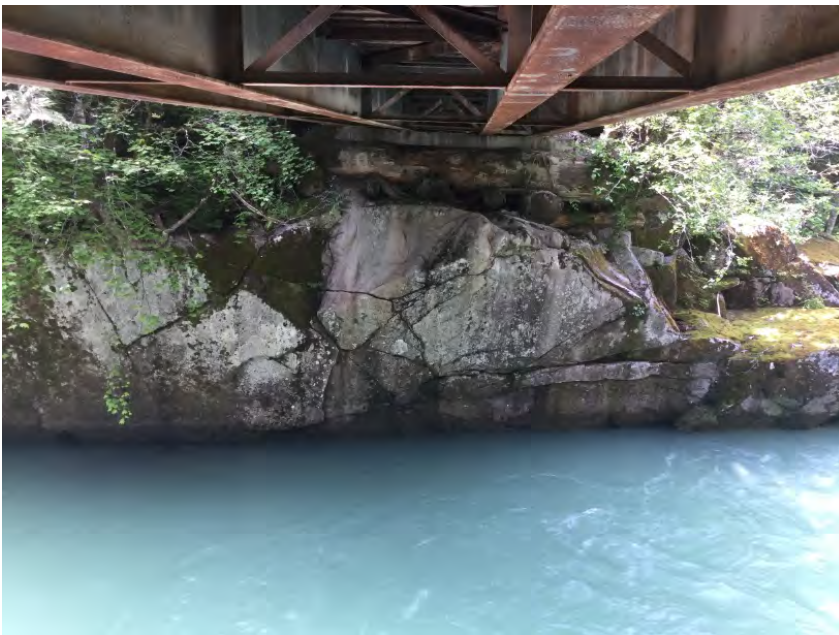
Right Bank Abutment when facing downstream

| Item | Monitor Description | Frequency |
|---|---|---|
| 1 | Sloping abutment at right bank | Anually |

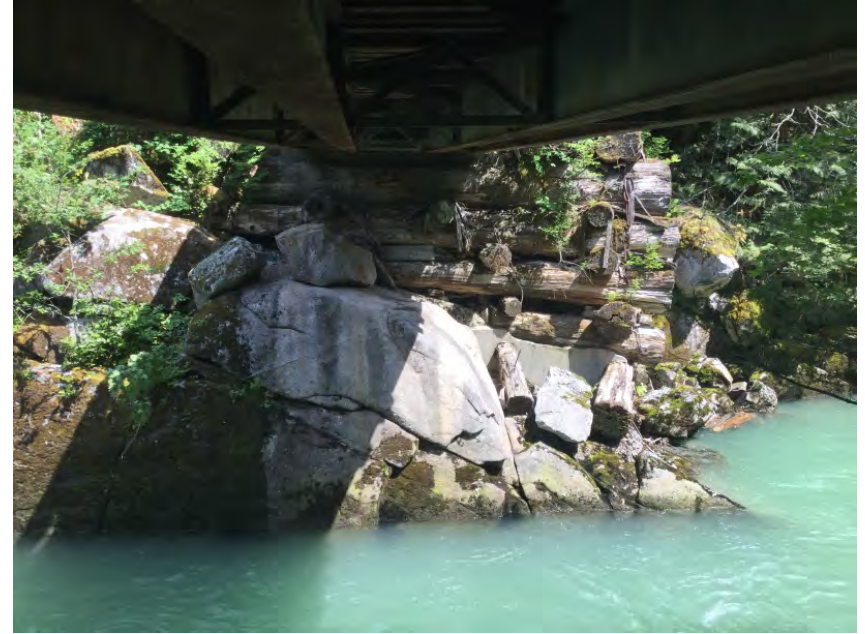
Left Bank Abutment when facing downstream

Fair to poor - Left bank is 4 face logs high at downstream and 2 upstream. Right bank is single log sill

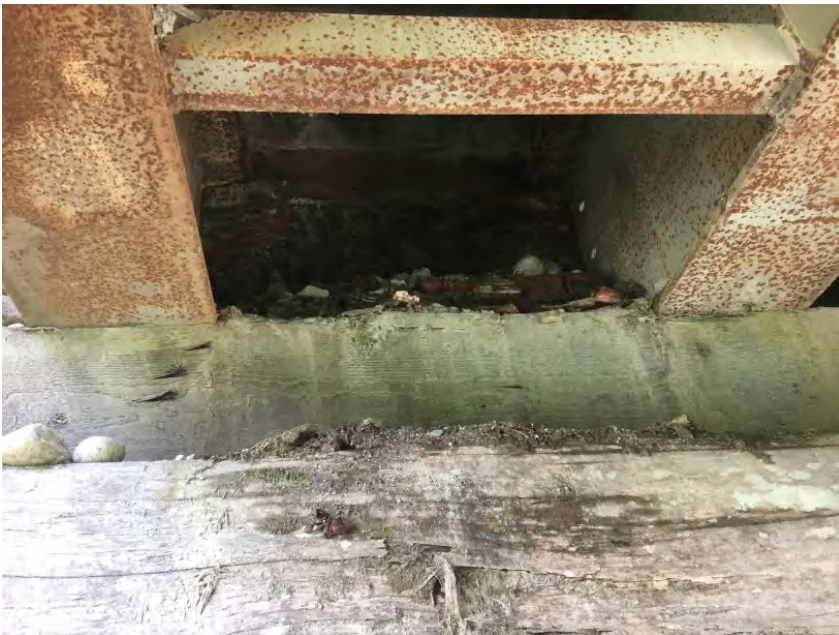
Rotten in locations and road fill will eventually start eroding through

Left bank ballast wall non existent in locations

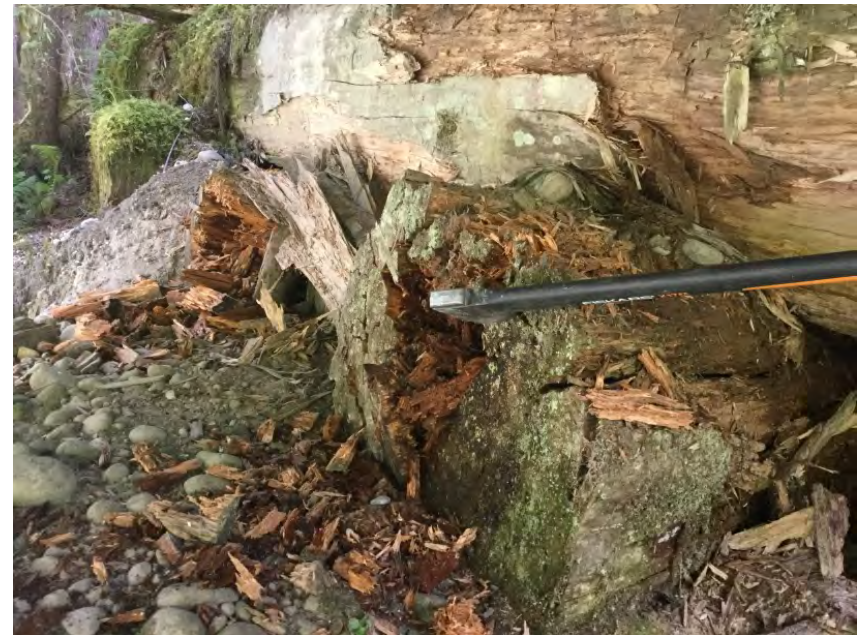
The right abutment slopes to the upstream at approx 3-5%. 3 of 5 mud sills are rotten, only the downstream and upstream ones competent with up to 100mm sap rot. Mud sill at upstream bearing on rock and log buried in fill and log has approx 100mm sap rot. The entire structure is considered to be at the end of its life and a complete replacement is recommended.

3 of 5 Mud sills on right bank rotten, only upstream and downstream still competent with 100mm sap rot noted

The timber deck is now at the end of its industrial life. The abutment is 32 years old and at the end of its industrial life. I recommend a complete replacement of the entire structure. Limit loading to L30 or 27 tonnes. Post load rating signs.

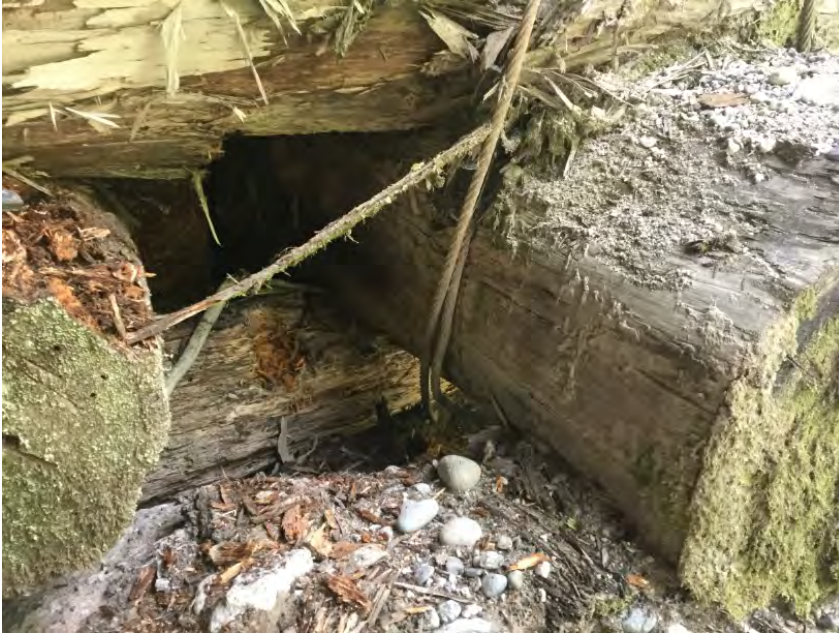
Upstream mud sill competent but bearing on rotten log in fill

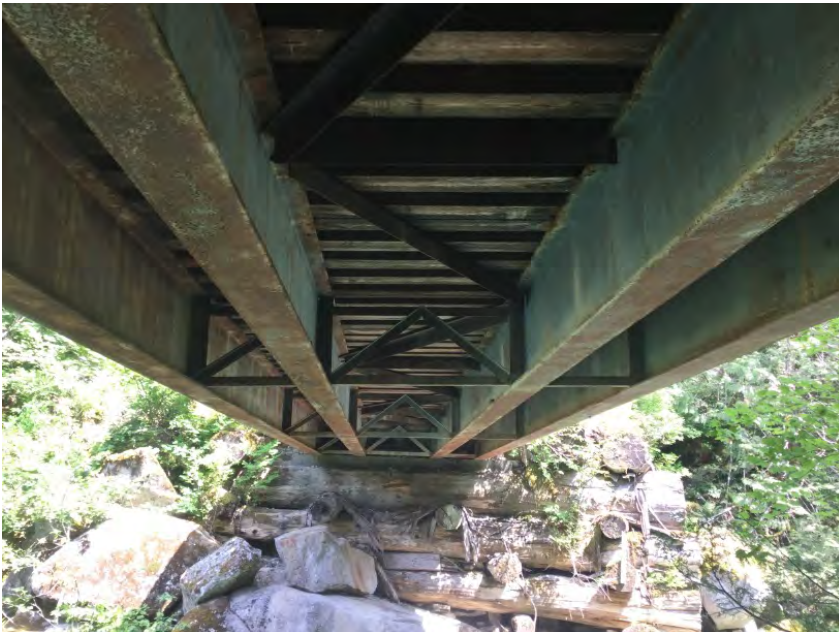
Superstructure

4 girders, Painted with corrosion. Girders appear to slope upstream at right abutment.
