CK-2274

STAVE 29.4km

2018 Inspection

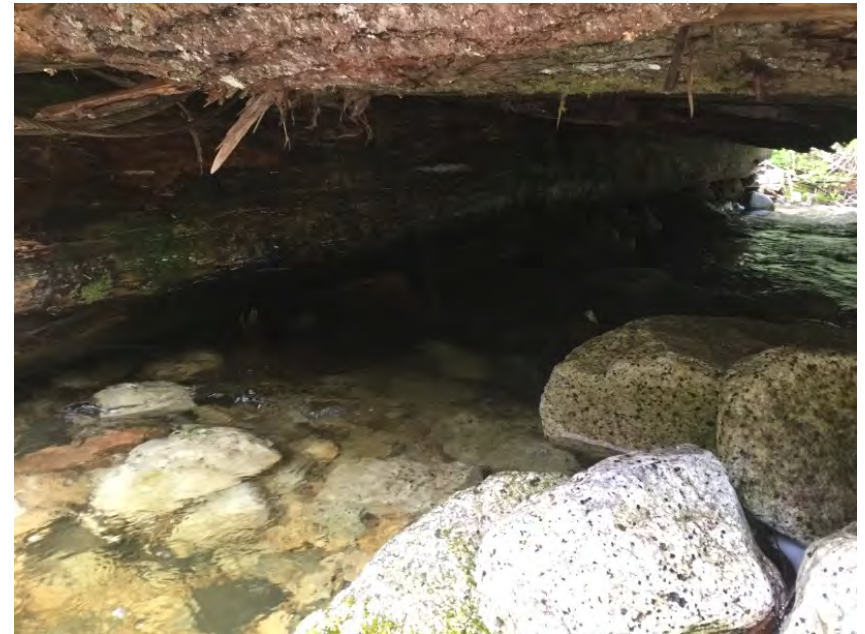
Left Bank Abutment when facing downstream

Left abutment scoured 80% length - 300mm gap and only bearing in 3 locations

Left abutment sill log 80% scoured

The bearing under the log sills continues to erode. The current load rating of 10 tonnes to continue. I recommend a complete replacement of the structure. Monitor for settlement and post bridge ahead signs.
