CK-2277

WINSLOW 0.9km

2018 Inspection

| Crossing Name | Beaver Dam Creek | | |

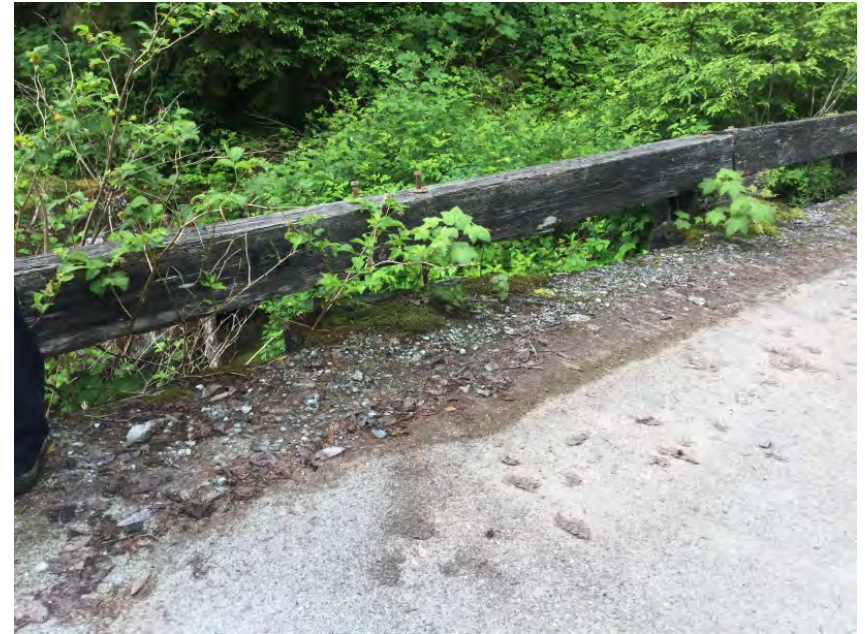
Guard Rail

| Curb Rail/Blocks/Posts | Poor | Rotten |

| Hardware | Poor | Loose rail bolts |

| Overall Deck Condition | Poor | Due to rail |

| 1 | Medium | Replace guardrail, risers and blocks |

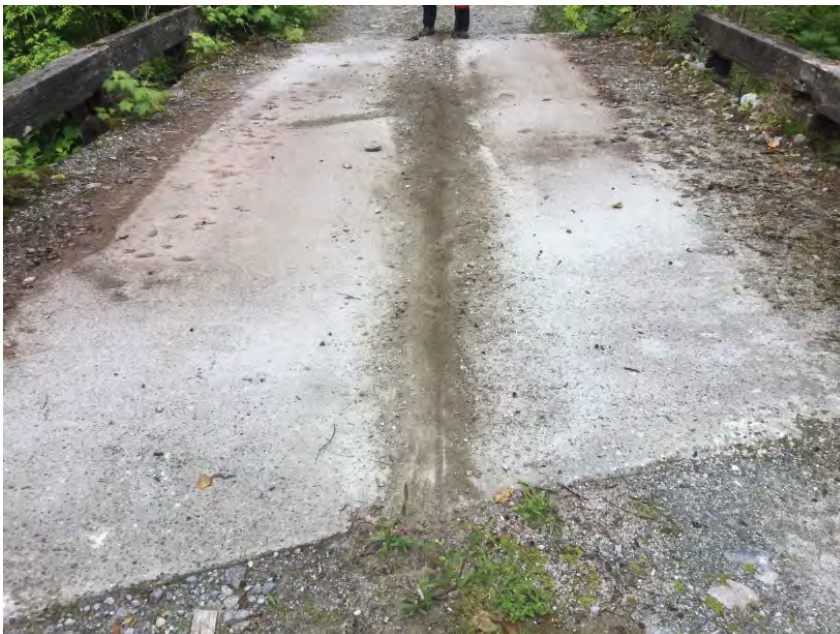
| Running Surface | Fair | Requires gravel fill at both approaches |

| Concrete Deck | Fair | Damage noted at either approach |

| 2 | Medium | Repair damage to deck |

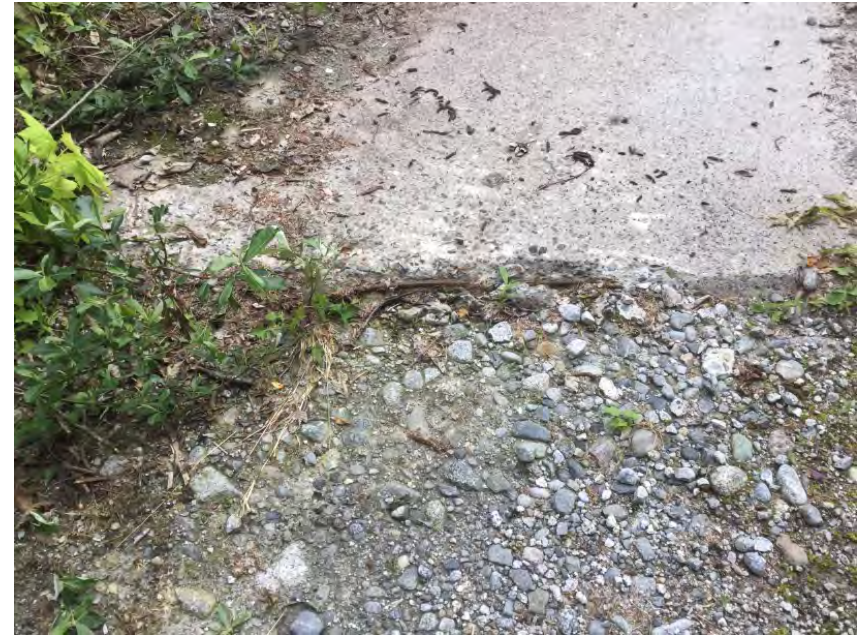
Deck damage at left approach

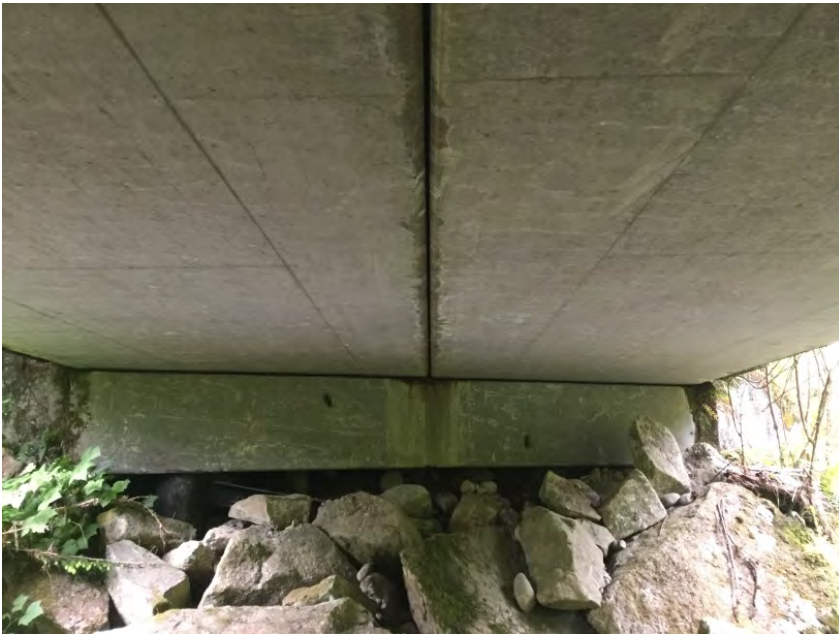
Superstructure

Girders Fair

2 concrete slabs with exposed rebar at girder ends
