CK-2285

TSILEUH 12.1km

2018 Inspection

| Crossing Name | Black Creek | | |

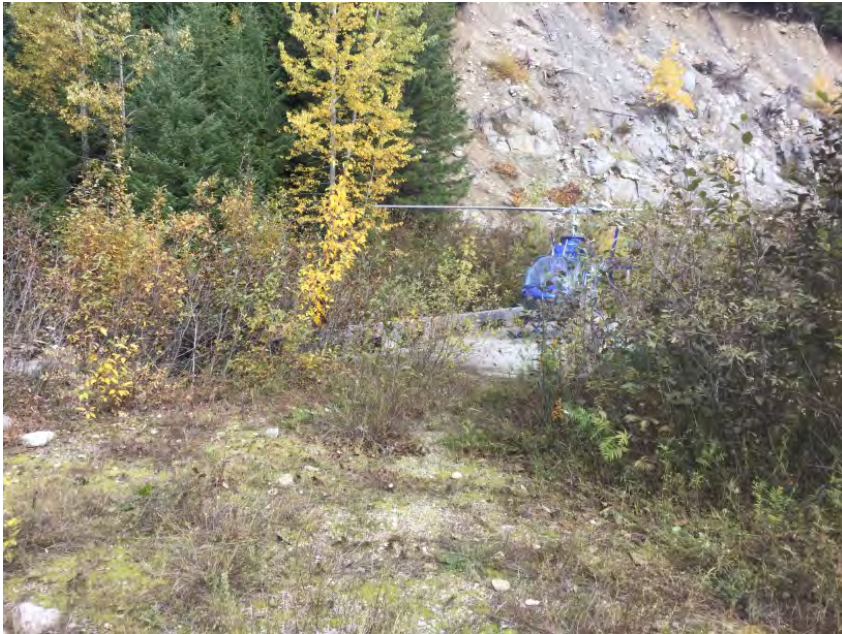
Approach from Right Bank when facing downstream

The FSR has failed 100m prior to the bridge and will require a significant repair

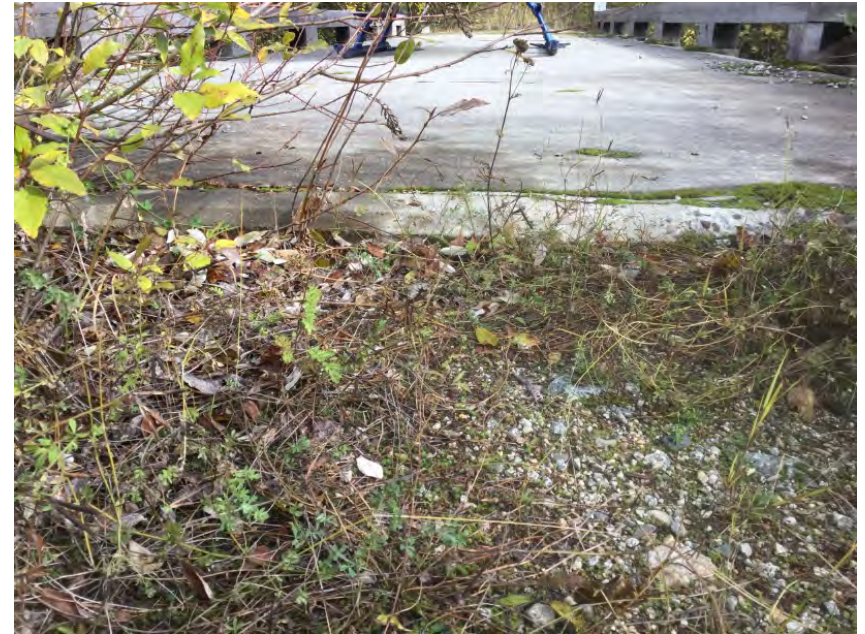
Deck elevation 100mm higher than road elevation

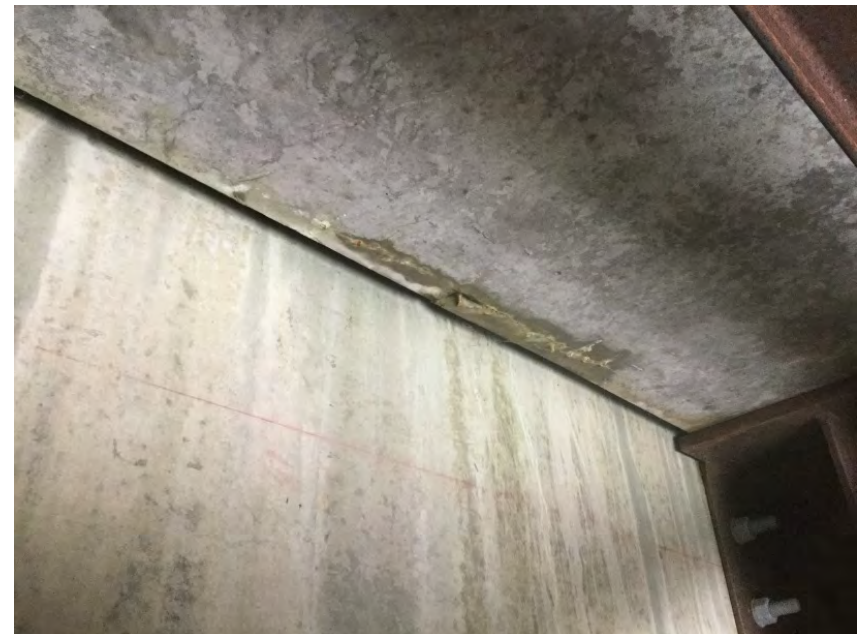
Minor damage noted to underside of panel 1 right bank

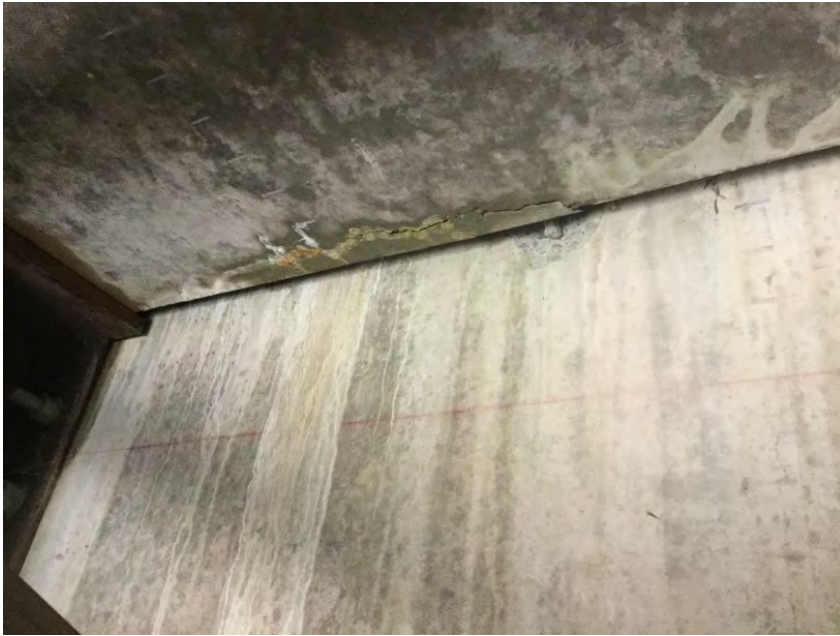
Minor damage noted to underside of panel 1 right bank

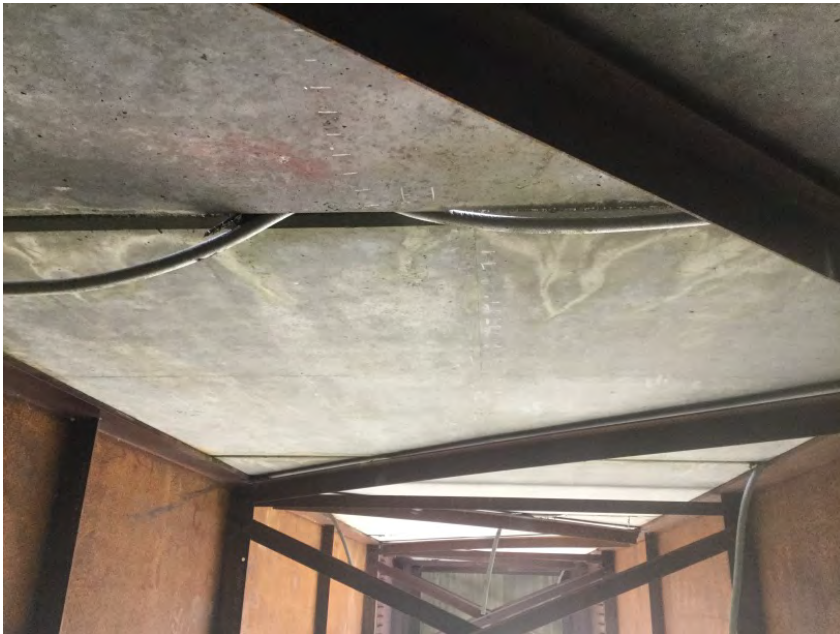
| Deck Joints | Poor | All foam backing and paraseal have failed |

Foam backing coming out of all deck joints

| Item | Priority | Repair Description |
|---|---|---|
| 1 | Medium | Replace all deck seals |

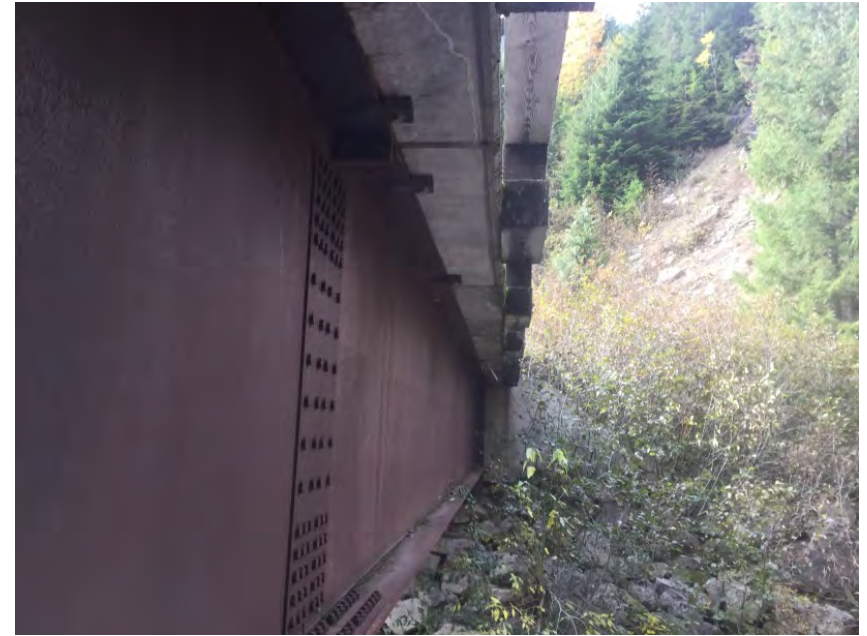
| Deck to Girder Bolts | Fair | Combination of clips and bolts |

Deck clips and bolts

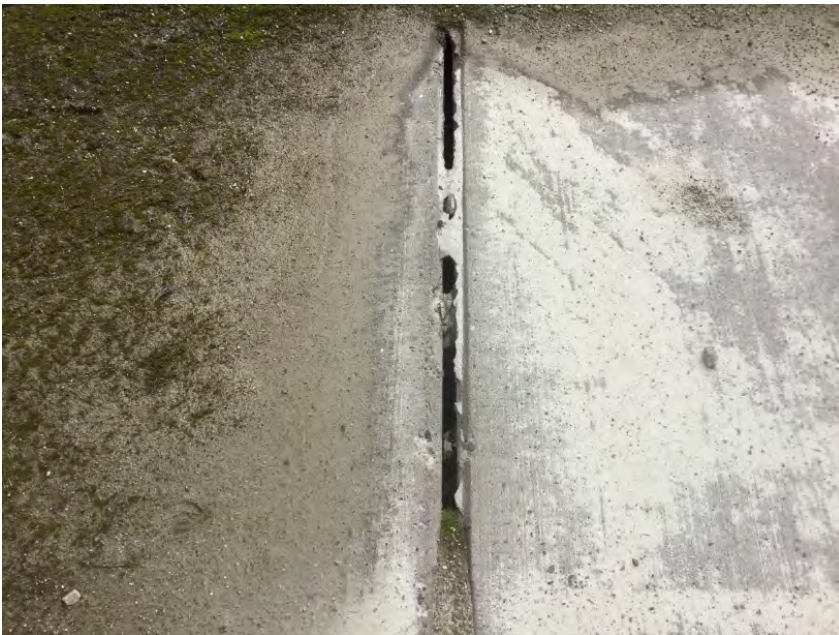
Deck seals all failed
