CK-2286

TSILEUH 17.7km

2018 Inspection

| Crossing Name | South Fork Tsileuh Creek |

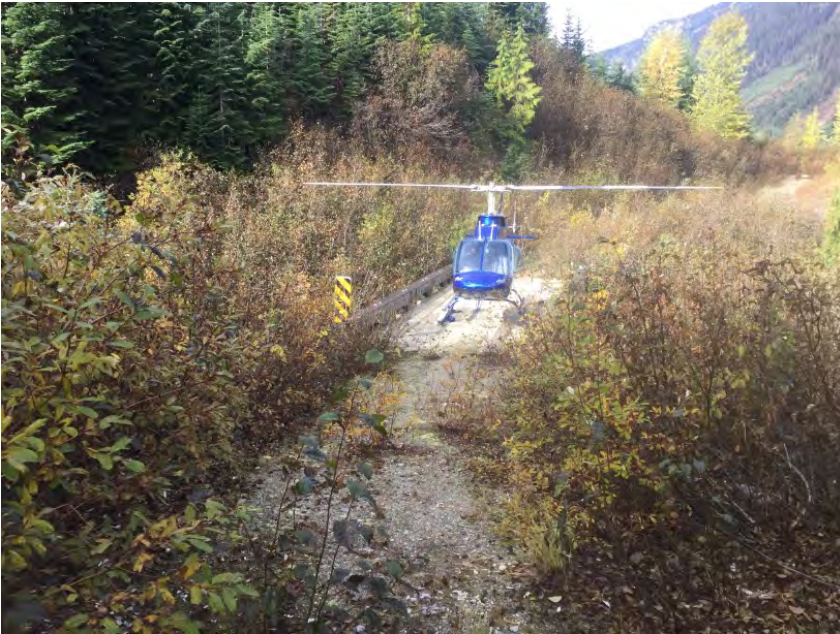
Approach from Right Bank when facing downstream

Alignment Fair

Brushing Required Y

| Item | Priority | Repair Description |
|---|---|---|
| 2 | Medium | Brush approaches and post bridge ahead signs |

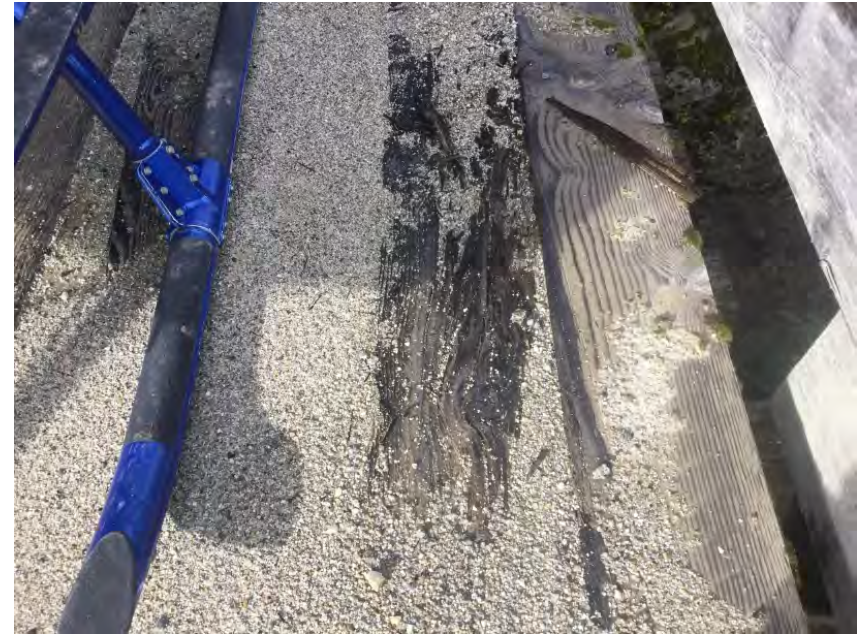
| Running Planks | Poor | Approach timbers showing wear along with random sections throughout |

| Overall Deck Condition | Poor | Due to riser and rail condition |

| Item | Priority | Repair Description |
|---|---|---|
| 1 | Medium | Replace planks, guardrail and risers |

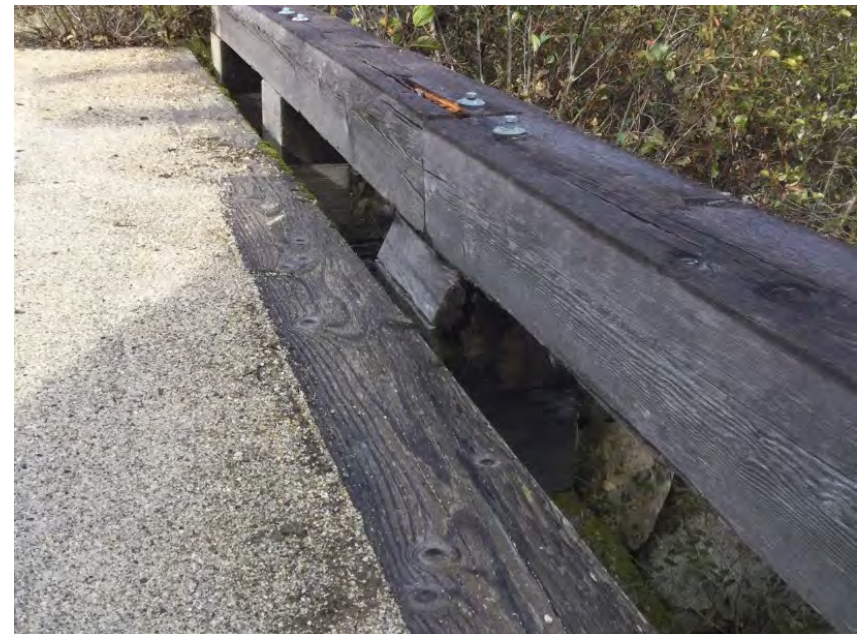
Guard Rail

| Curb Rail/Blocks/Posts | Poor | Rotten risers |

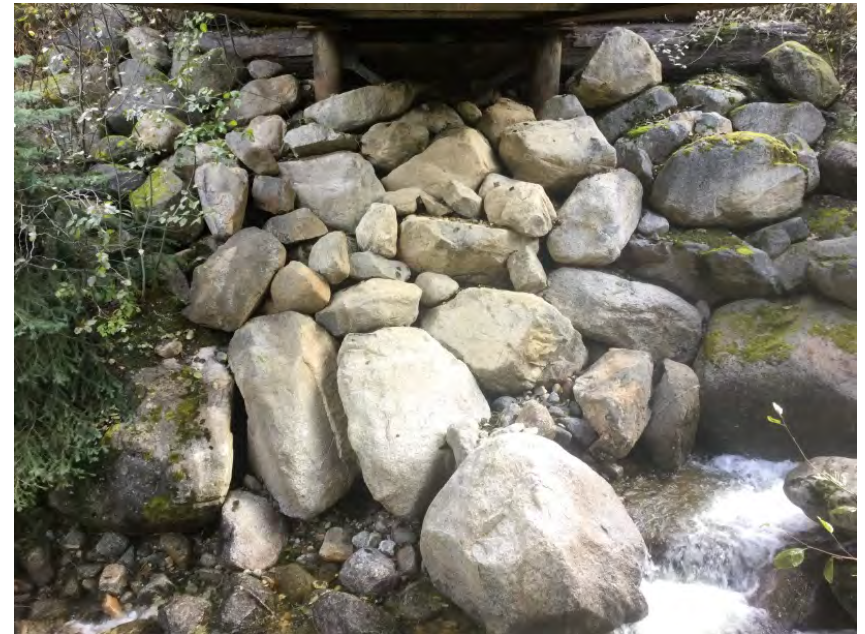
Right Bank Abutment when facing downstream

Piles or Posts Fair

Ballast Wall Fair Logs

Riprap Fair Large round rock at 1.25:1 slope and not well graded but stable

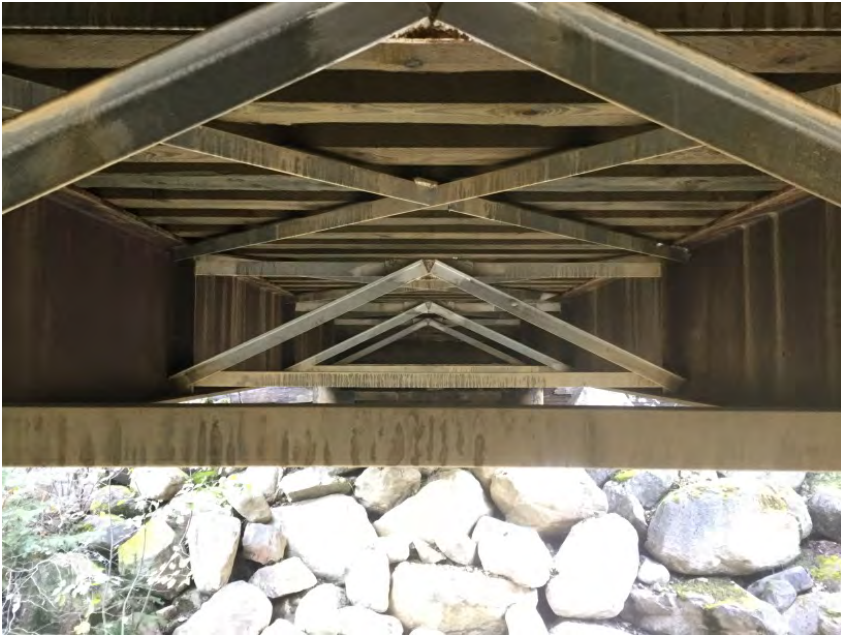
Superstructure

Girders Fair

Diaphragms Good 5 welded bays, galvanized

Bracing Good Galvanized
