CK-2287

SILVERHOPE 0.6km

2018 Inspection

| Crossing Name | Silverhope Creek (structure # |

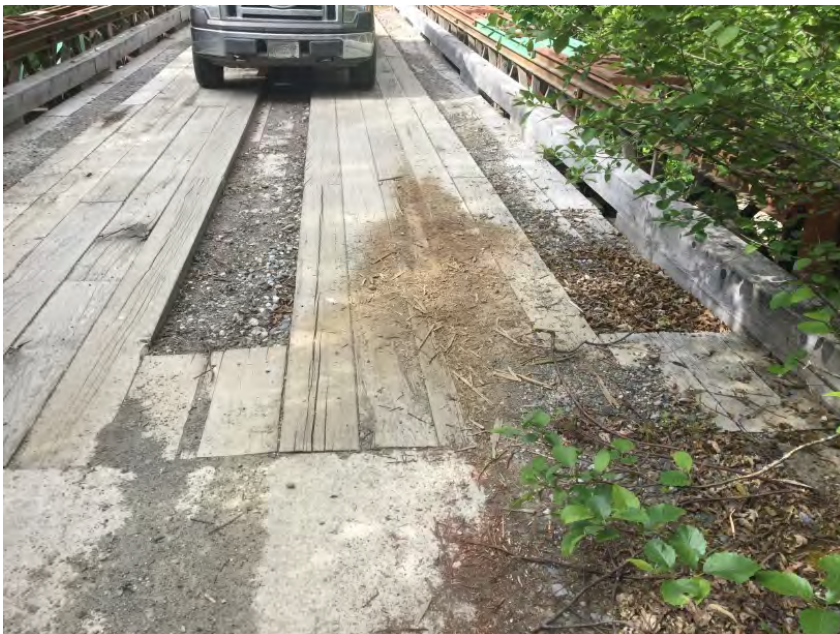
| Running Planks | Poor | Rotting |

| Sub Deck | Poor | Rotting |

| Ties | Poor | Rotting |

| Nails | Poor | Protruding |

| Overall Deck Condition | Poor | Due to timber condition |

Deck condition

Brush approaches, replace missing delineators and post bridge ahead signs. The timber deck is old and rotting, replace entire deck system. Monitor the lockblock condition. Current load rating of L45 or 41 tonnes to continue. Post load rating signs.

| Repair Item | Priority | Repair Description |
|---|---|---|
| 3 | Medium | Replace entire imber deck |

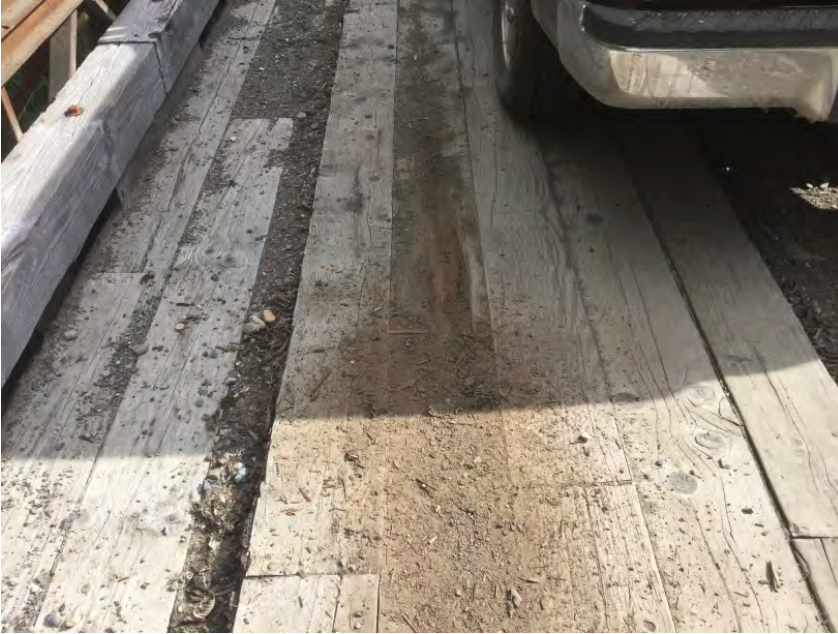
Deck condition

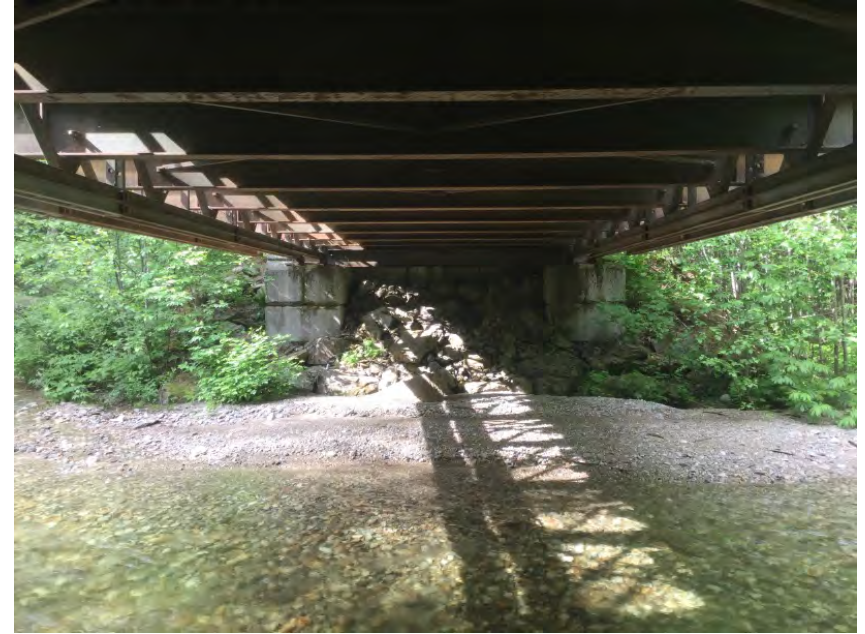
Left Bank Abutment when facing downstream

Concrete **Poor** **Left abutment poor with cracking blocks**

Ballast Wall **Fair** **Transoms in front of lock blocks**

| Item | Monitor Description | Frequency |
|---|---|---|
| 1 | Lock block condition | Routine Inspection |

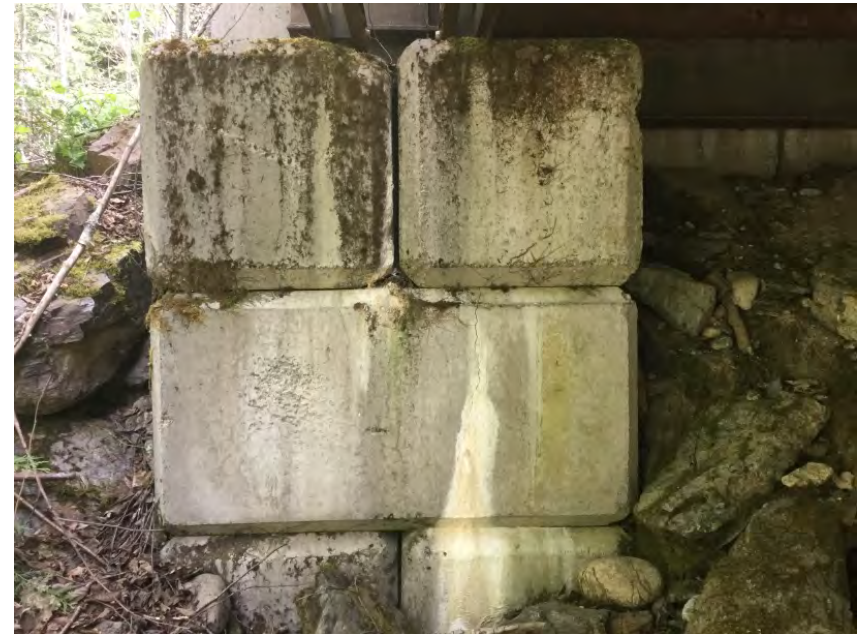
Downstream right bank lockblock cracked with efflorescence

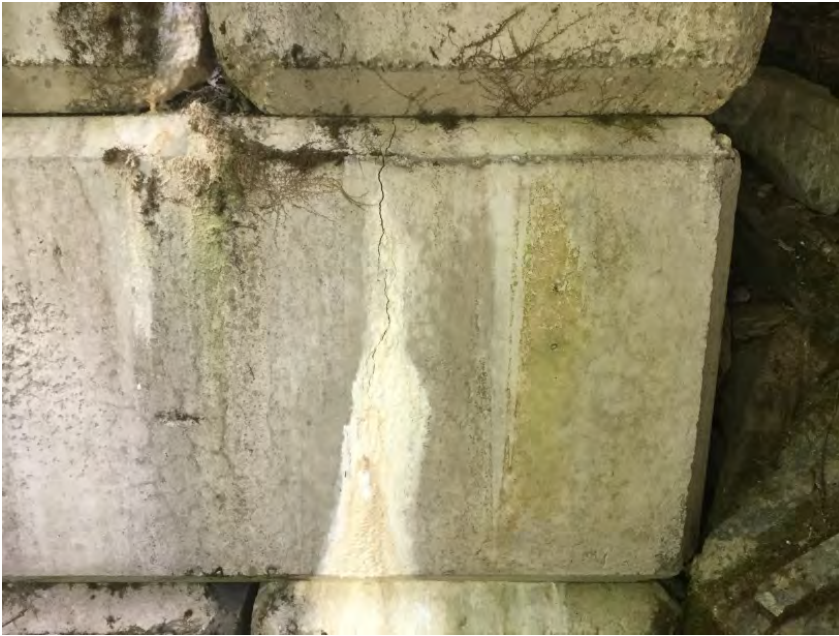
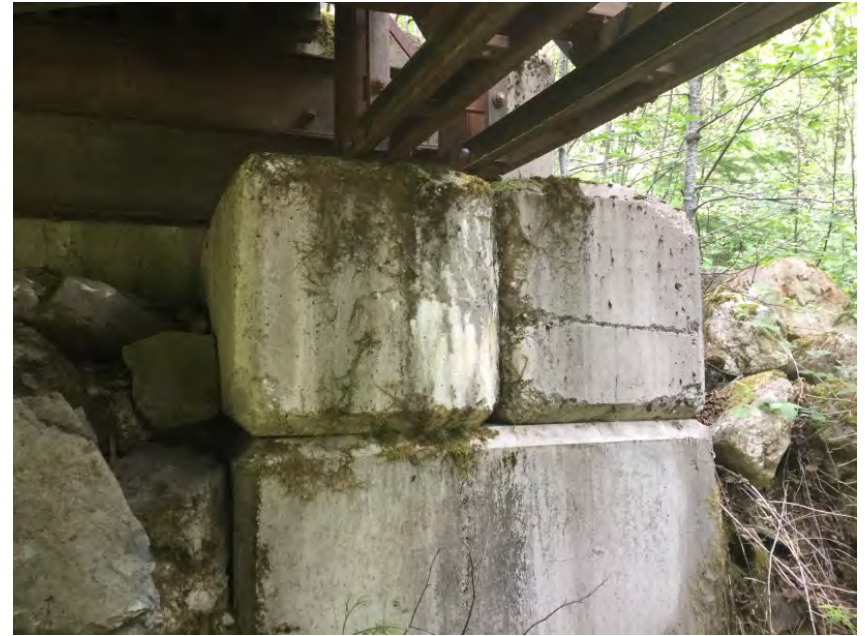
Lockblock condition

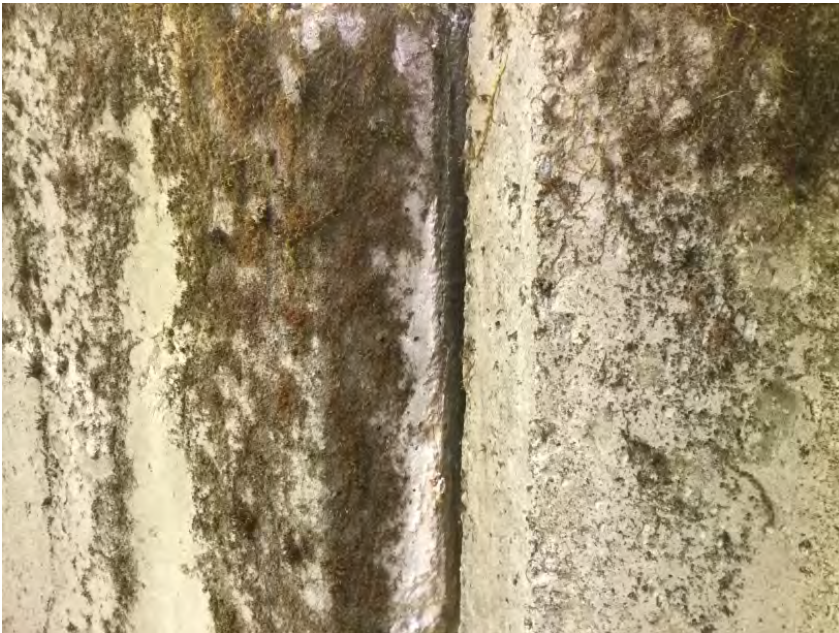
Another lockblock cracking

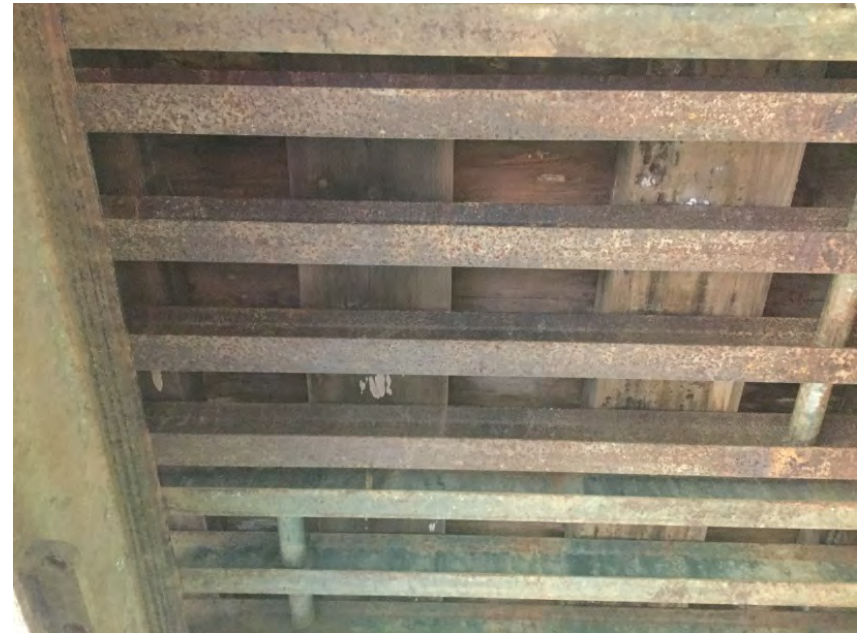
Deck from underneath

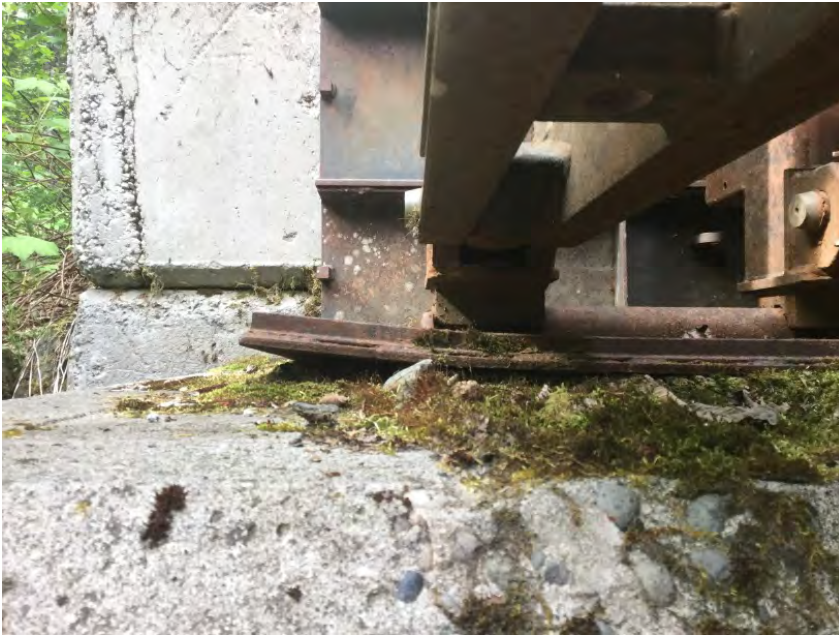
Bearings **Fair**

Upstream left bank bearing plate

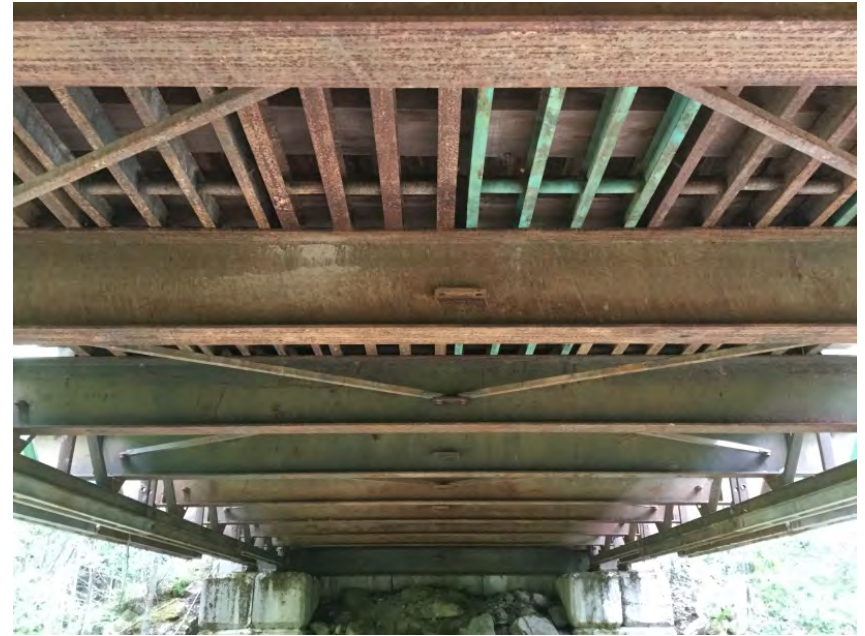
Girders Fair

Double single reinforced acrow/bailey

Bracing Fair

Hardware Fair

Superstructure
