CK-2288

UZTLIUS CREEK 6.4km

2018 Inspection

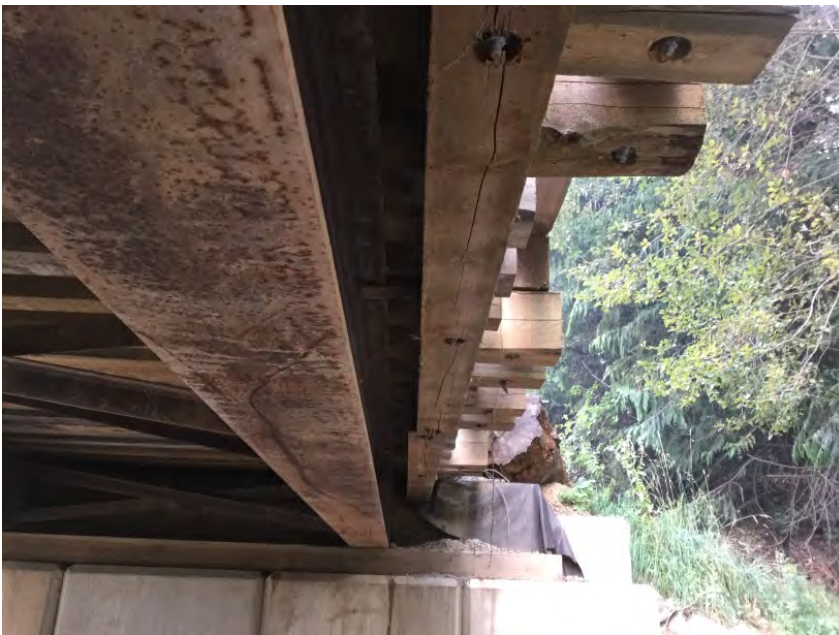
Modular deck panels are only fastened in 3 locations upstream and 3 locations downstream, monitor for movement

Deck to Girder Bolts      **Fair**      Only 3 clips per end noted

Only 3 Deck clips per end

Grade approaches and post bridge ahead signs. The current load rating of L100 or 91 tonnes to continue. Monitor the deck panels for movement.

| Item | Monitor Description | Frequency |
|---|---|---|
| 1 | Modular deck panel movement | Routine Inspection |
