CK-2300

UZTLIUS CREEK 13.4km

2018 Inspection

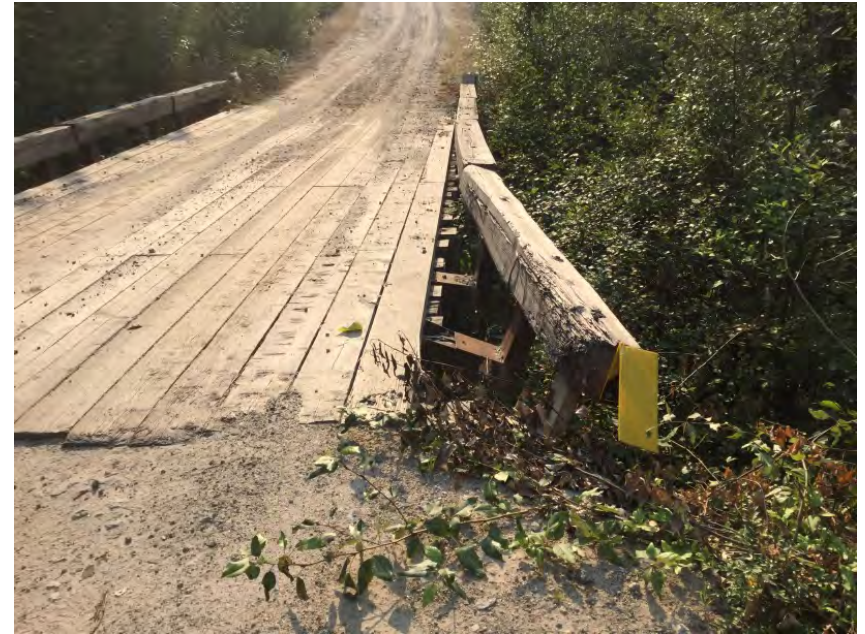
Curb Rail/Blocks/Posts Poor Damaged downstream right approach

Overall Deck Condition Poor Due to rail condition

Damaged guardrail at downstream right approach

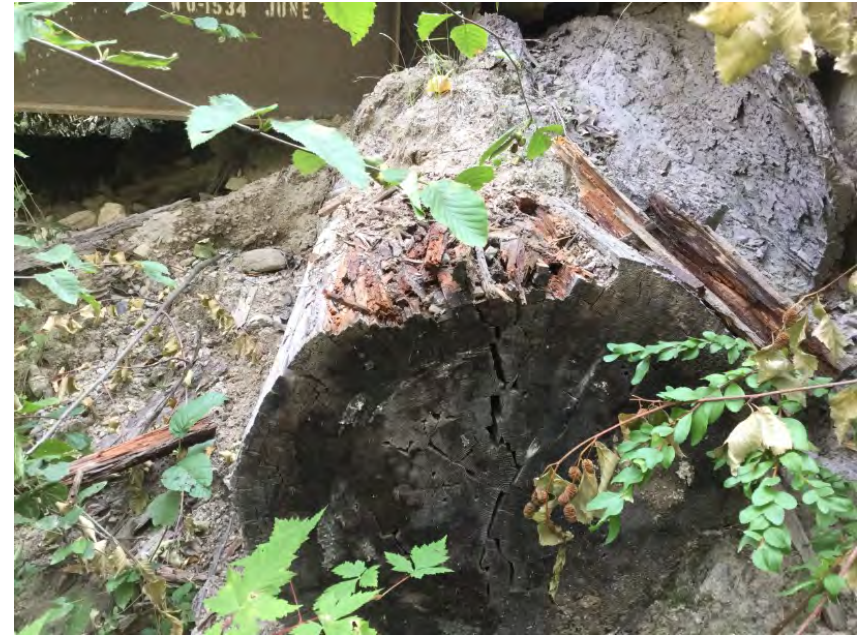
Caps or Sills Poor Significant sap rot in both sills - only for steel girder

Log sill at left bank in poor condition

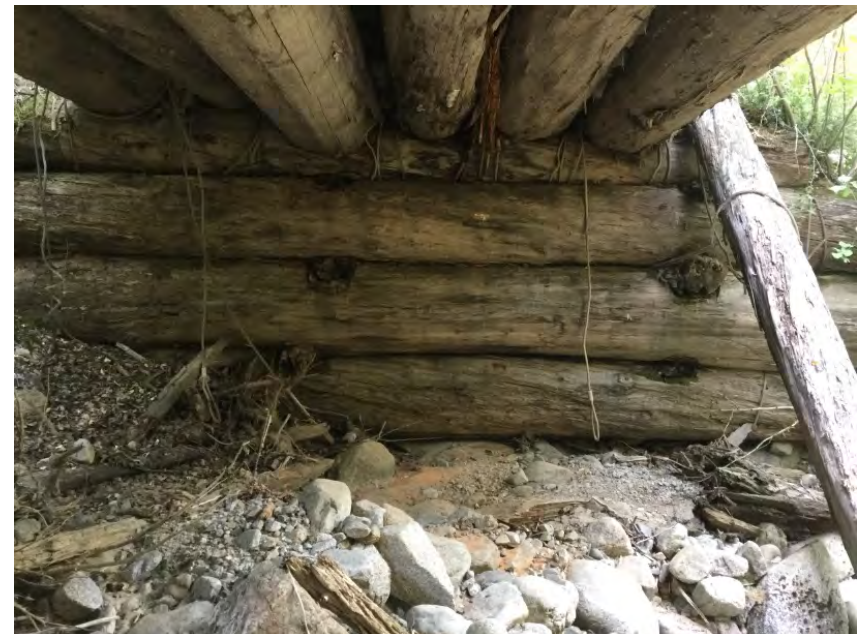
Left Bank Abutment when facing downstream

Log/Timber Cribs Poor Old and rotten - for log stringer structure

Tie Backs Poor Old and rotten - for log stringer structure

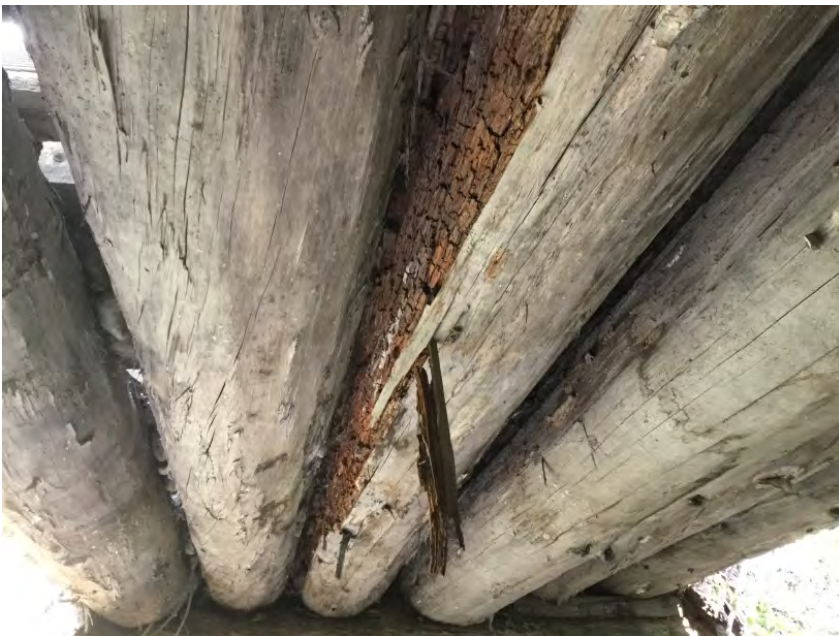
The old log stringer bridge condition puts the steel girder with timber deck structure at risk. Monitor old stringers for failure.  
BMs noted onsite  
Continue with pickup traffic

Log stringer condition

The current load rating of 5 tonnes to continue. Replace structure soon.

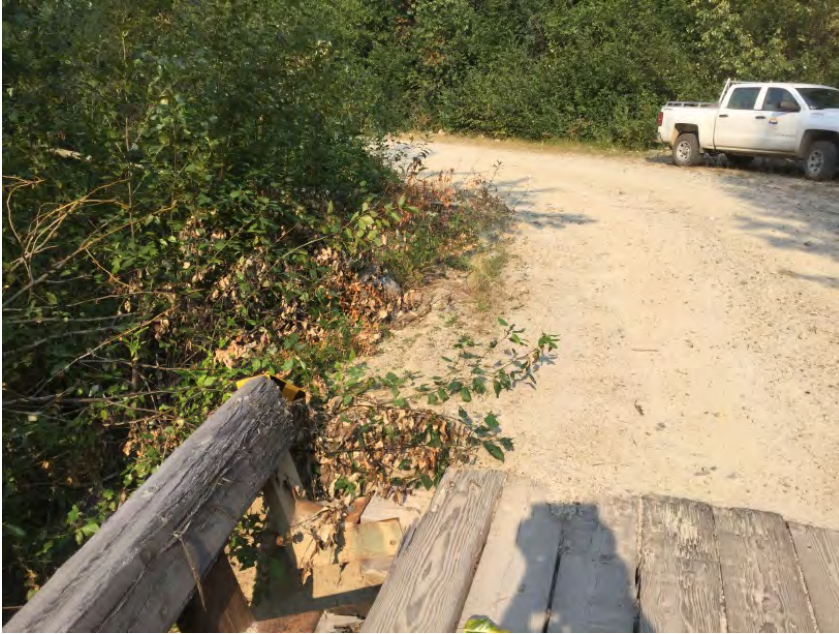
No fender log downstream right approach

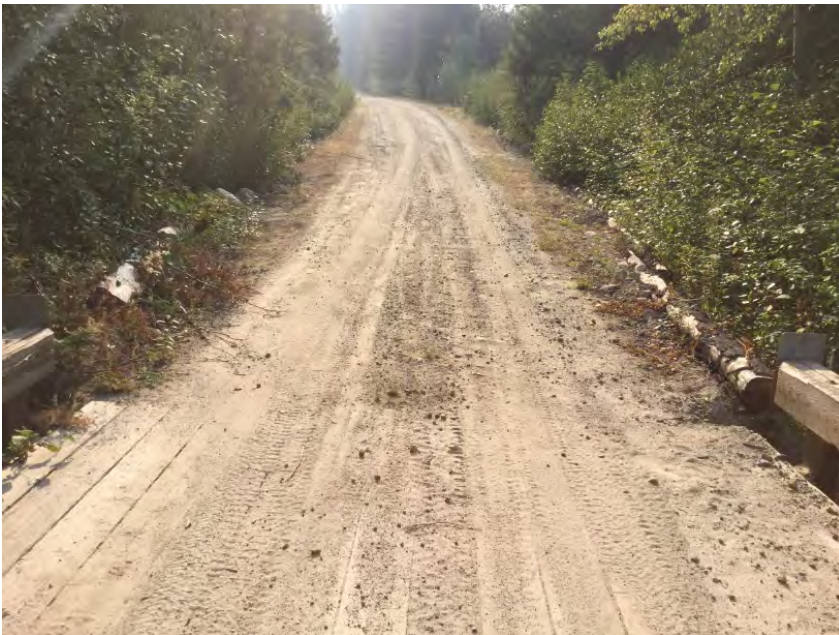
Insufficient log fenders at left approach
