CK-2302

UZTLIUS CREEK 35.4km

2018 Inspection

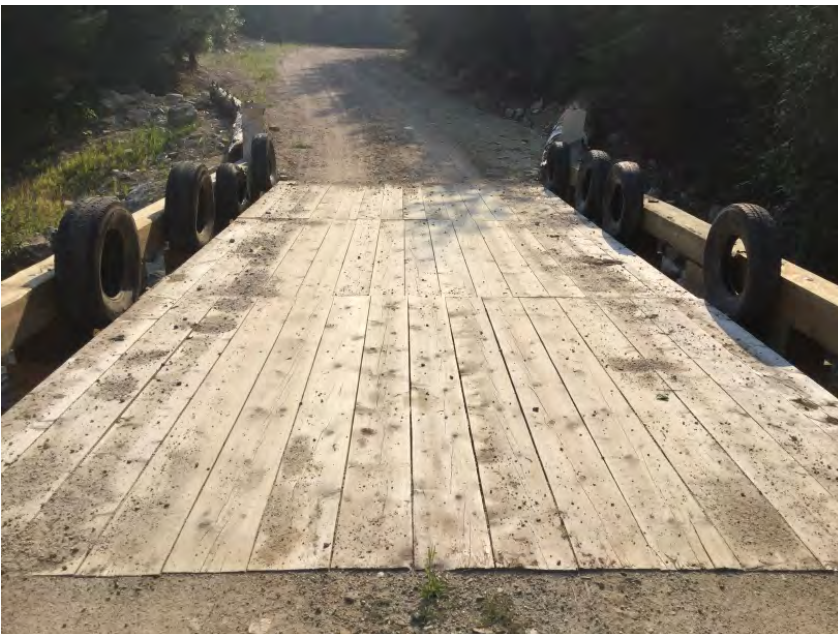
Overall Deck Condition      Fair

The current load rating of L100 or 91 tonnes to continue. Monitor deck panels for movement.

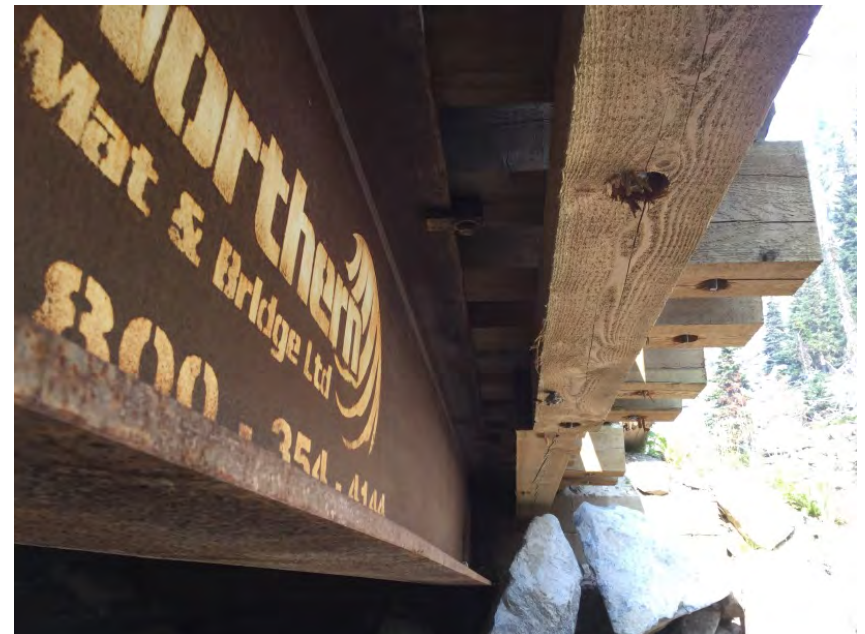
Deck clips

Deck to Girder Bolts      Fair      Only fastened to girders at 3 locations both ends

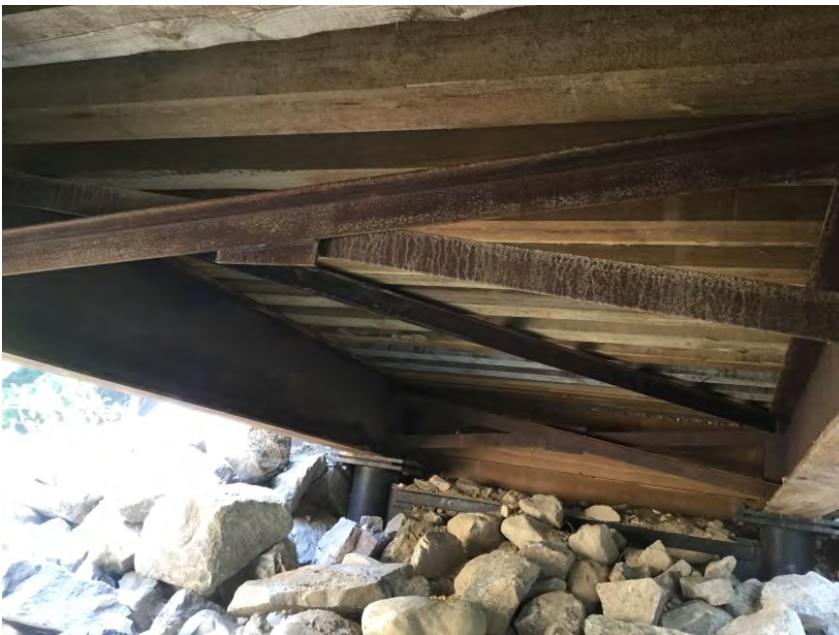
Superstructure

Girders **Good**Diaphragms **Good**Bracing **Good**
