CK-2306

UZTLIUS-E ANDERSON 27.2km

2018 Inspection

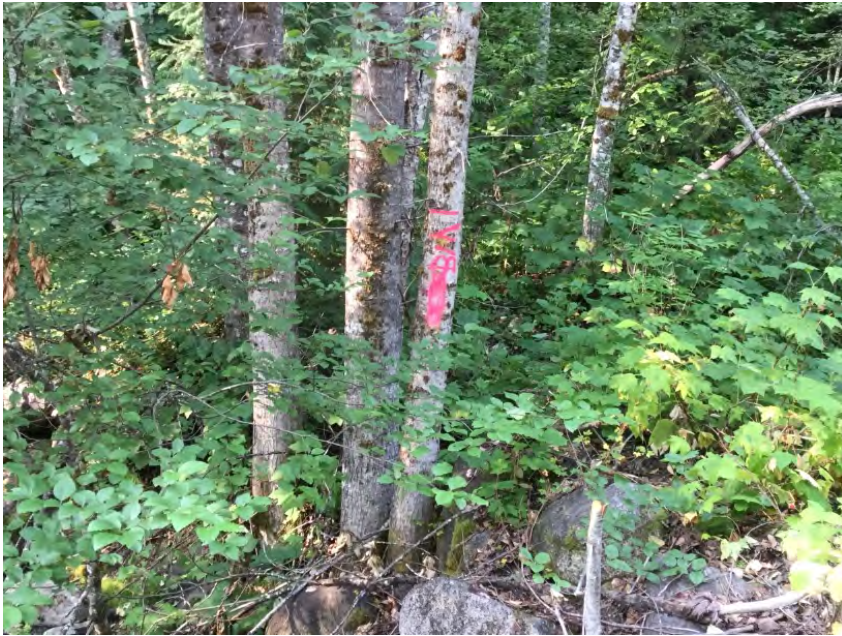
Recently surveyed

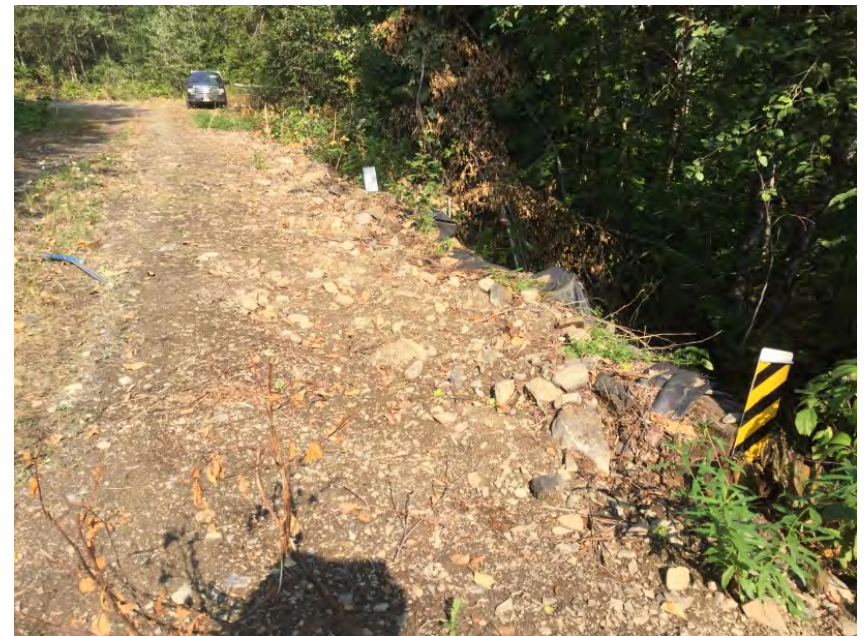
| Curb Rail/Blocks/Posts | Poor | Too low |

No bull rail downstream

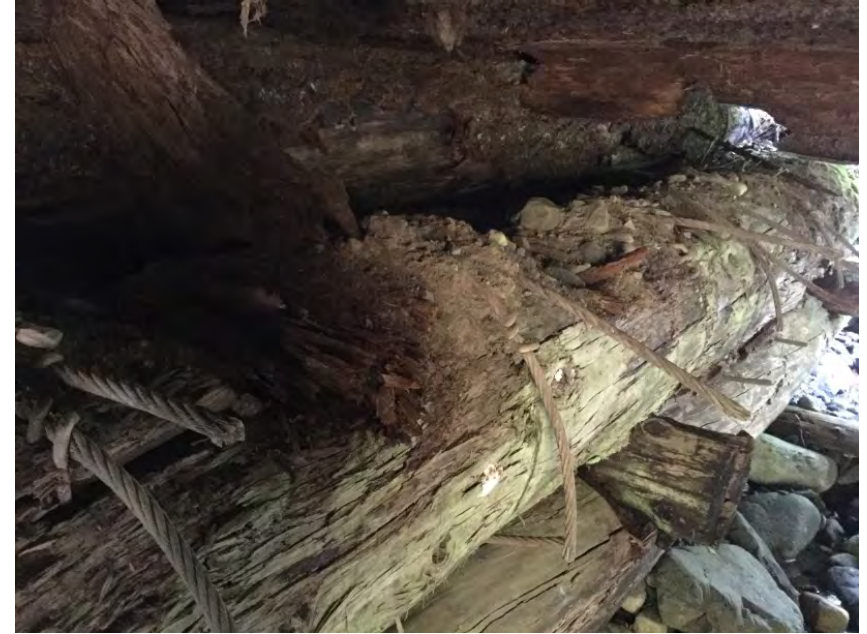
Right bank sill 1m behind old log crib. Crib has been extensively scoured and is risk to rotating. When it does rotate the fill behind it will fail and so to will the existing bearing sill. Because of the issues with abutment the stringers were not assessed for rot as the replacement structure will need to be longer and the stringers unusable. That said the stringers do not appear to be very old with minor sap rot starting (all Fd stringers). The site has been recently surveyed.

Bearing sill at right bank 1m behind scoured crib

| 1 | High | Replace entire structure |

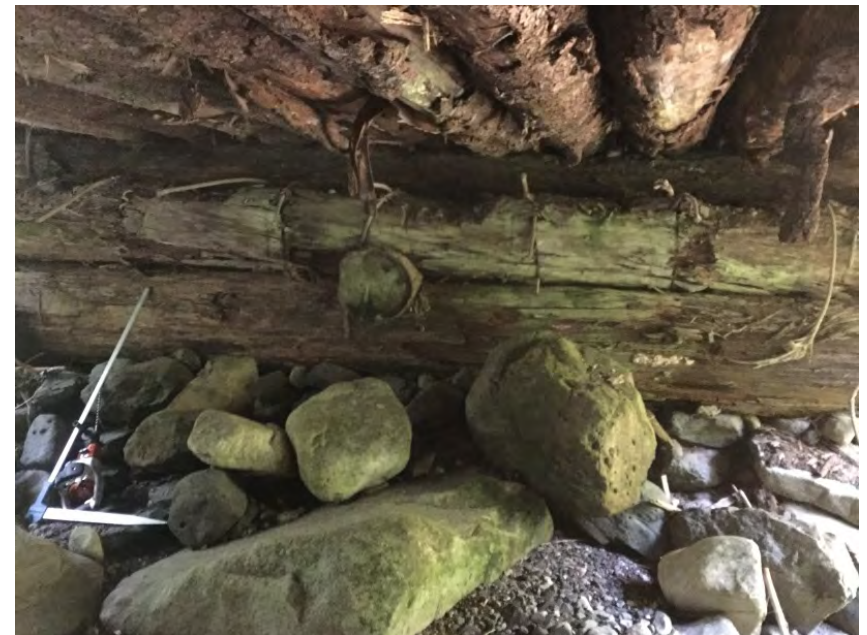
Left Bank Abutment when facing downstream

Log/Timber Cribs Poor Old, rotten and undermined - only supporting fill

Fill Poor Failing under left crib
