CK-2307

UZTLIUS-E ANDERSON 12.8km

2018 Inspection

| Crossing Name | East Anderson Creek |

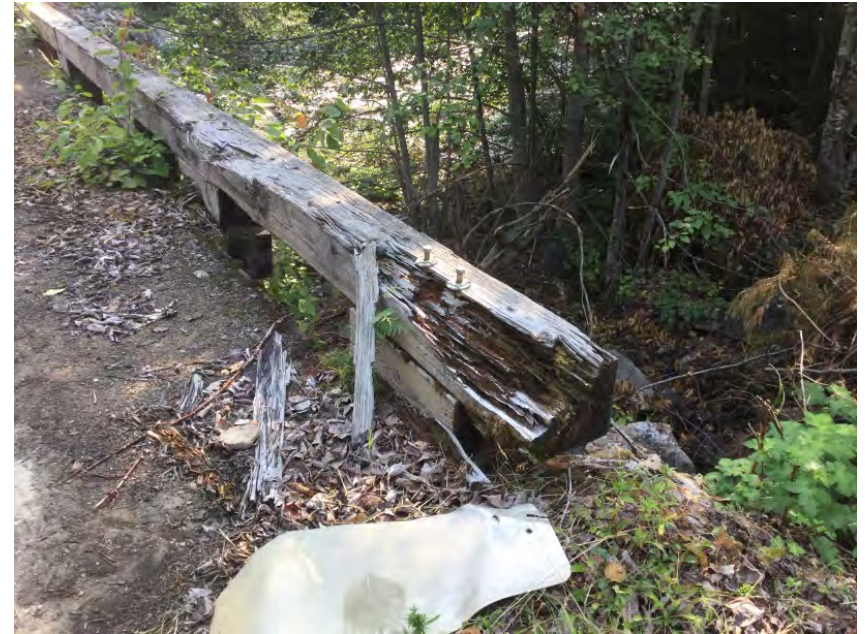
Guard Rail

Curb Rail/Blocks/Posts      Poor      Rotten

Hardware      Poor      Loose rail bolts

Overall Deck Condition      Poor      Due to rail

| Item | Priority | Repair Description |
|---|---|---|
| 1 | High | Replace guardrail, riser and blocks |

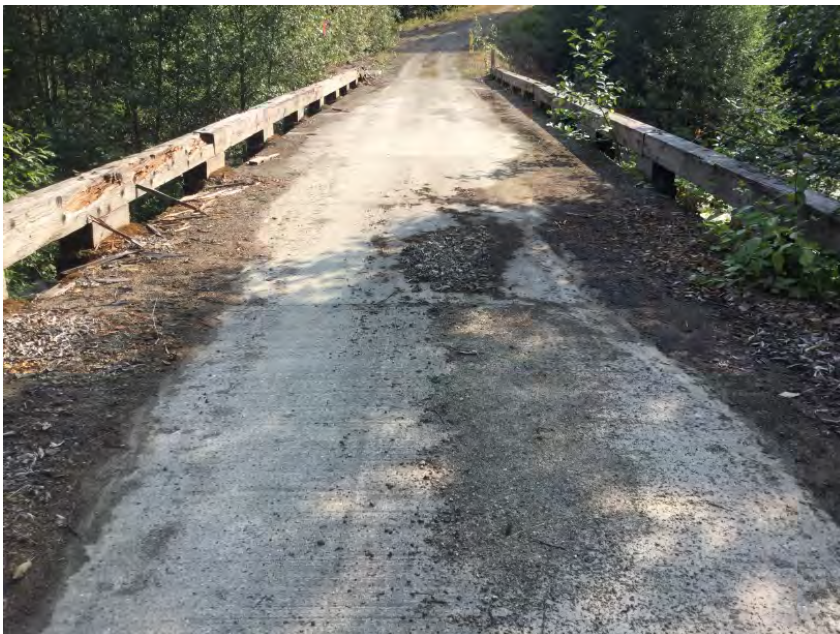
Concrete Deck      Fair      Some damage from tracked equipment

Deck Joints      Fair      Hairline cracks noted at surface

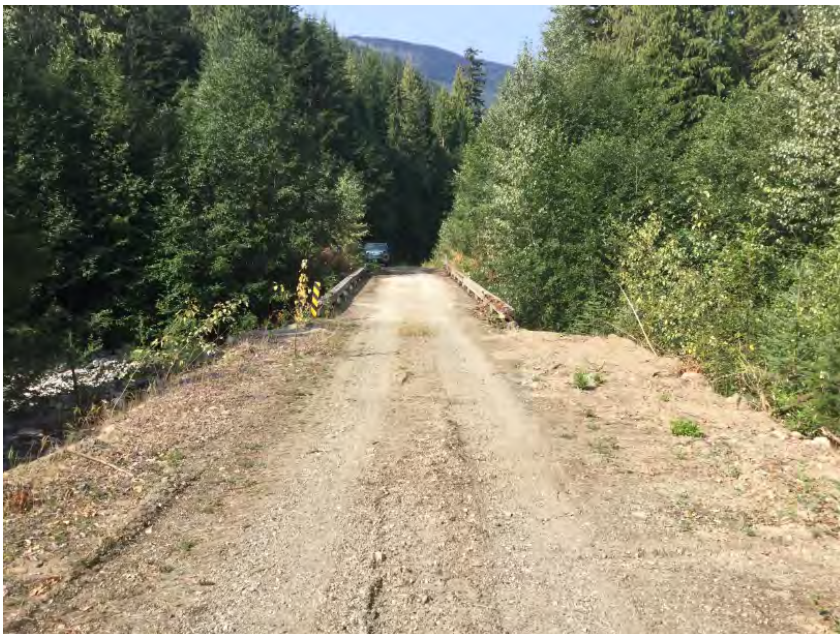
Approach from Right Bank when facing downstream

VC left approach and HC and VC right approach

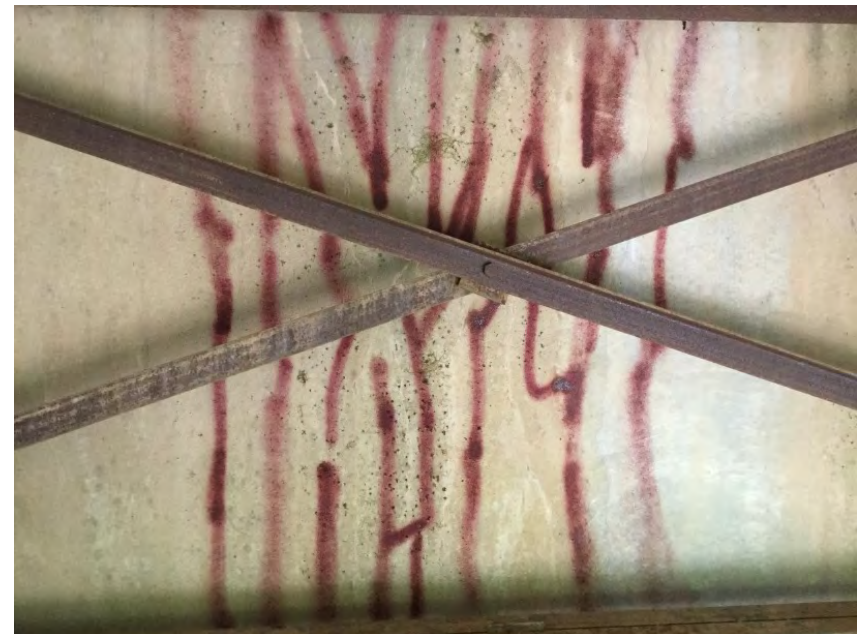
Ballast Wall Fair

Hairline cracks noted on both walls

Hairline cracks noted on right bank ballast wall

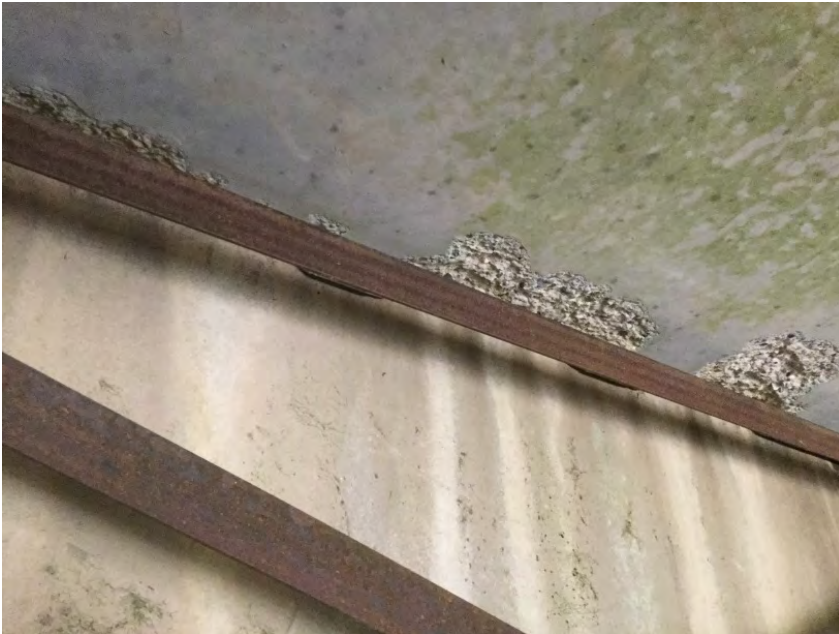
Comments    Repair damage to underside of panel 1

Damage noted to underside of panel 1 at left bank

| Item | Priority | Repair Description |
|---|---|---|
| 4 | Medium | Repair damage to concrete deck panel consistent with the Concrete Repair Guide for Concrete Bridge Components (FLNRO, 2017). |

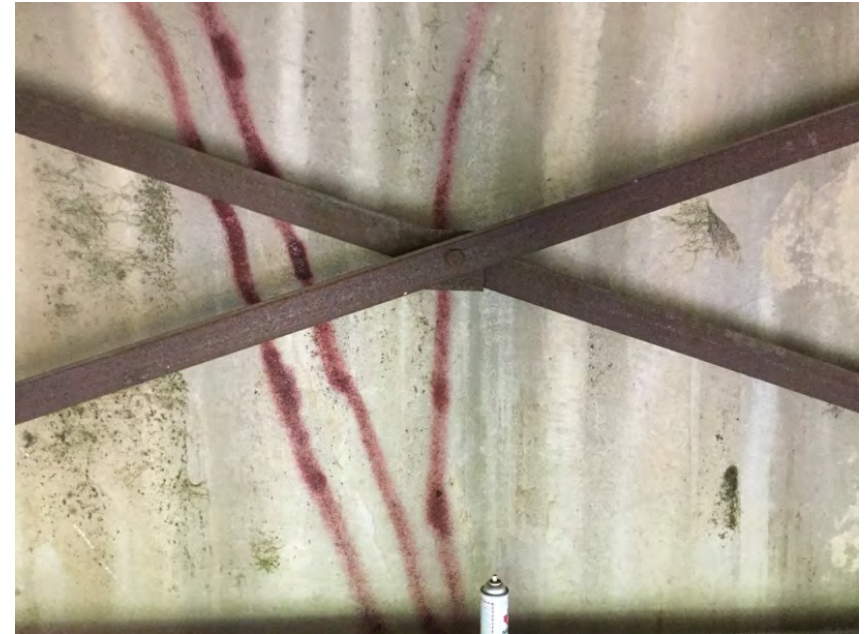
Hairline cracks noted on left bank ballast wall
