CK-2308

UZTLIUS-E ANDERSON 29.3km

2018 Inspection

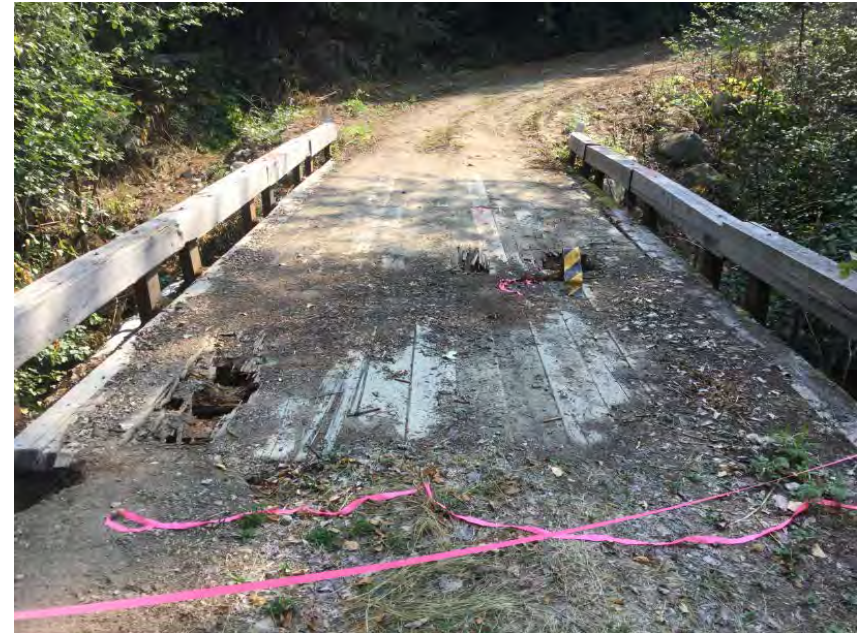
Overall Deck Condition

Poor

Rotten

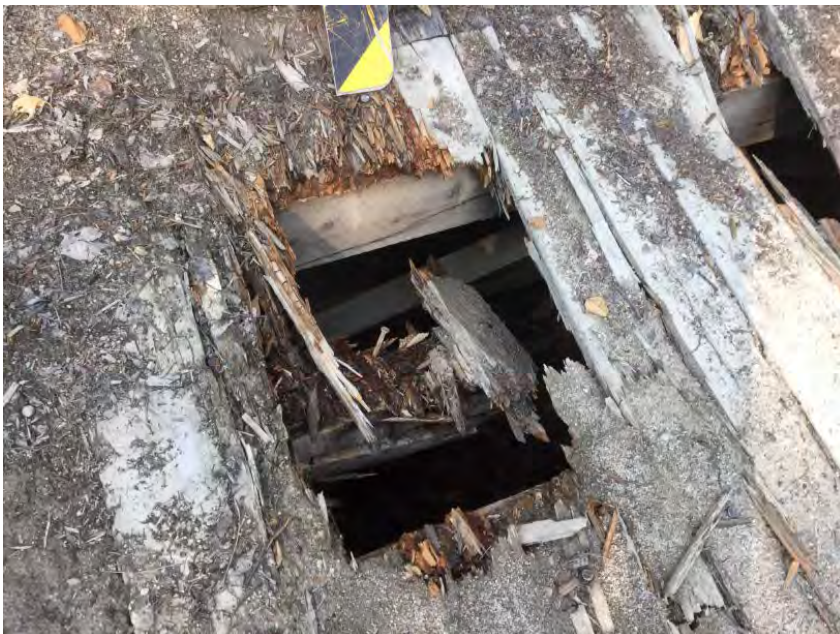
Rotten and broken

Broken tie

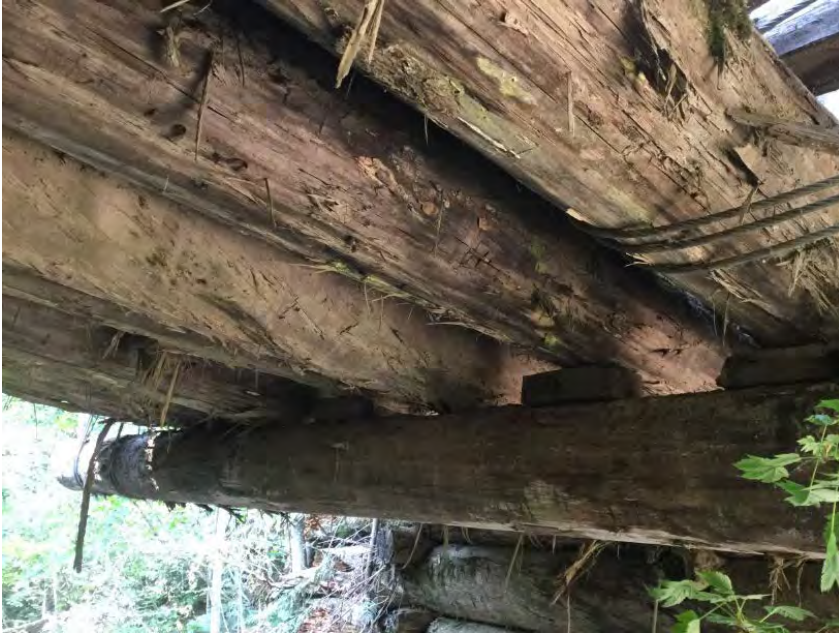
Log stringers

The entire log stringer structure (lower structure) is in poor condition. The log sills and timber deck on the steel girder are also in poor condition. Bridge was condemned in 2016 but access still exists. The site appears to have been surveyed recently.

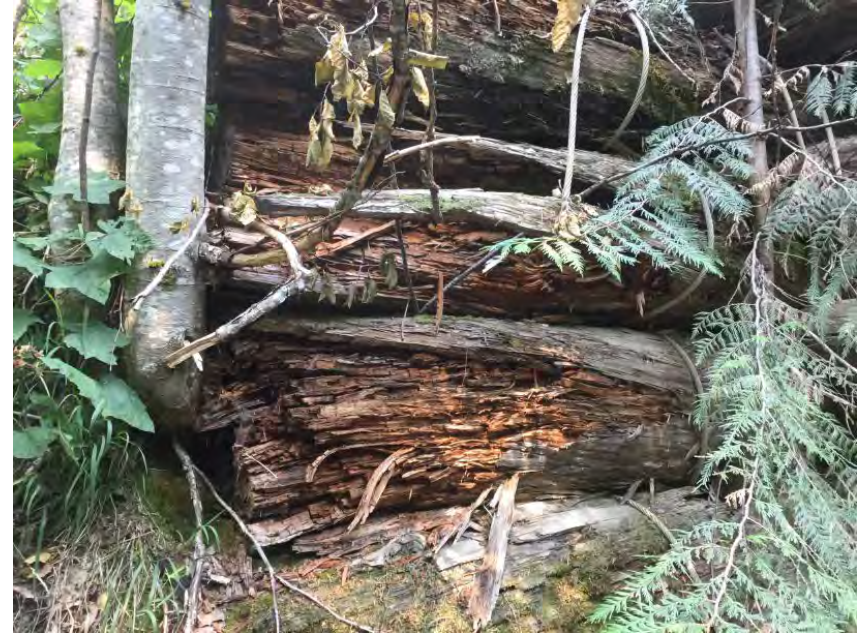
Log/Timber Cribs Poor

Rotten

Log crib condition

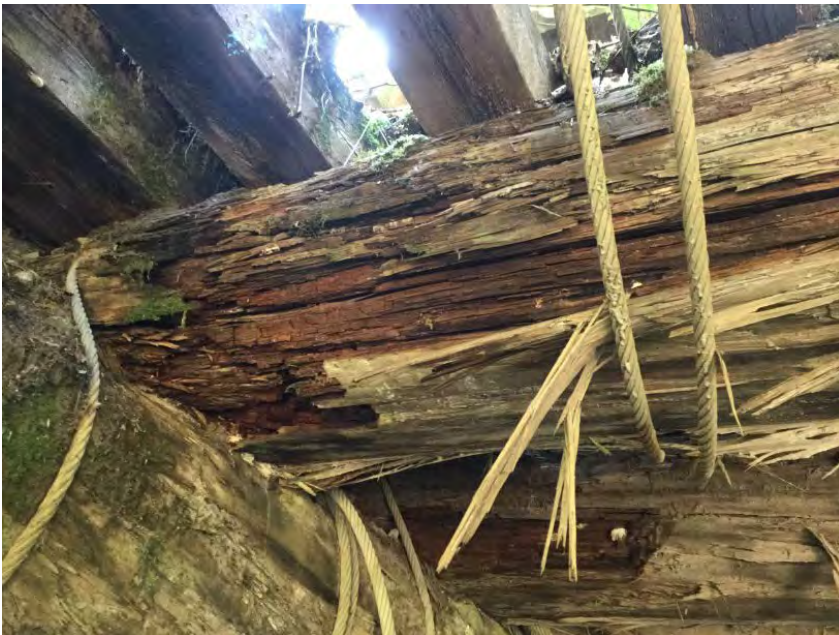
Log stringer condition

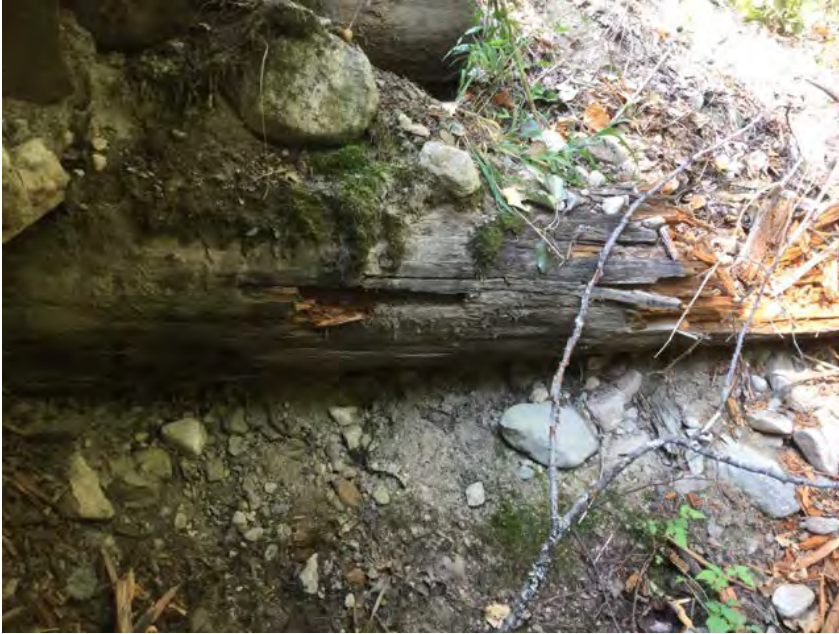
Caps or Sills Poor

Rotten

Upstream right bank sill condition

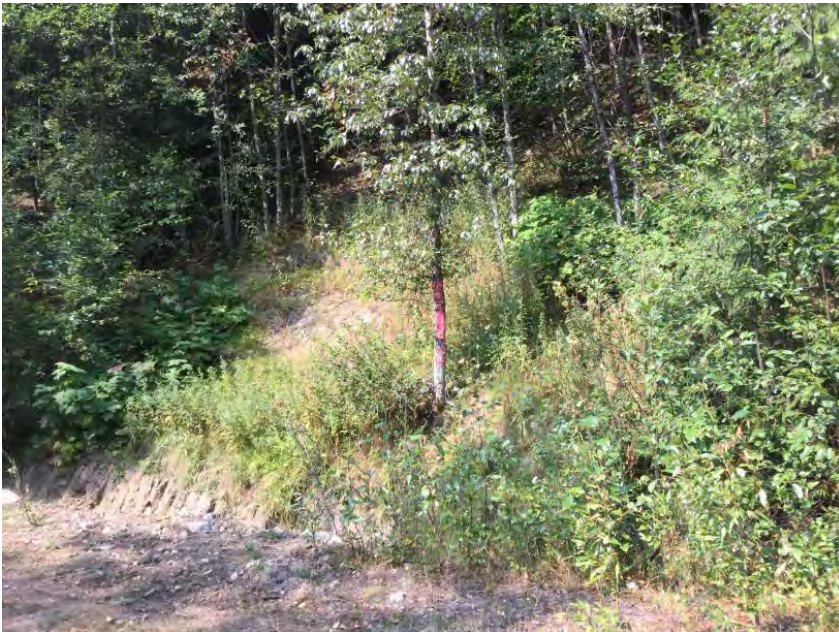
Site has been surveyed
