CK-2309

UZTLIUS-E ANDERSON 17.1km

2018 Inspection

| Structure Class | Major Culvert |

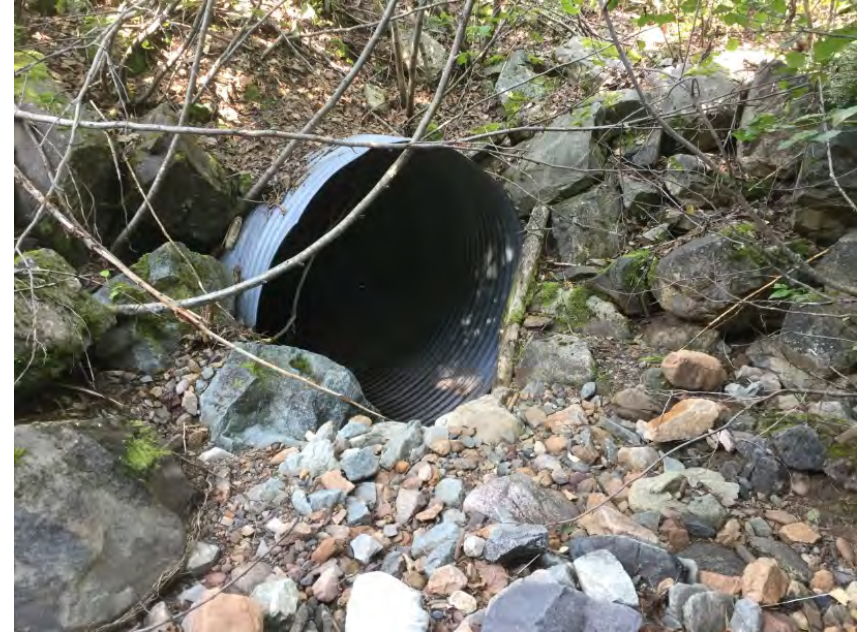
Inlet

Fair to poor as material is building up at inlet

| 2 | High | Clean inlet |

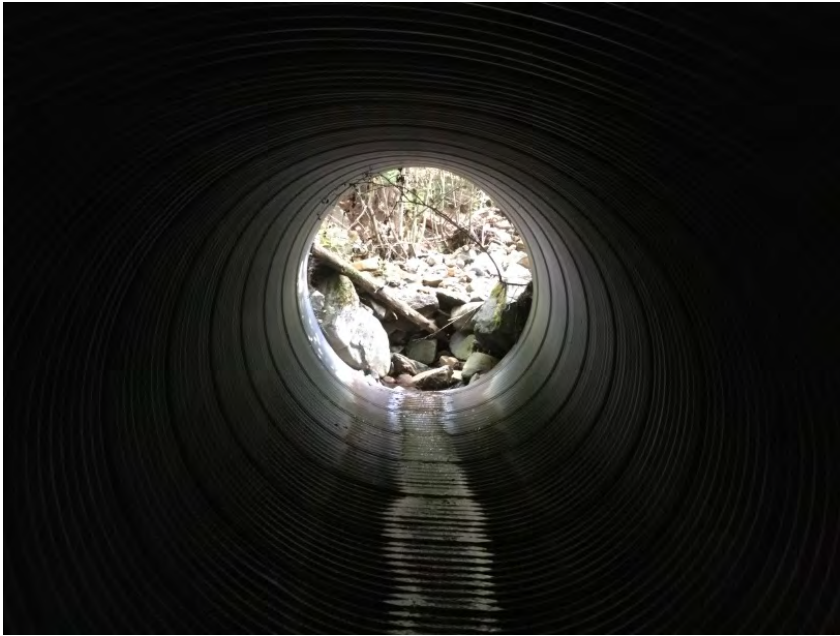
| Estimated Present Water Level Width (m) | 0.1 | Aggradation | <input checked="" type="checkbox"/> | Scour | <input type="checkbox"/> |

Material building up at inlet

Clean inlet and brush approaches when active. Monitor the bedload at the inlet. Present load rating of L75 or 68 tonnes to continue.

| Item | Monitor Description | Frequency |
|---|---|---|
| 1 | Aggradation | Routine Inspection |

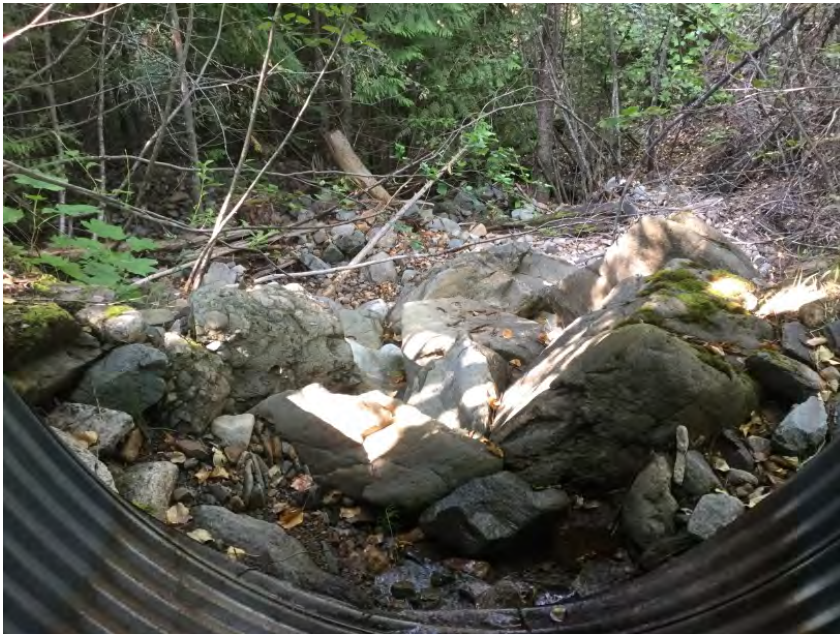
Outlet

Good
