CK-2310

UZTLIUS-E ANDERSON 18.5km

2018 Inspection

| Structure Class | Major Culvert |

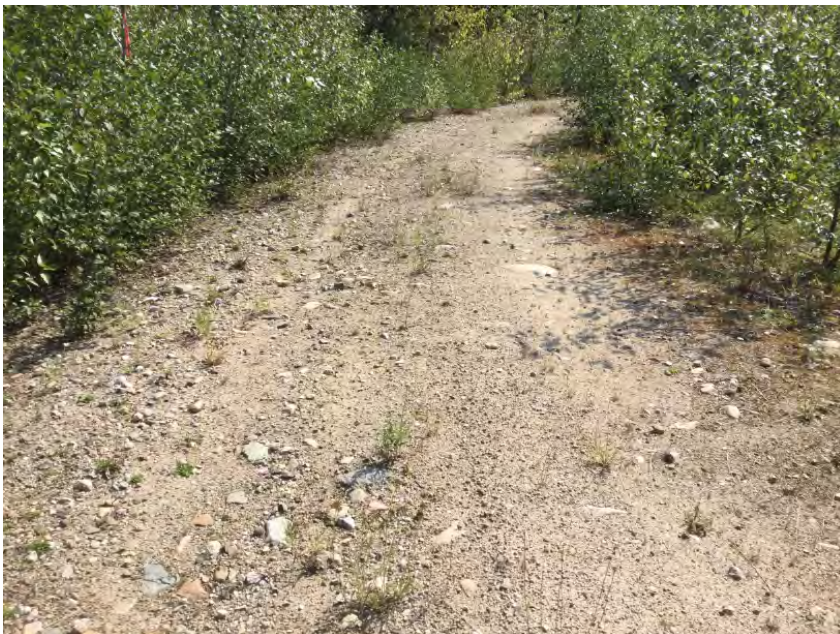
Running surface

Road Surface Fair

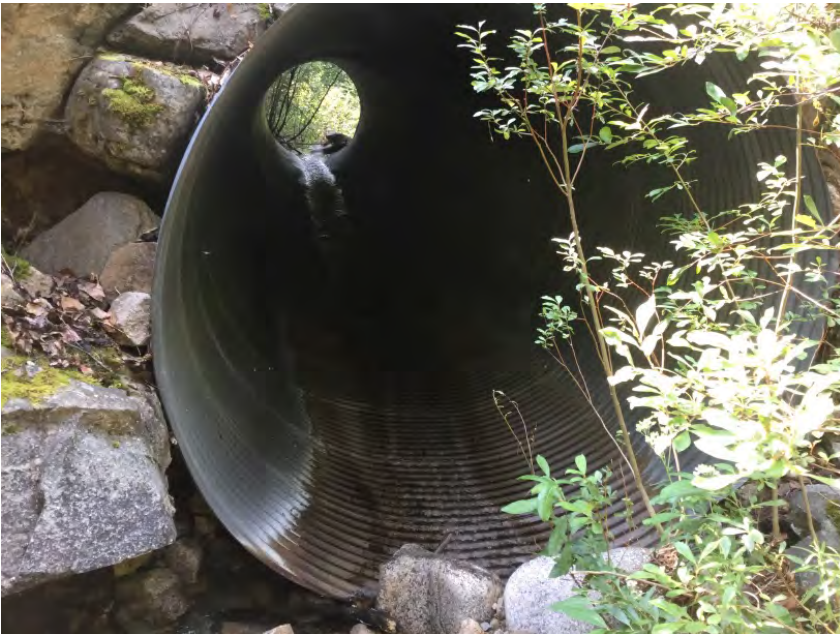
Inlet      Good

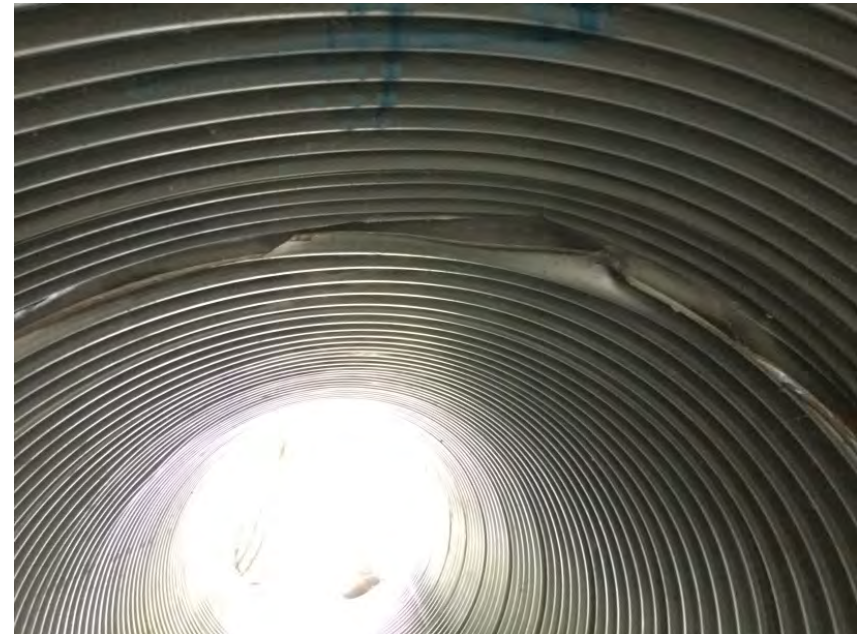
Coupled Connections      Fair      Minor damage noted

Damage at coupler location

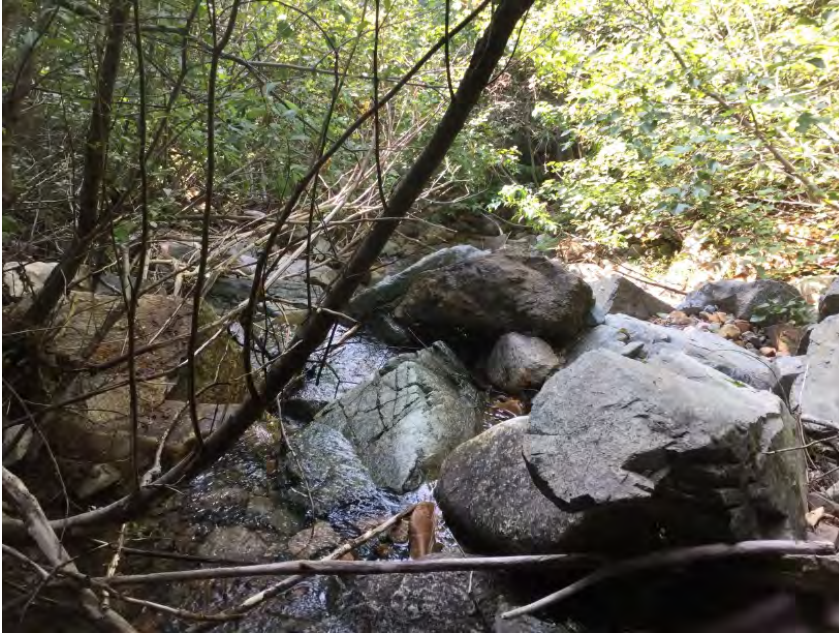
Outlet      Good
