CK-2312

WEAVER LAKE 2.6km

2018 Inspection

| Crossing Name | Weaver Creek | | |

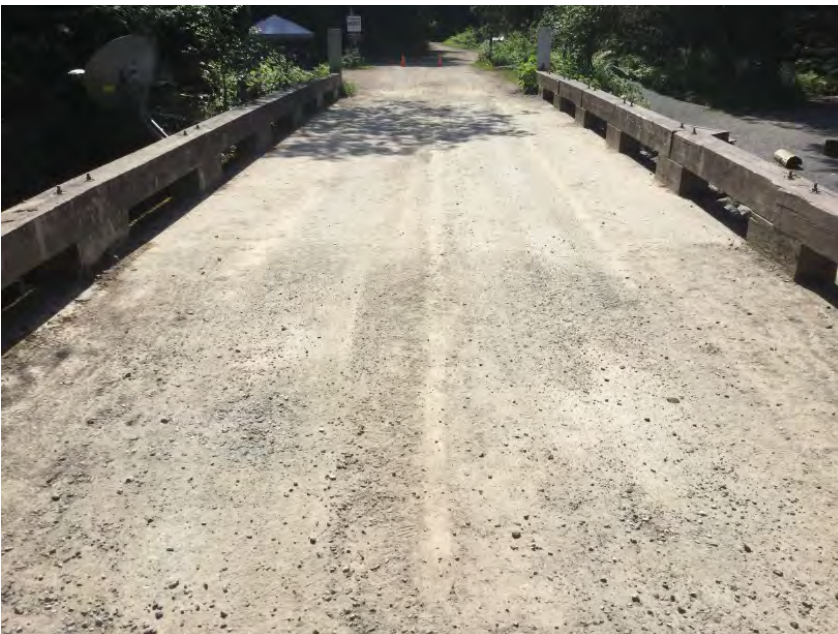
Deck

Curb Rail/Blocks/Posts Fair Risers have rot where debris accumulations are present, however limited to the just base of the riser - they do not appear to have deteriorated any further since last inspection

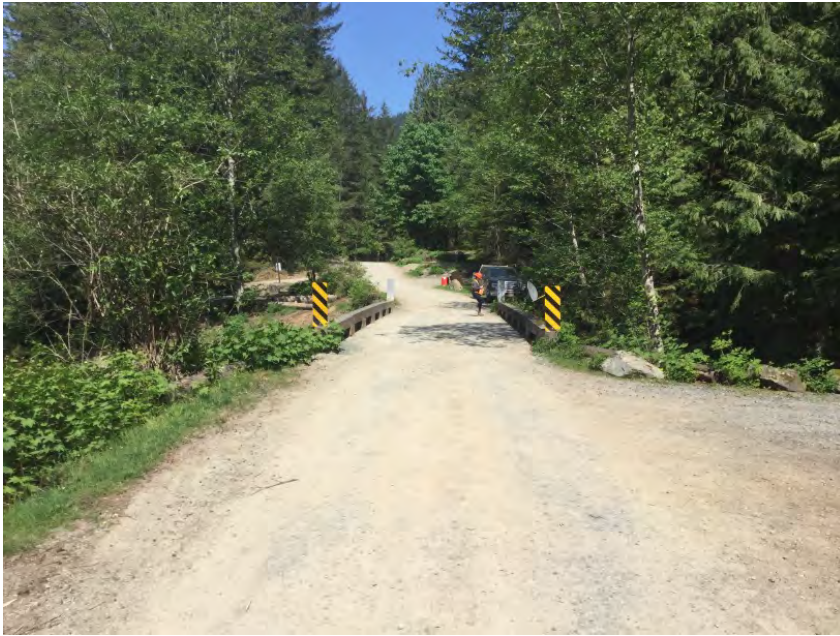
Approach from Right Bank when facing downstream

Fender Condition Fair Logs and rocks, right approach fenders small

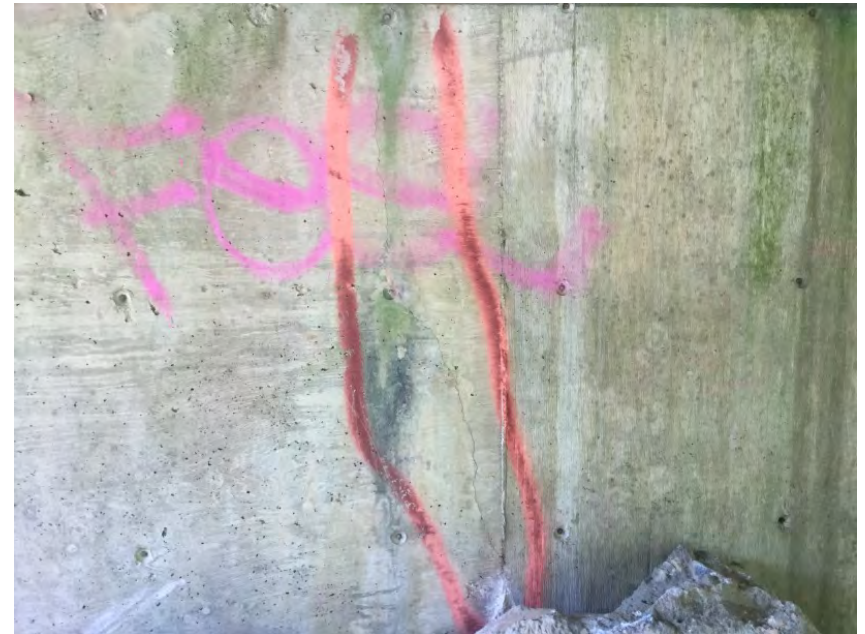
Concrete Good Hairline crack noted on left abutment, both CIP

Hairline crack noted on left CIP

Remove the debris accumulations at the inlet of the bridge. Replace the logs retaining the road approach fill on top of the Concrete Cast In Place (CIP) abutments. Replace the 2 existing right side delineators with proper left handed ones. Monitor the hairline crack in the left abutment. The present load rating of L60 or 54 tonnes to continue.

| Item | Monitor Description | Frequency |
|---|---|---|
| 1 | Hairline crack on left abutment | Routine Inspection |

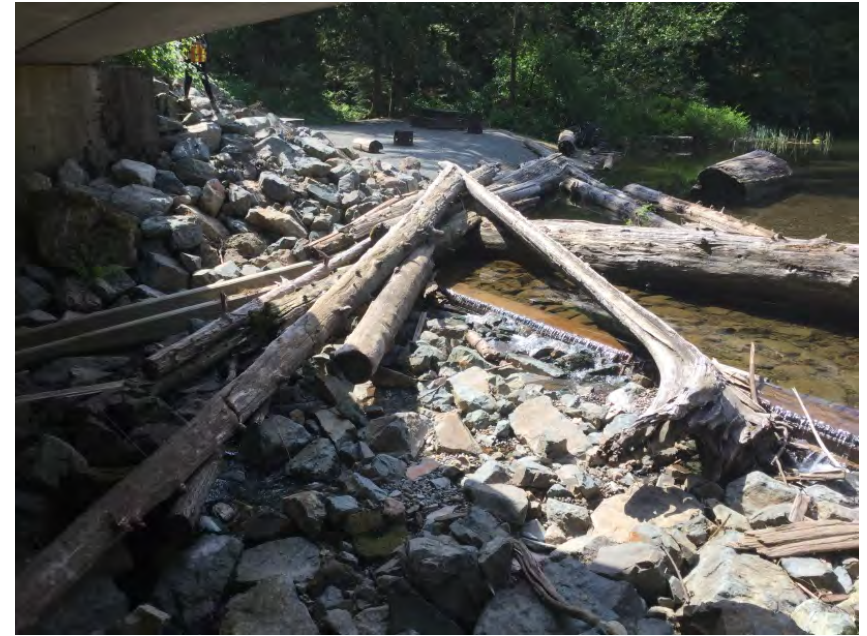
| Estimated Present Water Level Depth (m) | 0.5 | High Water | <input type="checkbox"/> | Debris | <input checked="" type="checkbox"/> |

Debris at inlet to be removed

Debris accumulations at the inlet of the bridge should be removed

| Item | Priority | Repair Description |
|---|---|---|
| 2 | Medium | Remove the debris accumulations at the inlet of the bridge |

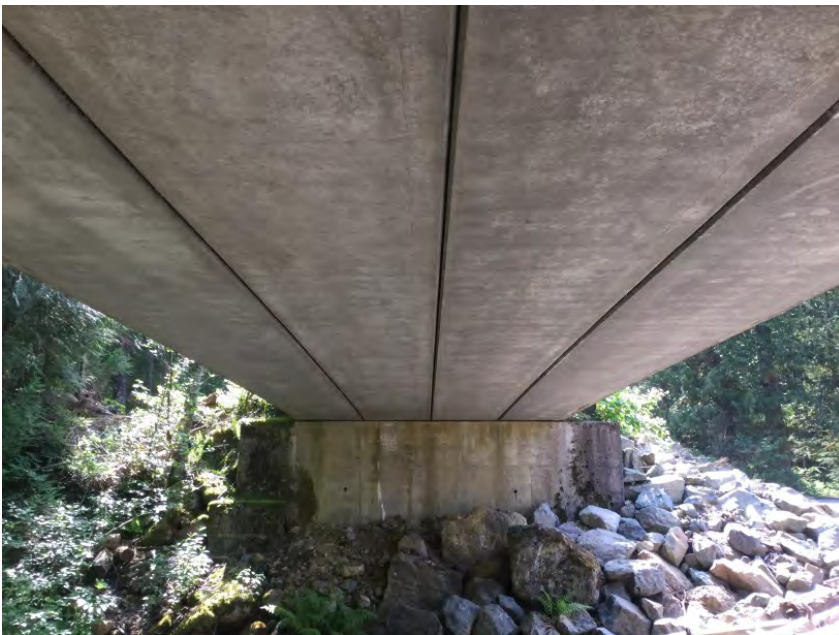
Superstructure

Girders Good 4 concrete slabs

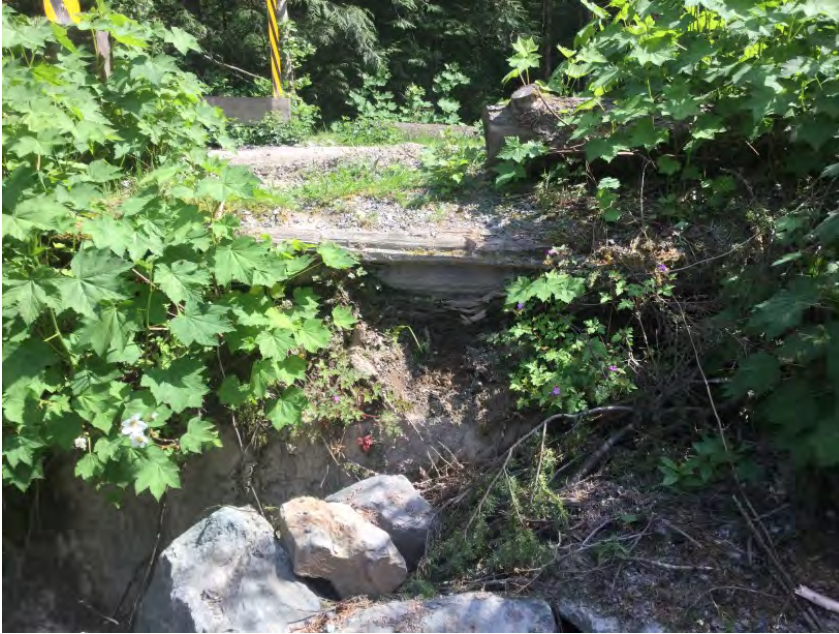
Wing Wall Fair CIP with logs on top - the CIP is rated as Good and the logs are rated as poor as they are rotting

Logs retaining fill at either approach rotting

| Item | Priority | Repair Description |
|---|---|---|
| 3 | Medium | Replace the logs retaining the road fill at either approach |
