CK-2315

BERKEY 5700 0.3km

2018 Inspection

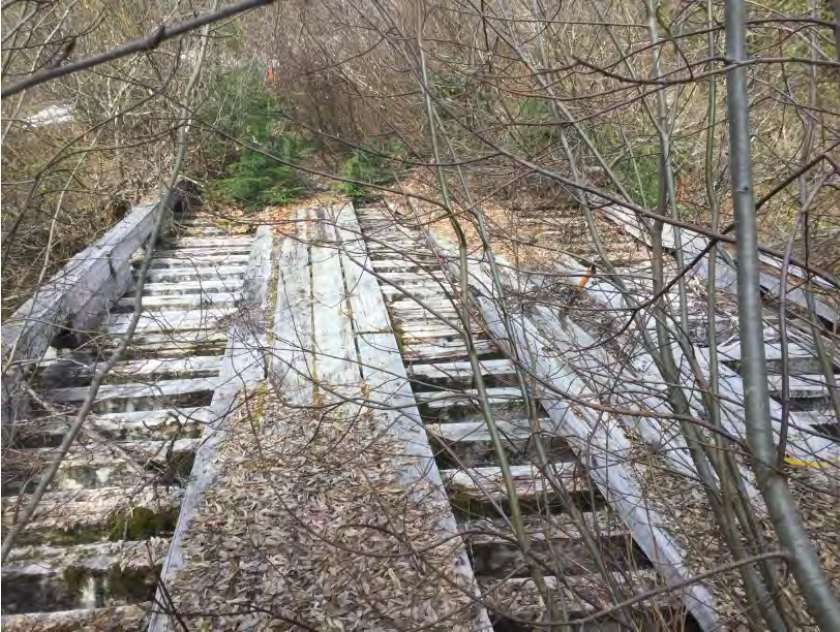
Approach from Right Bank when facing downstream

Road Surface Poor Grown over with Alder

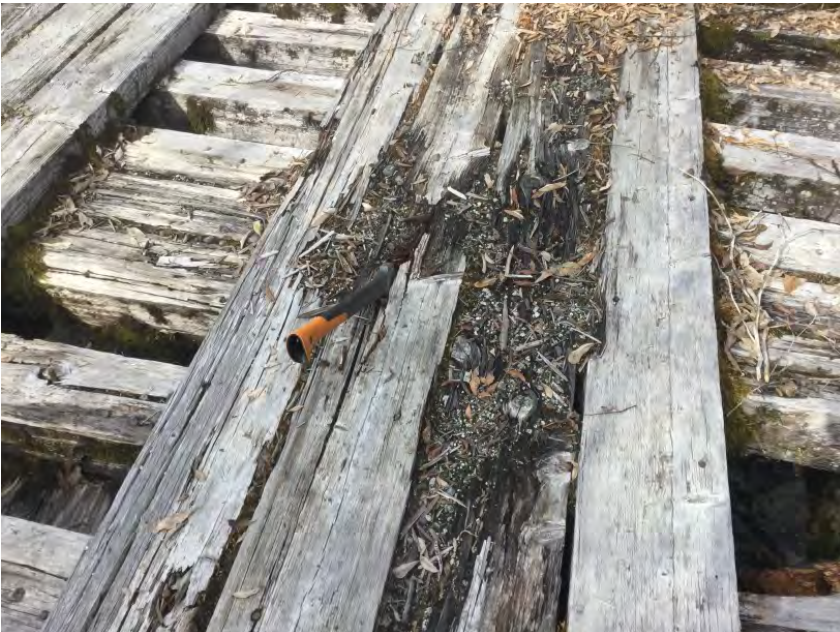
| Running Surface | Poor | Grown over with Alder |

| Running Planks | Poor | Rotten |

| Ties | Poor | Rotten |

| Curb Rail/Blocks/Posts | Poor | Rotten |

| Overall Deck Condition | Poor | Rotten |

| 1 | High | Replace bridge with activity |

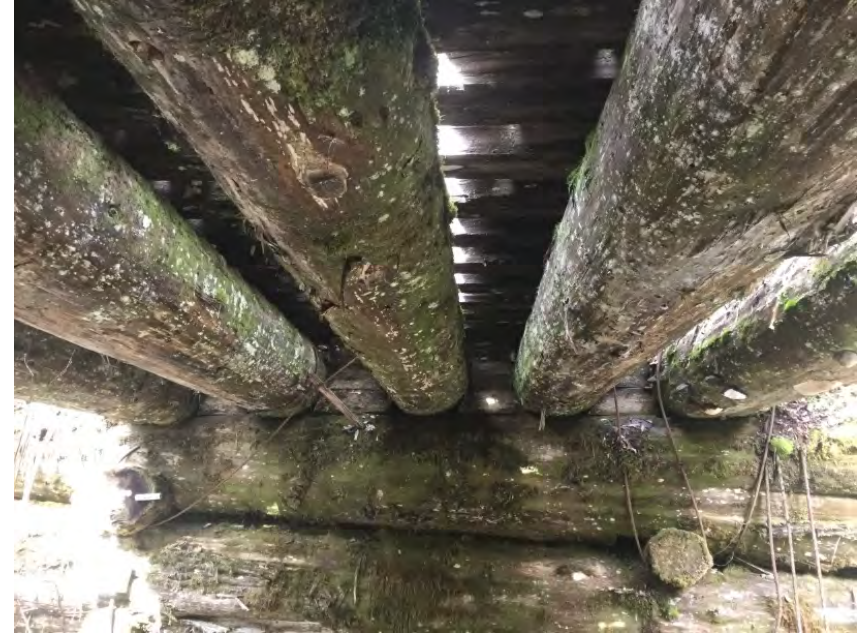
Stringers

All stringers visually rotten

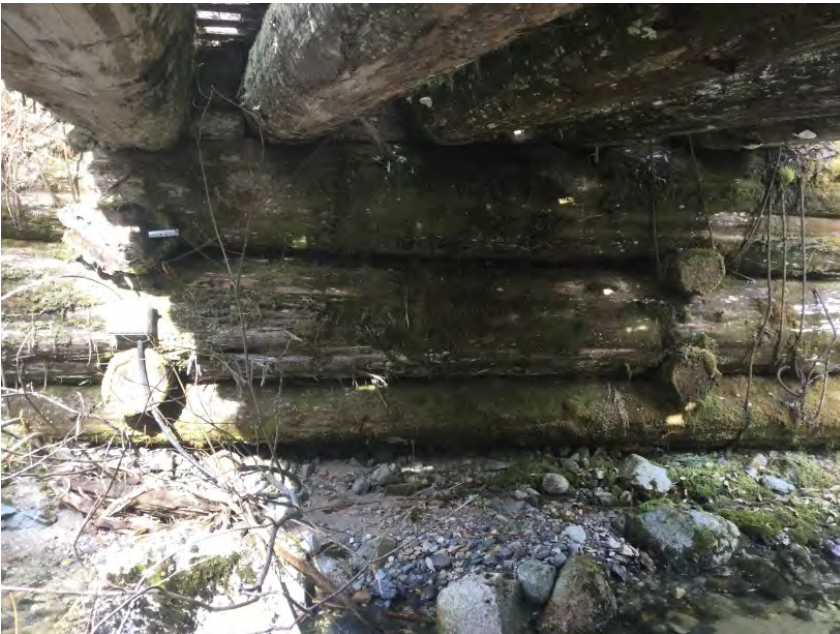
Left Bank Abutment when facing downstream

Log/Timber Cribs Fair Fair to poor, Cw and Fd

Riprap Poor None in front of crib

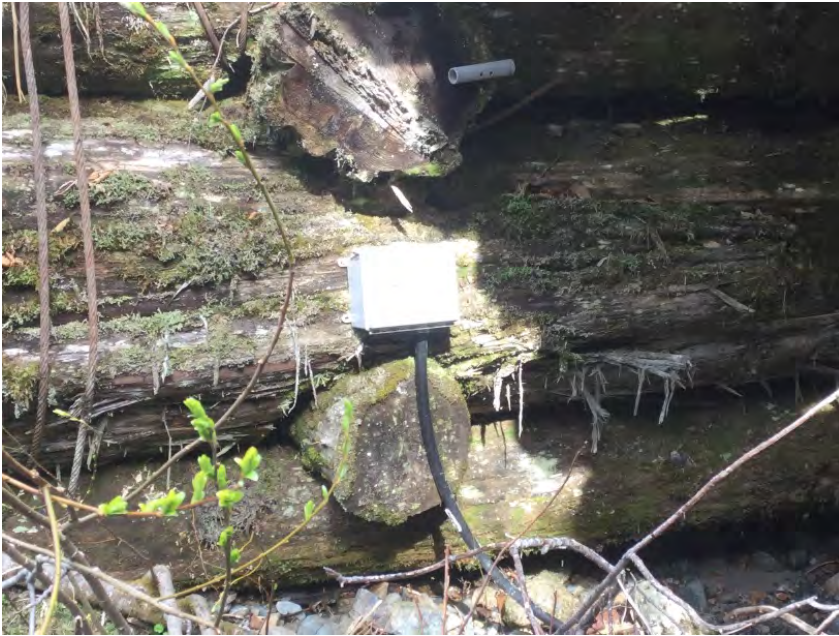
Water gauge under bridge and attached to left abutment

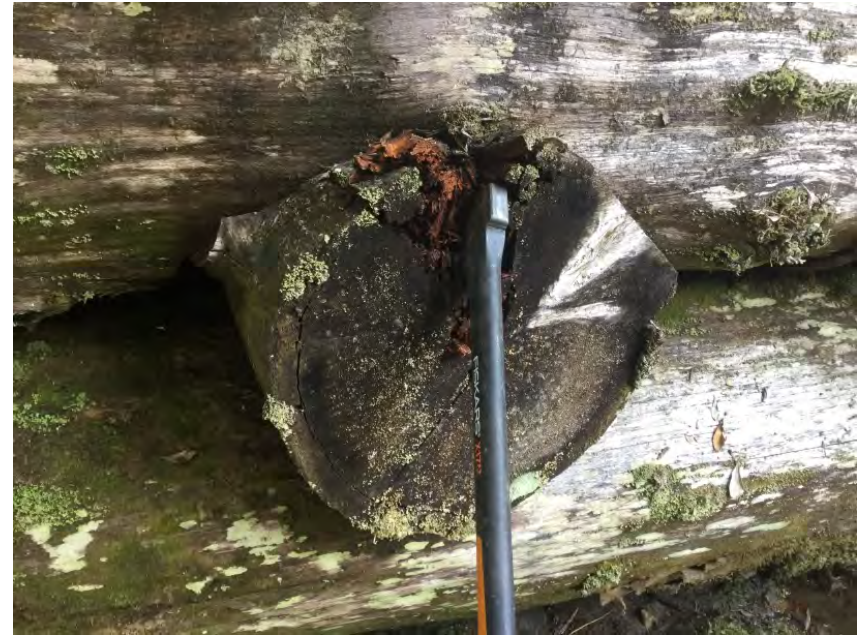
Tieback condition

Tie Backs Poor Rotten
