CK-2327

STAVE 0km

2018 Inspection

| Crossing Name | Side Creek | | |

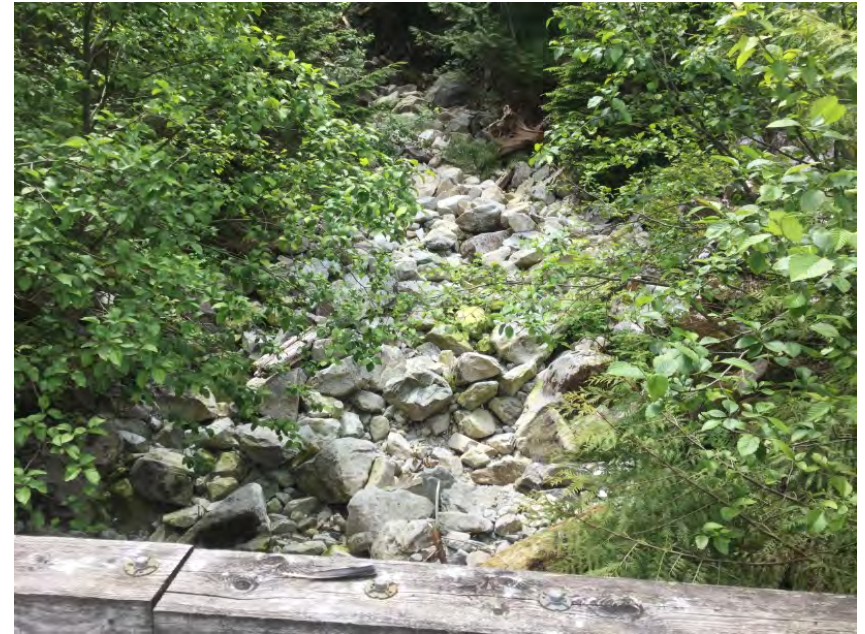
Upstream from Crossing

Comments Dry channel with woody debris jammed up against the upstream girder partially blocking the inlet

| 1 | High | Clean inlet prior to fall rain events |

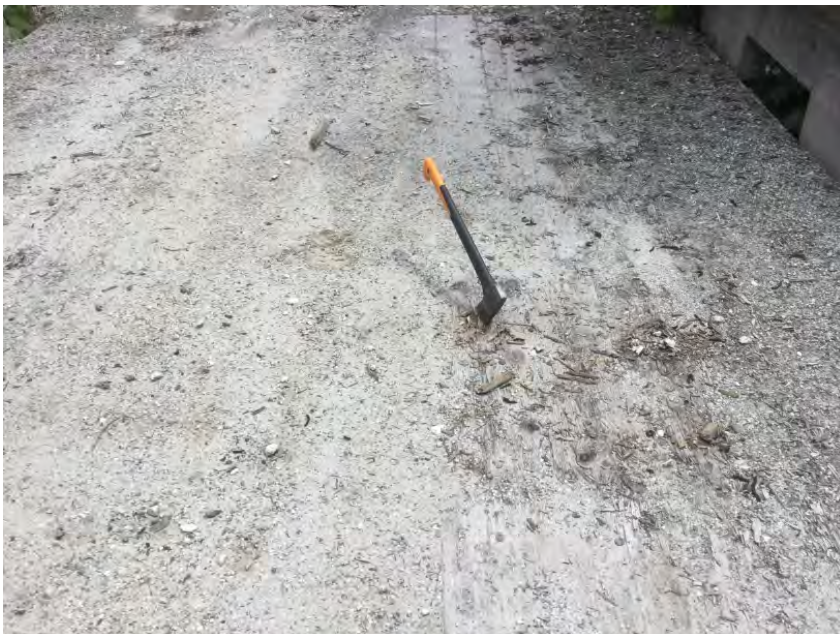
Deck

Rotting and wearing

Poor

Old and rotting

The steel girders are originally from the old weight scale at the log dump and were refurbished in 1995 for this install. The girders are still in fair condition but appear to be too short for the site. For short term use replace both timber sills, both ballast walls, all the ties and running planks. Install fenders at all corners, post bridge ahead signs, brush and grade approaches. Limit loading to 30 tonnes until bridge work complete - please post load rating signs and clean the inlet. Monitor the bottom lock block at the downstream right abutment. For long term planning consider the site for a complete replacement with a longer structure.

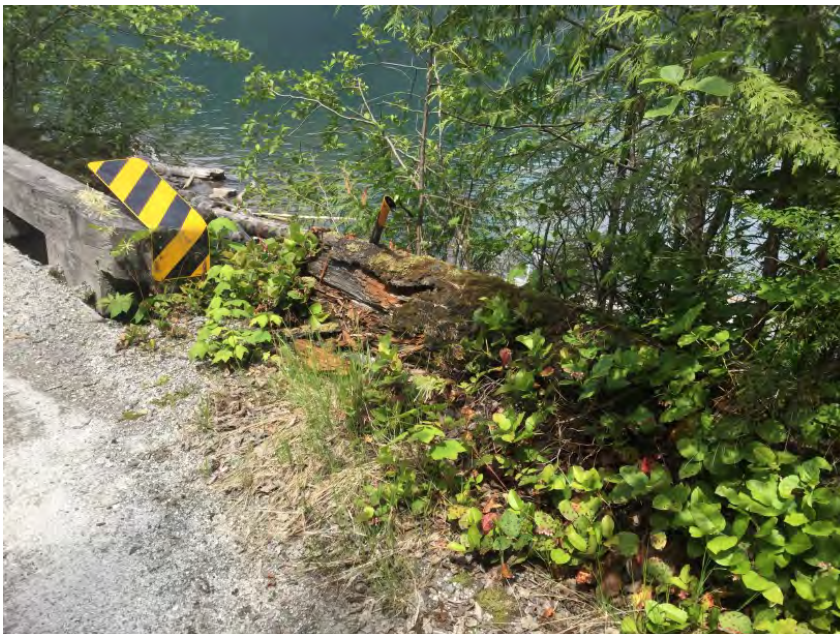
Fender Condition Poor None at left approach, rotten right approach

Rotten fender

| 2 | Medium | Brush approaches and add new fenders to both approaches |

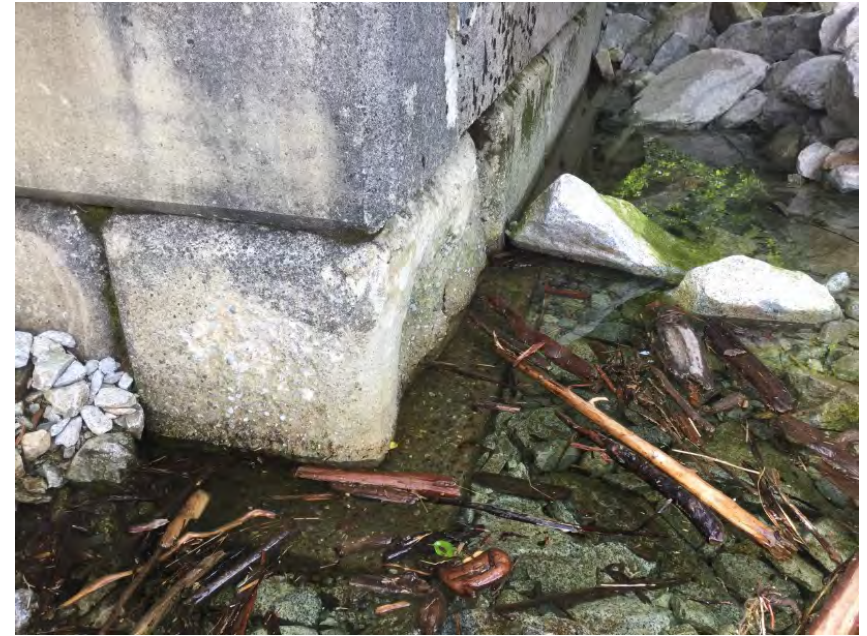
Concrete Fair 3 rows of lock blocks with D/S right abutment block heavily spalled and now cracked

Bottom lock block at downstream right abutment in poor condition

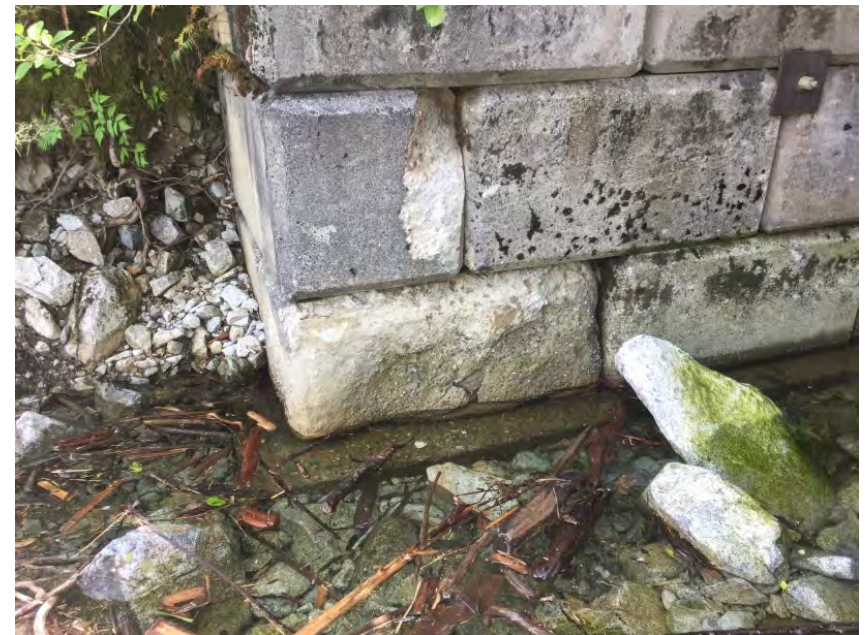
Bottom lock blocks at downstream right abutment

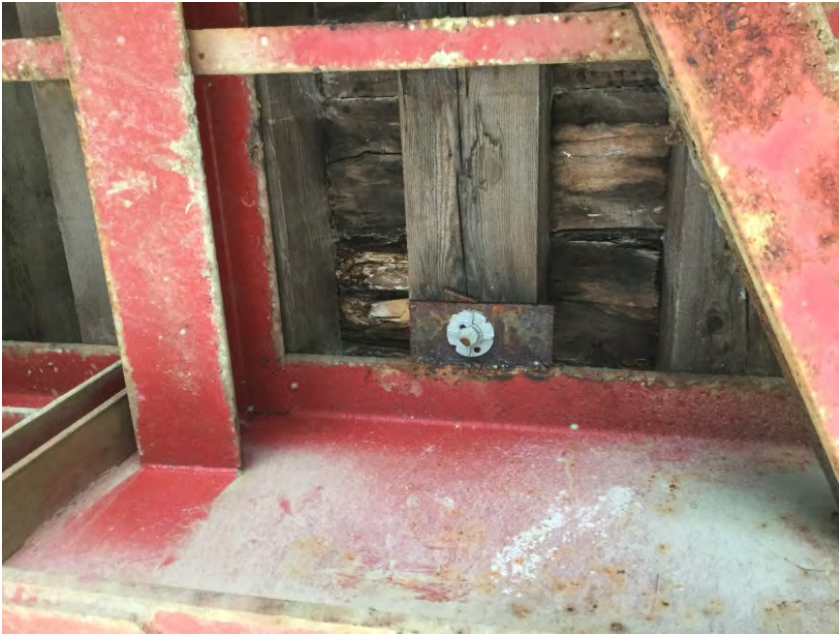
Deck bolts

Fair

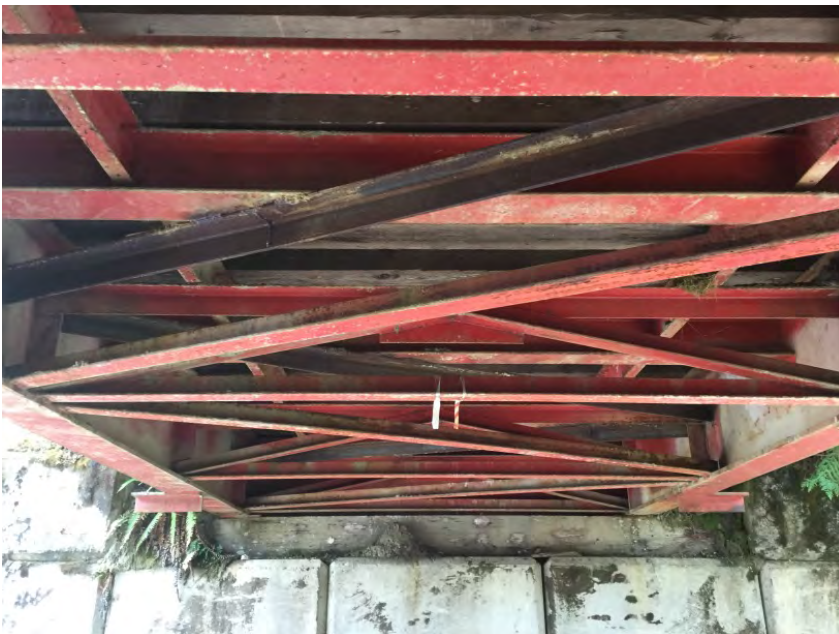
Superstructure

Girders Fair

Painted steel with additional bracing added

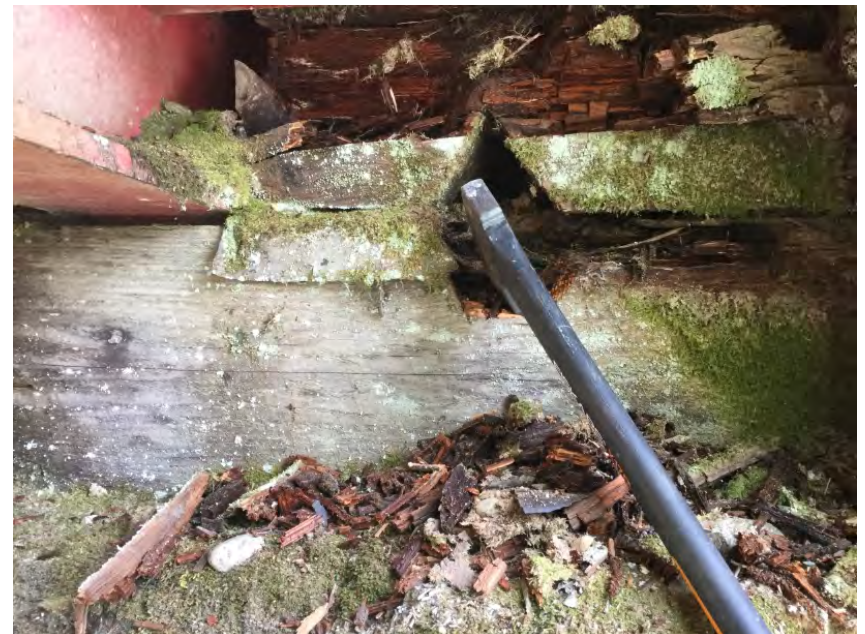
Caps or Sills Poor Rotten timber sills

Timber sill condition

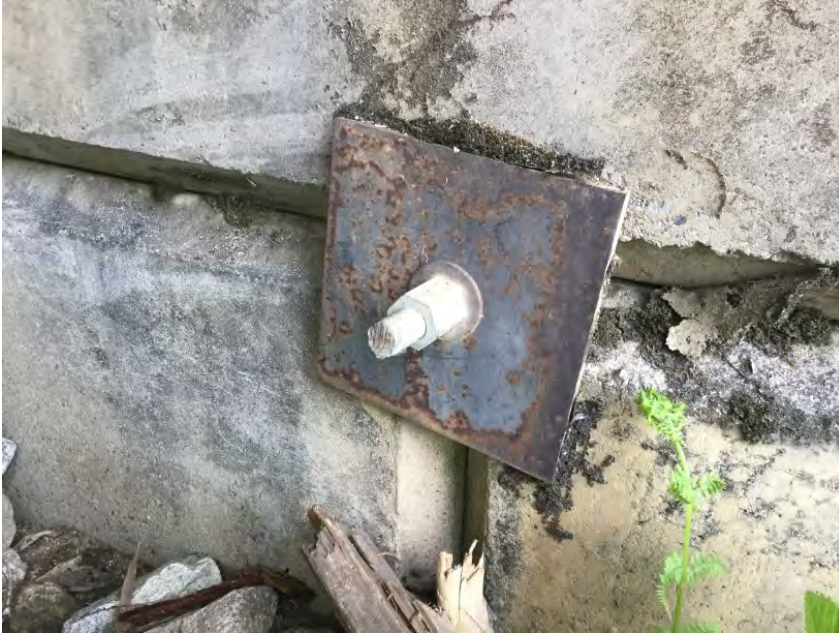
Lock block tieback

Tie Backs Good 25mm Thread rod with 250mm x 250mm x 15mm plate
