CK-2331

STAVE 4.3km

2018 Inspection

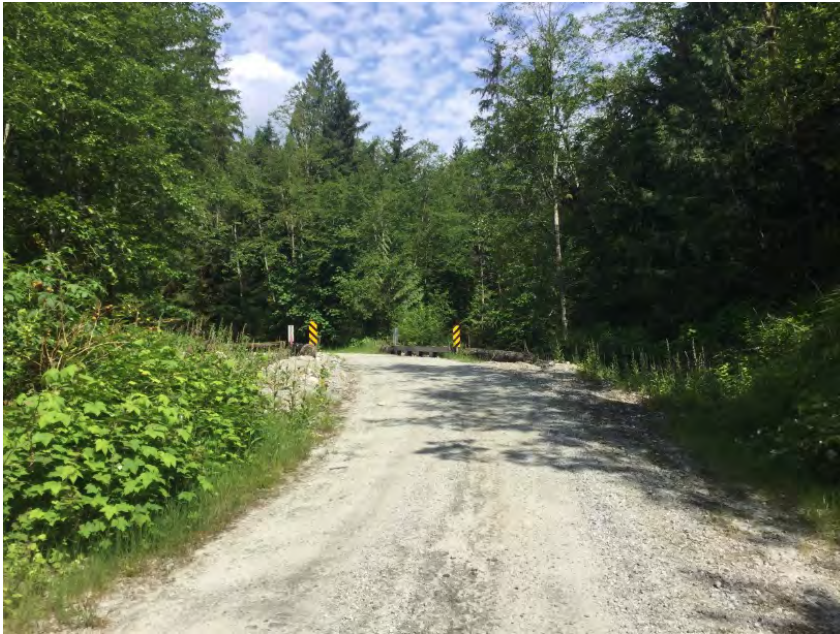
Approach from Left Bank when facing downstream

HC both approaches

Bridge Ahead Signs  
Missing
☐ 0
 ☐ 1
 ☒ 2

Install bridge ahead signs and grade approaches with industrial activity. The present load rating of L75 or 68 tonnes to continue. Monitor bedload and scour.

| 1 | Medium | Post bridge ahead signs |

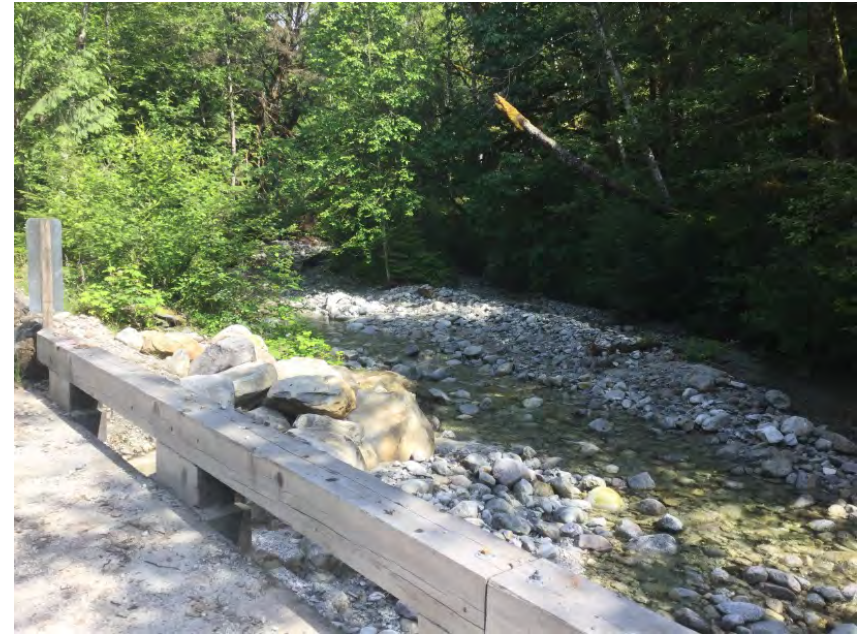
Upstream from Crossing

Comments Stream heavily turns through crossing location. The stream is depositing bedload at the right abutment end and scouring out of the downstream left abutment.

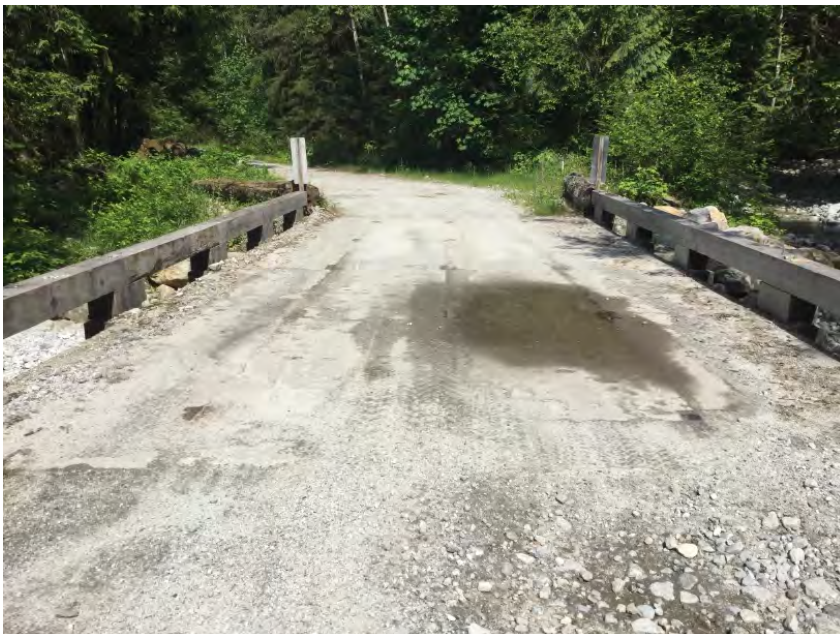
Concrete Deck Fair Reused girders; wear noted most likely from tracked equipment

Overall Deck Condition Fair

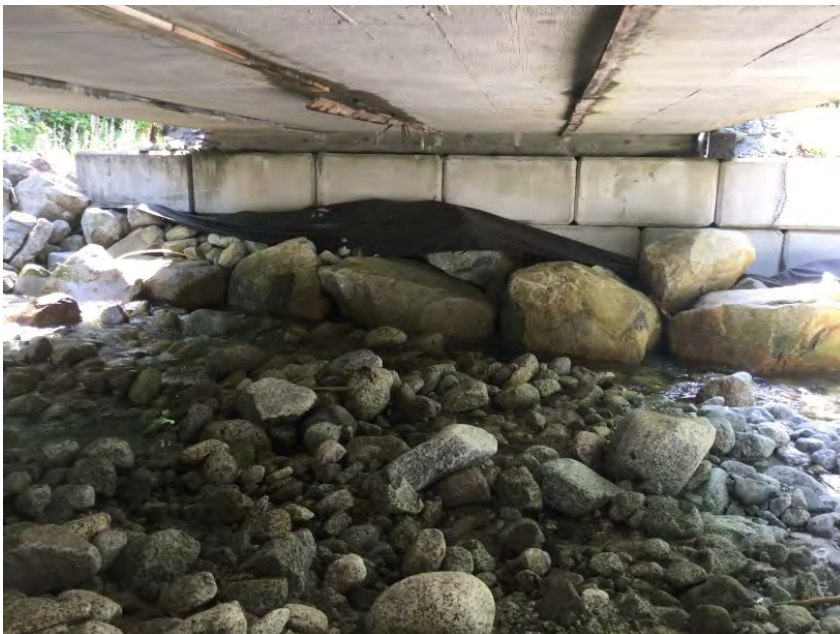
Left Bank Abutment when facing downstream

Downstream left abutment scour noted; stream elevation lower than footing elevation

| Item | Monitor Description | Frequency |
|---|---|---|
| 1 | Bedload at the right abutment and scour at the left abutment | Routine Inspection |

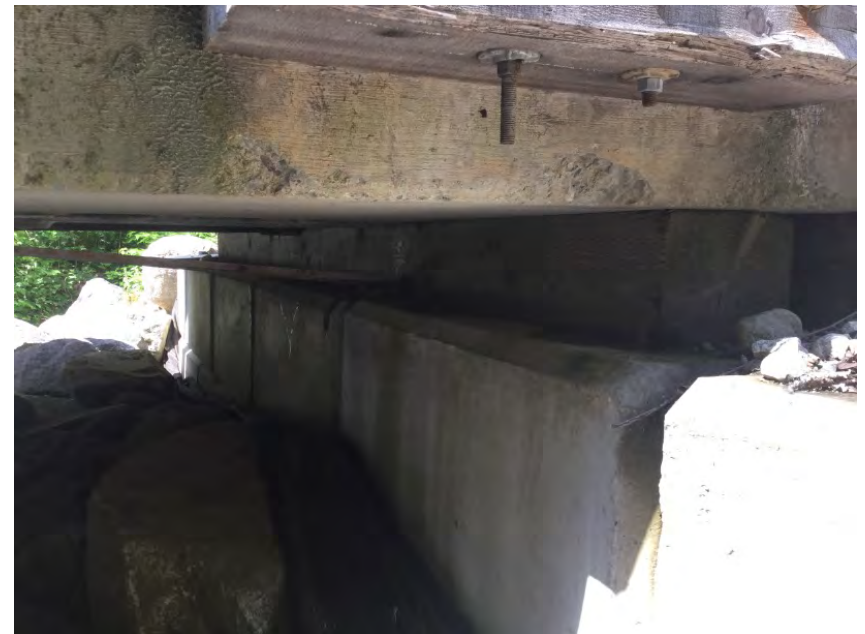
250mm x 300mm treated timber

Treated timber sill

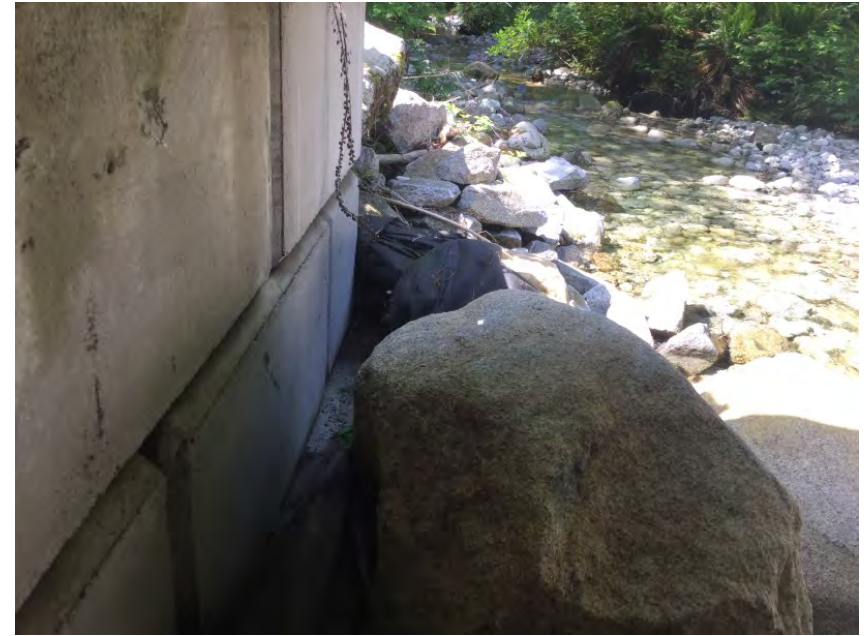
Downstream left bank spread footing visible

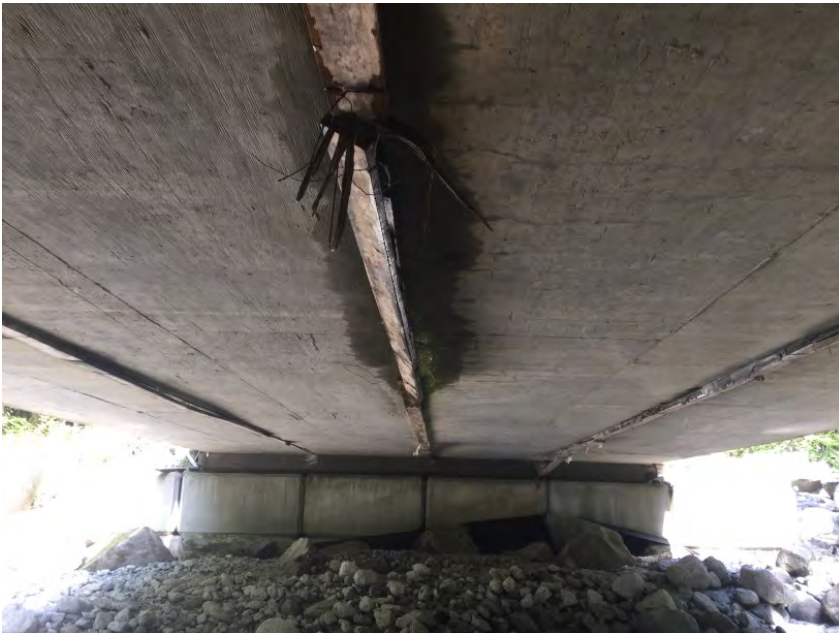
Superstructure

Girders Fair 4 reused concrete slab girders

Welded/grouted shear connectors Fair Welded shear connector and joints grouted
