CK-2332

STAVE 1.4km

2018 Inspection

| Structure Class | Major Culvert |

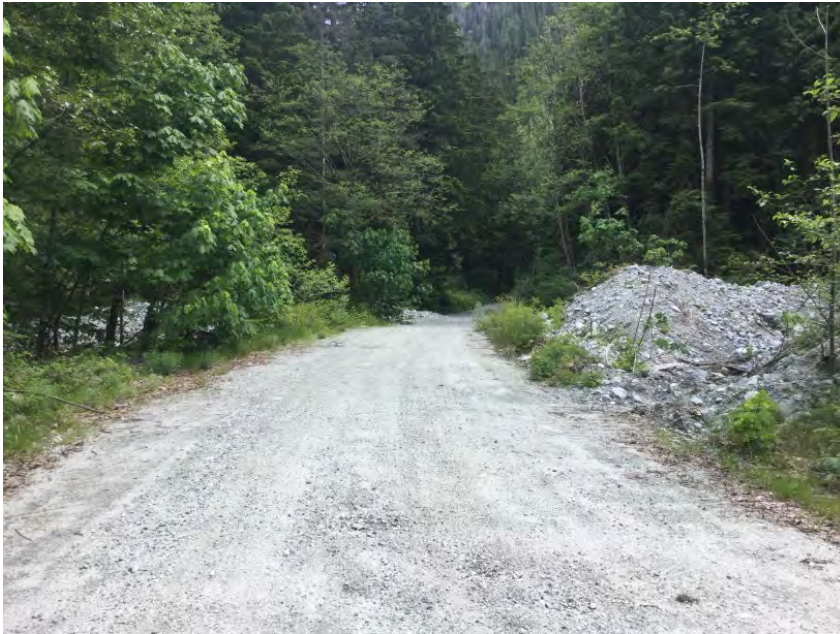
Approach from Left Bank when facing downstream

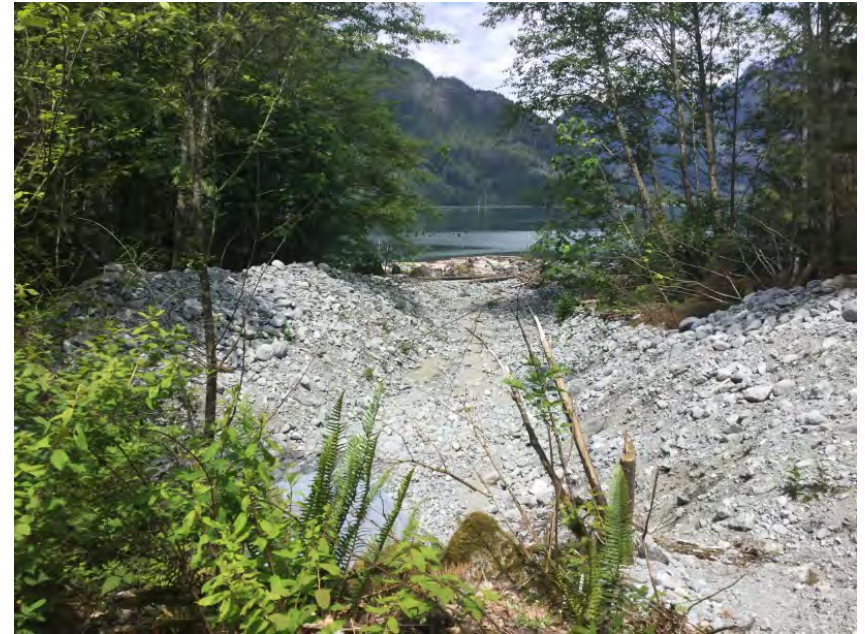
Downstream from Crossing

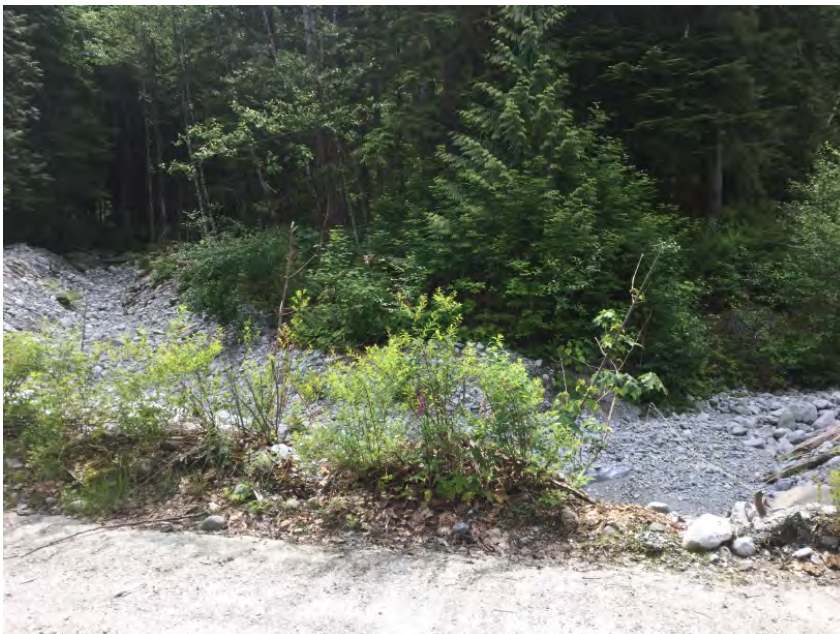
Comments Site prone to significant bedload accumulations as site on active fan

Upstream from Crossing

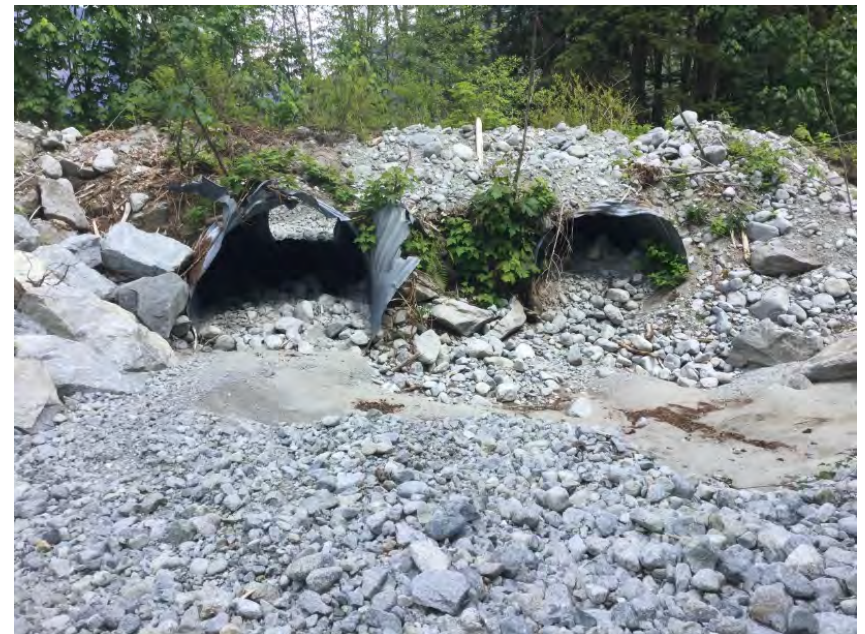
Inlet Fair Damage to both culverts from recent event and both partially plugged

| 1 | Medium | Clean inlet of both culverts |

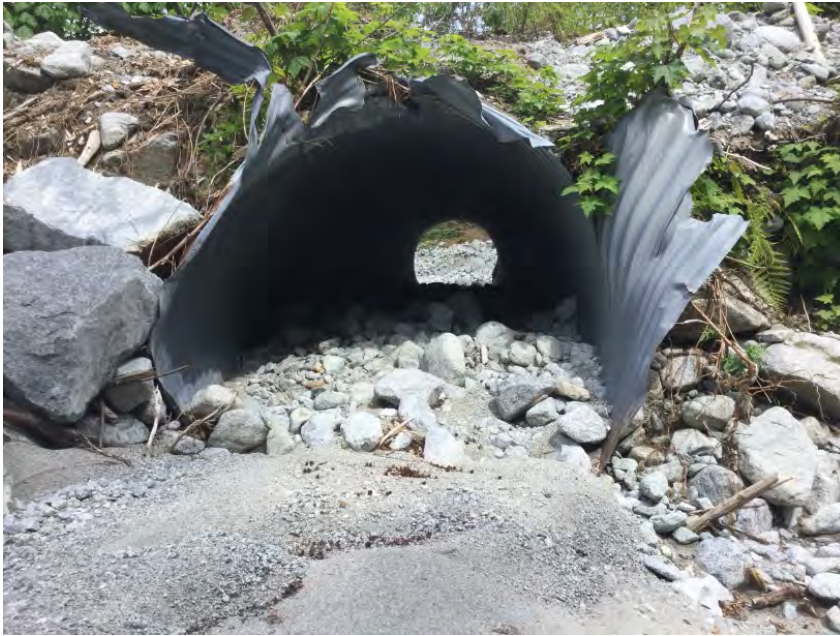
Low chain inlet damage from recent event

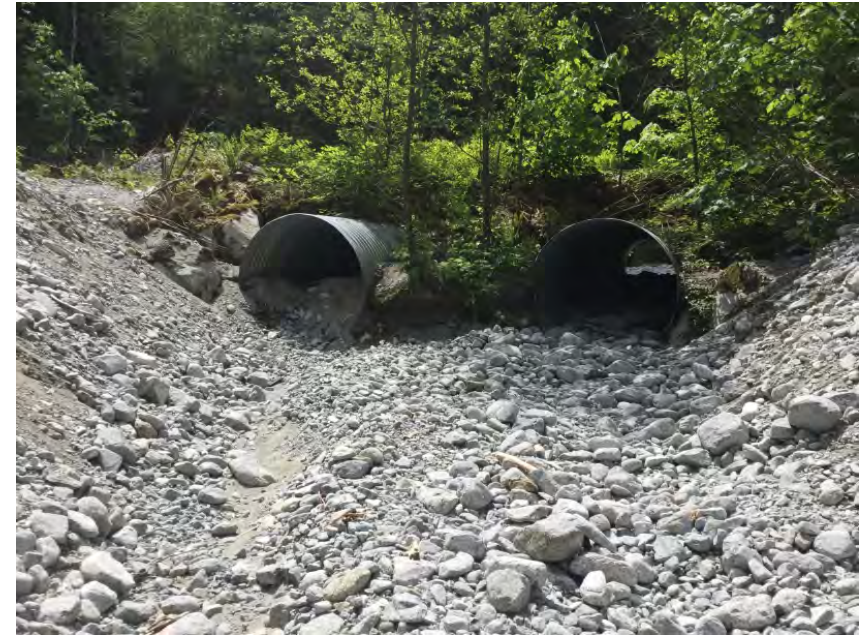
Outlet Fair Fair to poor as high chain culvert only achieving 30% flow capacity

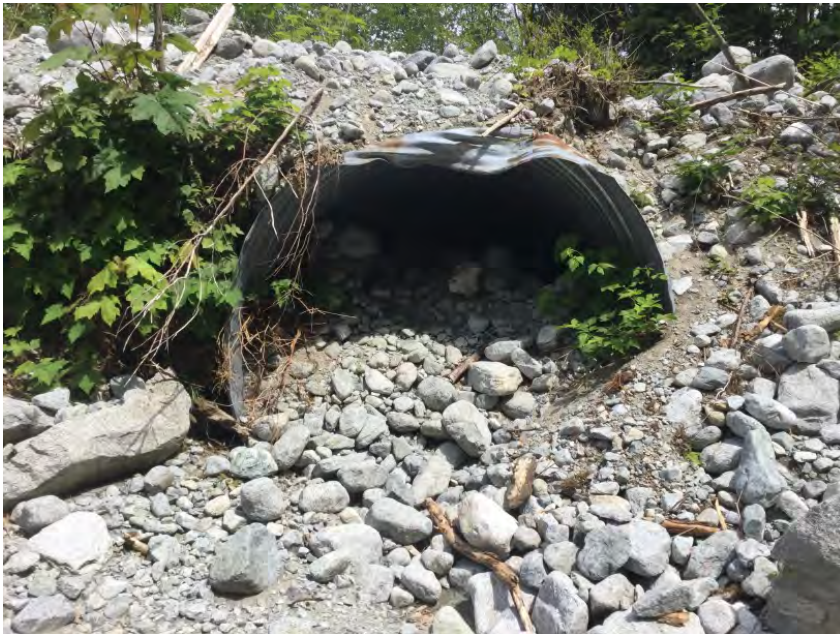
High chain inlet 67% plugged from recent event

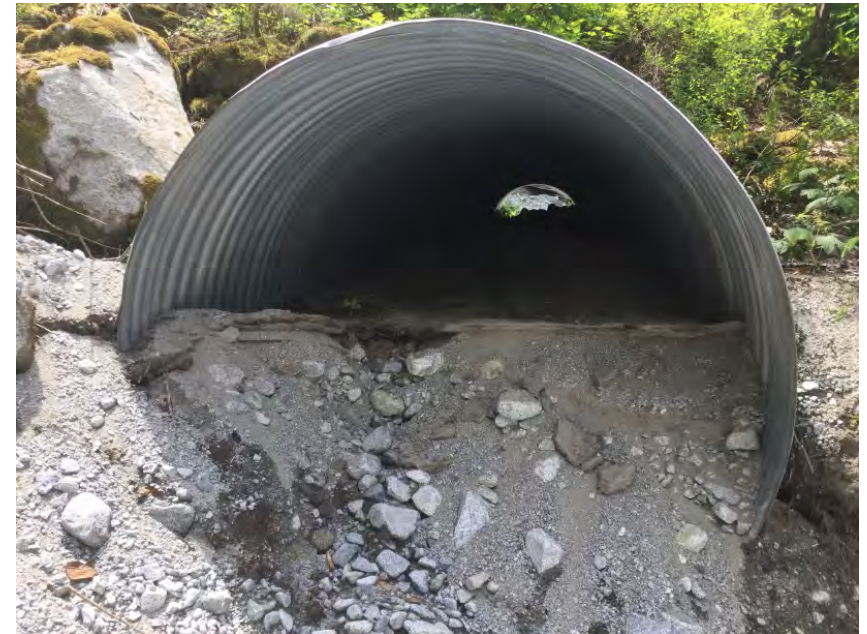
High chain culvert 50% plugged
