CK-2333

STAVE 2.5km

2018 Inspection

| Structure Class | Major Culvert |

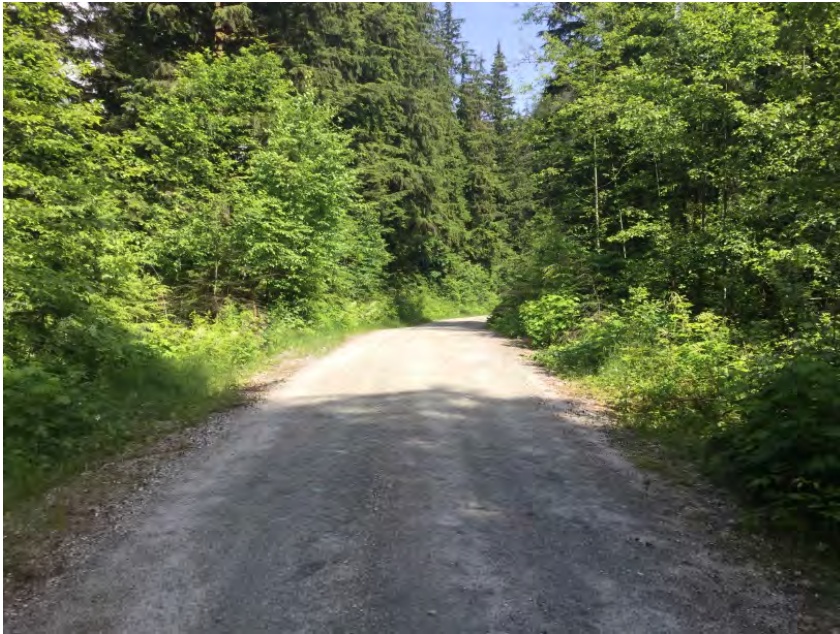
Approach from Left Bank when facing downstream

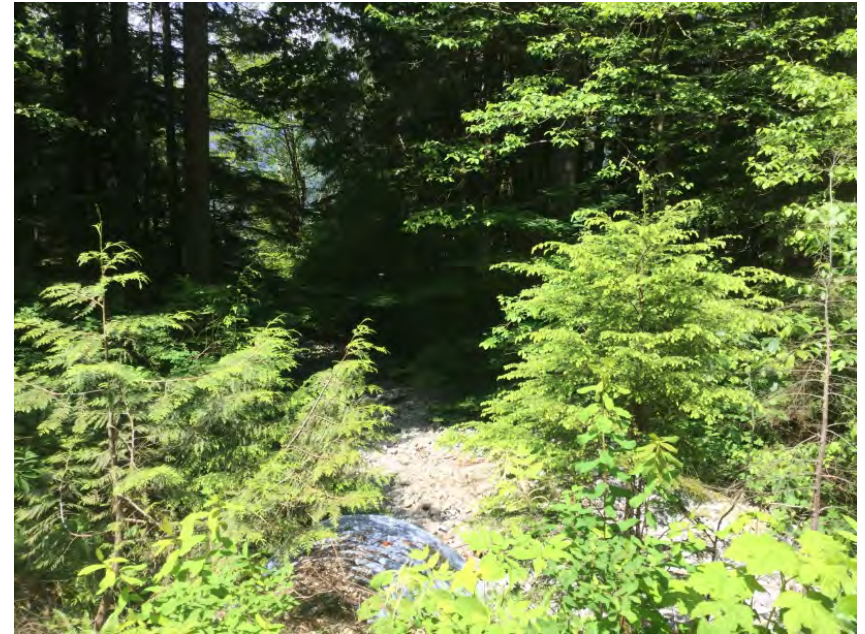
Downstream from Crossing

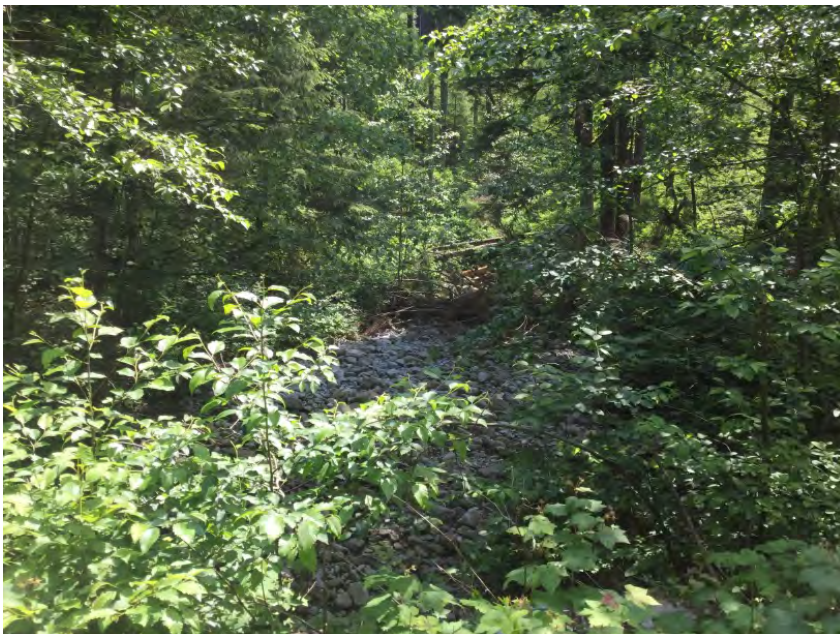
Upstream from Crossing

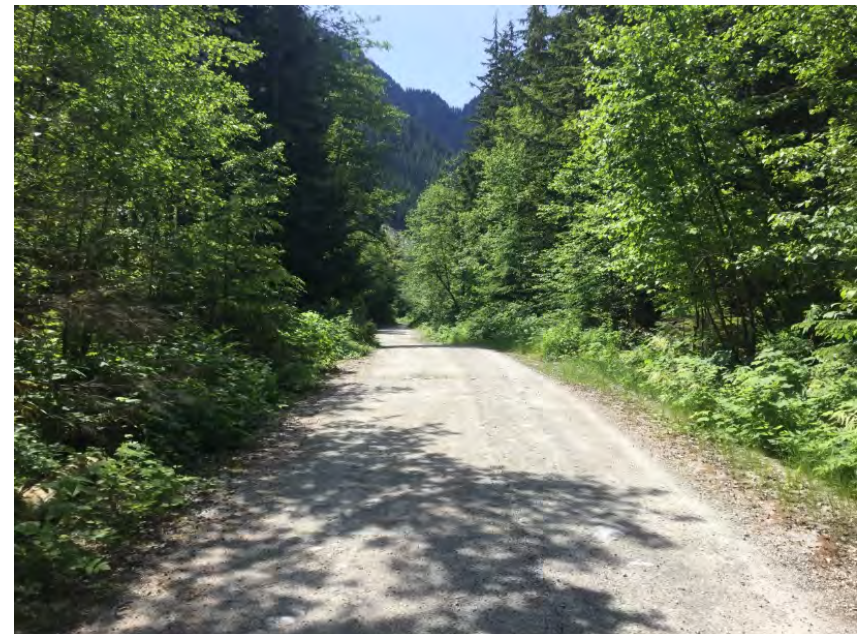
Approach from Right Bank when facing downstream

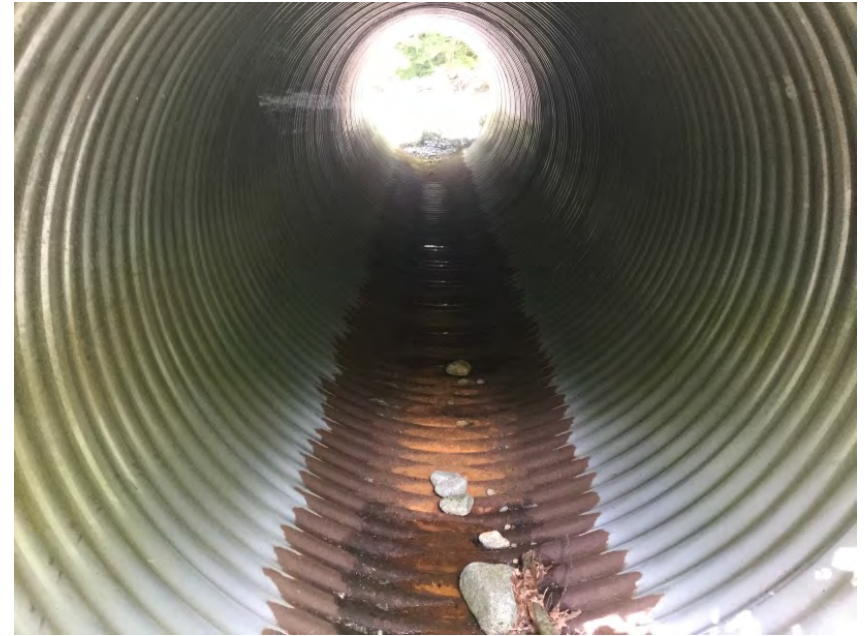
Clean through the low chain culvert

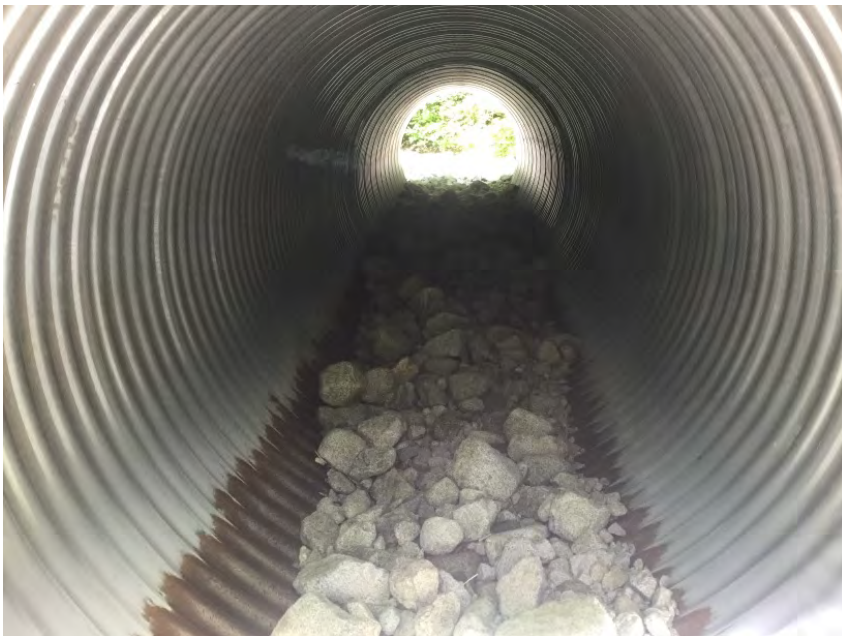
| Estimated Present Water Level Width (m) | 0 | Aggradation | <input checked="" type="checkbox"/> | Scour | <input type="checkbox"/> |

Aggrading in highchain culvert

Monitor bedload accumulations. Present load rating of L75 or 68 tonnes to continue.

| Item | Monitor Description | Frequency |
|---|---|---|
| 1 | Aggradation | Routine Inspection |
