CK-2334

STAVE 3.7km

2018 Inspection

| Structure Class | Major Culvert | | |

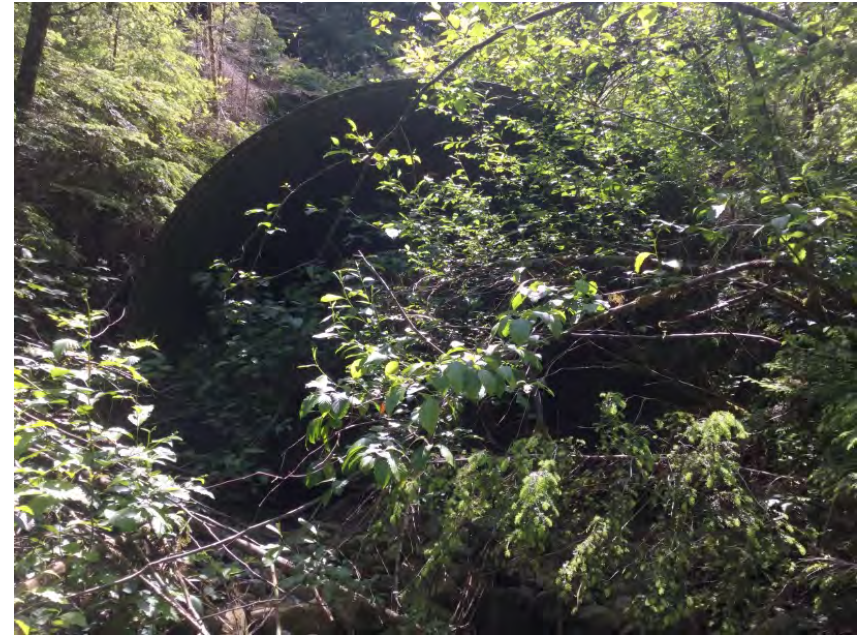
Outlet

Fair

Minor scour noted at outlet of ellipse culvert
