CK-2336

STAVE 6.2km

2018 Inspection

| Structure Class | Major Culvert | | |

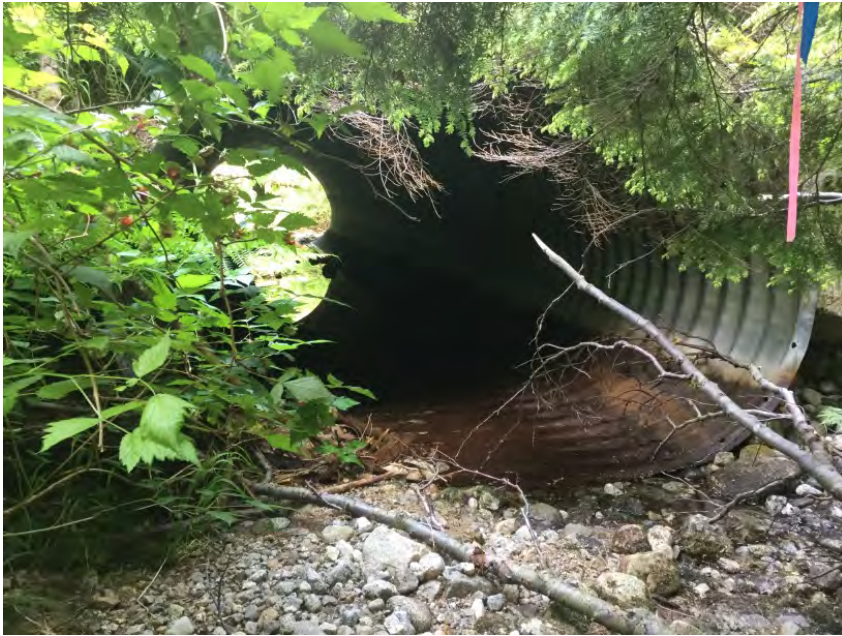
Inlet

Good

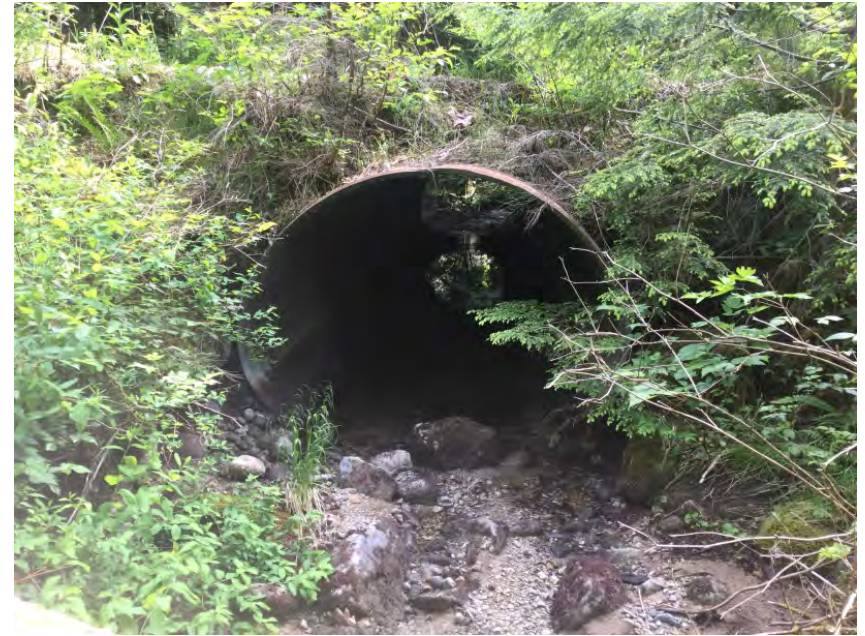
Outlet

Good
