CK-2340

STAVE 16.1km

2018 Inspection

| Structure Class | Major Culvert |

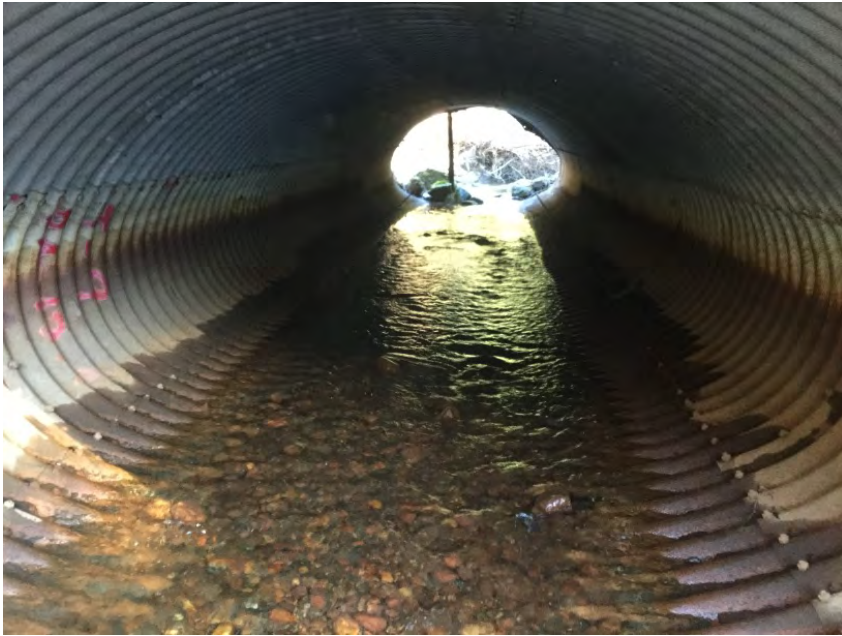
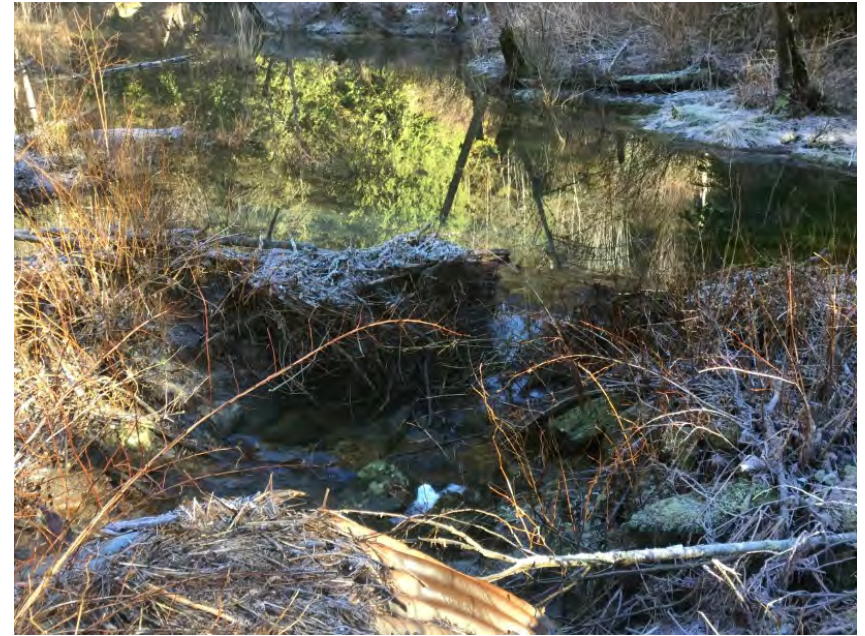
Minor damage noted and debris starting to collect, beaver in area

Inlet debris, see material on top of the culvert

Remove the debris collection at the inlet and monitor. The current load rating of L75 or 68 tonnes to continue.

| Item | Priority | Repair Description |
|---|---|---|
| 1 | Medium | Remove debris buildup at inlet |
