CK-2345

WINSLOW 2.4km

2018 Inspection

| Crossing Name | Bradley Creek | | |

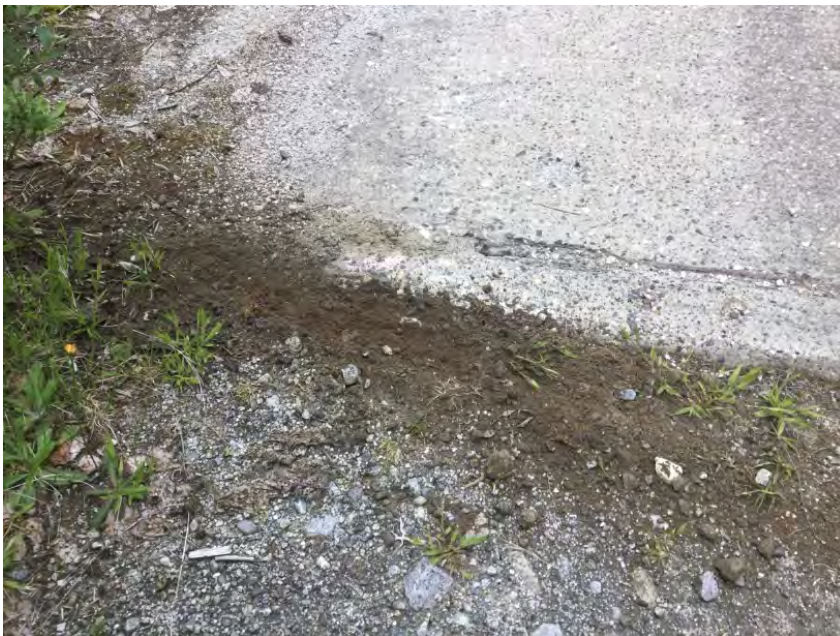
Ballast Wall Fair Damage noted to top of both walls

Damage noted to right ballast wall

| 3 | Medium | Repair damage to ballast walls and grade approaches |

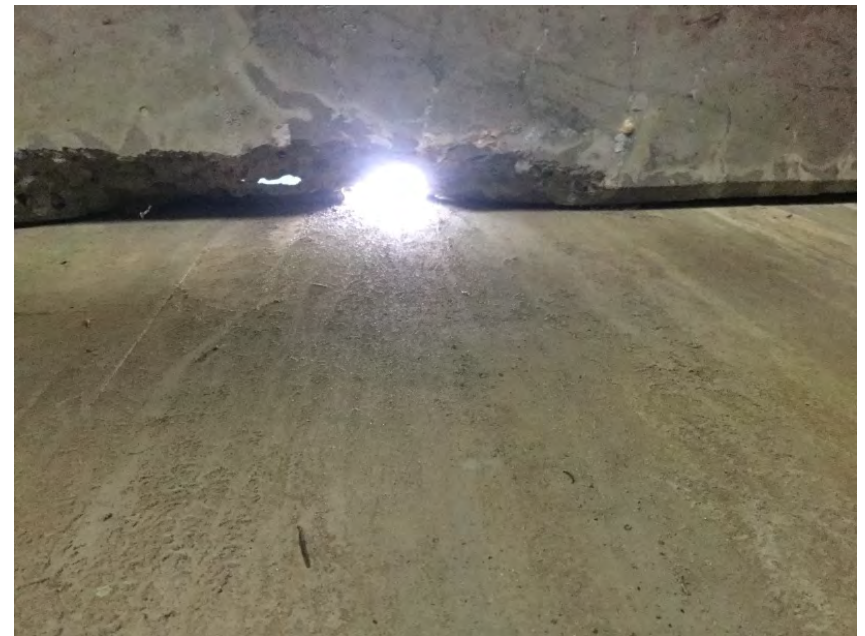
Damage noted on bottom side of panel 1 right bank

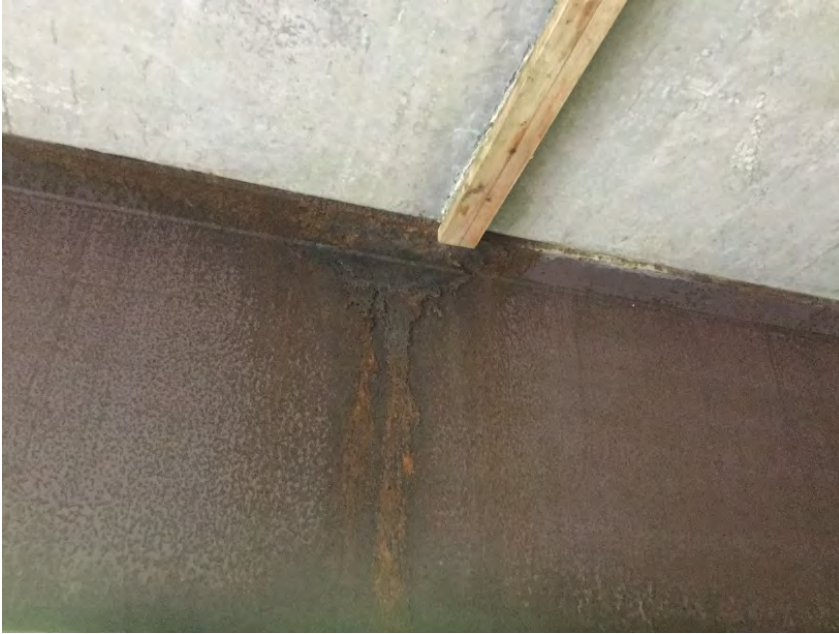
Deck Joints      Fair      Evidence that water is getting through

Some water getting through deck joints

| 1 | Deck joint condition | |

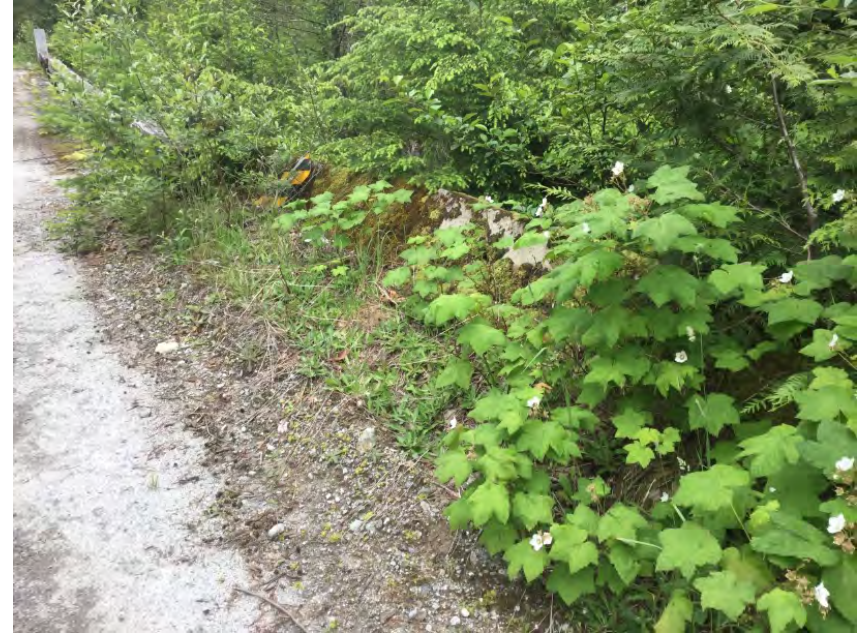
Downstream right approach barriers pushed off road

Downstream right bank no posts pushed off road slightly

| 2 | Medium | Brush approaches, post bridge ahead signs and reset downstream right barriers |
