CK-2346

BOISE 0.9km

2019 Inspection

| Structure Class | Temporary Bridge | | |

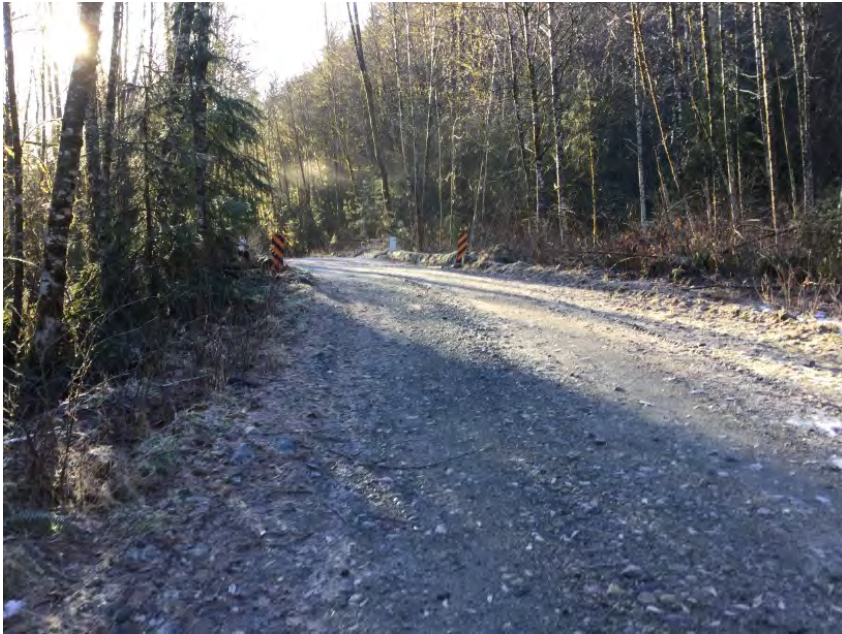
Approach from Left Bank when facing downstream

Bridge Ahead Signs  
Missing
☐ 0
 ☐ 1
 ☒ 2

Fender Condition Poor

| 2 | High | Post load rating signs |

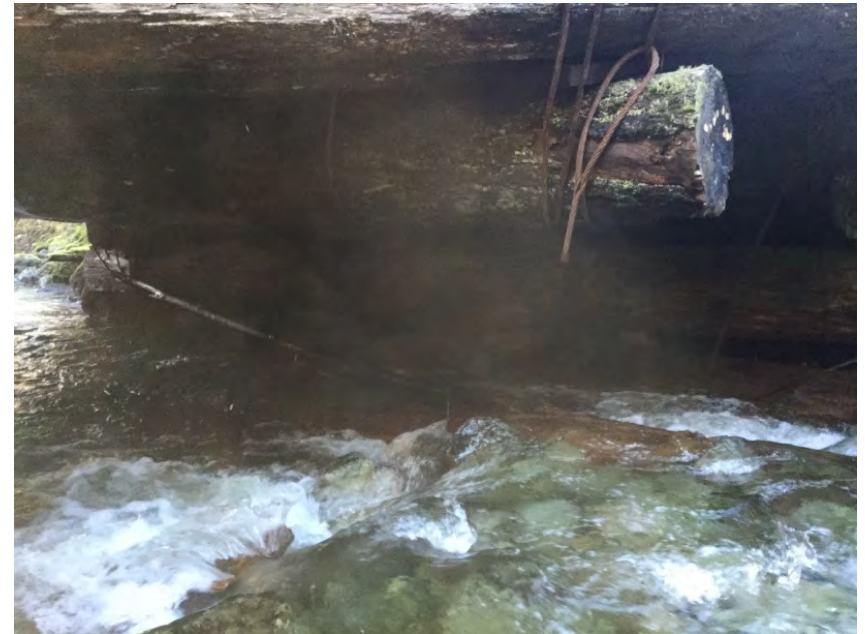
Right Bank Abutment when facing downstream

Log/Timber Cribs Poor

3 face logs right bank, 2 face logs left bank visual with muddsills. Face logs cantilever upstream left bank and downstream right bank. Scour noted between face logs.

Tie Backs Poor

3x each side and rotting

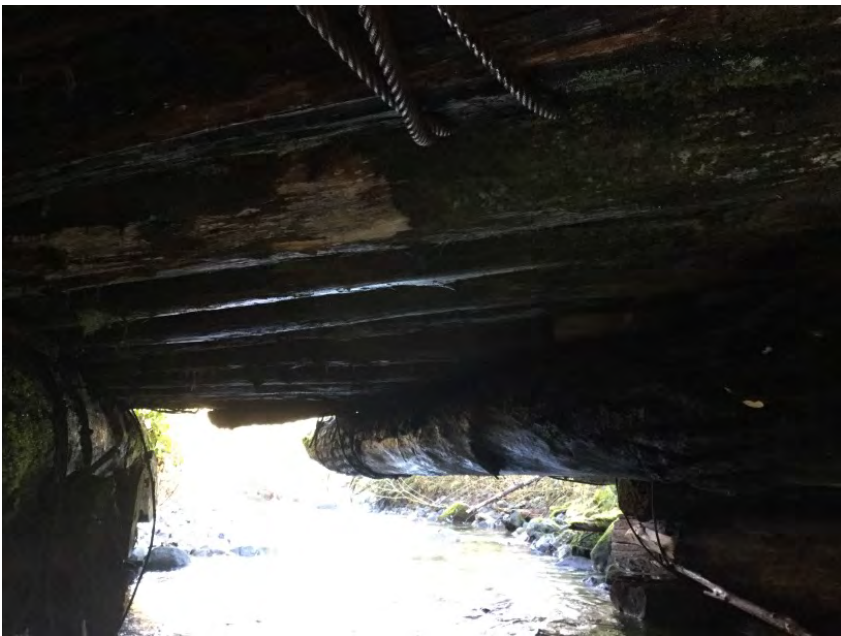
Needle Beam Poor Fd, fruiting bodies present and not tight to all stringers

Needle Lashing/  
Shimming Poor loose lashing

Stringers not accessible due to high flows. Use stringer information from 2016 inspection
