CK-2352

WINSLOW 1.4km

2018 Inspection

| Crossing Name | Side Creek |

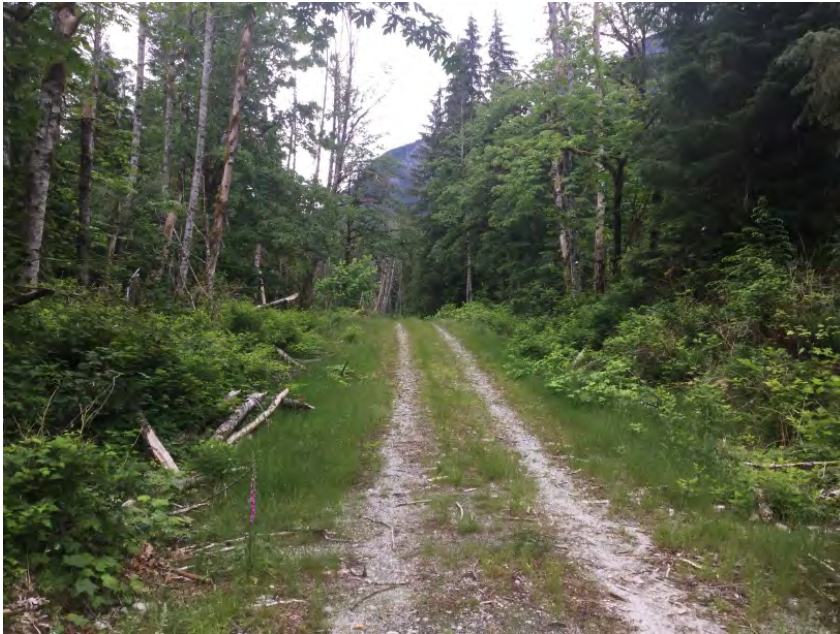
Approach from Left Bank when facing downstream

VC either approach limits visibility

| 1 | Medium | Brush approaches |
| 2 | Medium | Add gravel to right approach |
| 3 | Medium | Post bridge ahead signs |

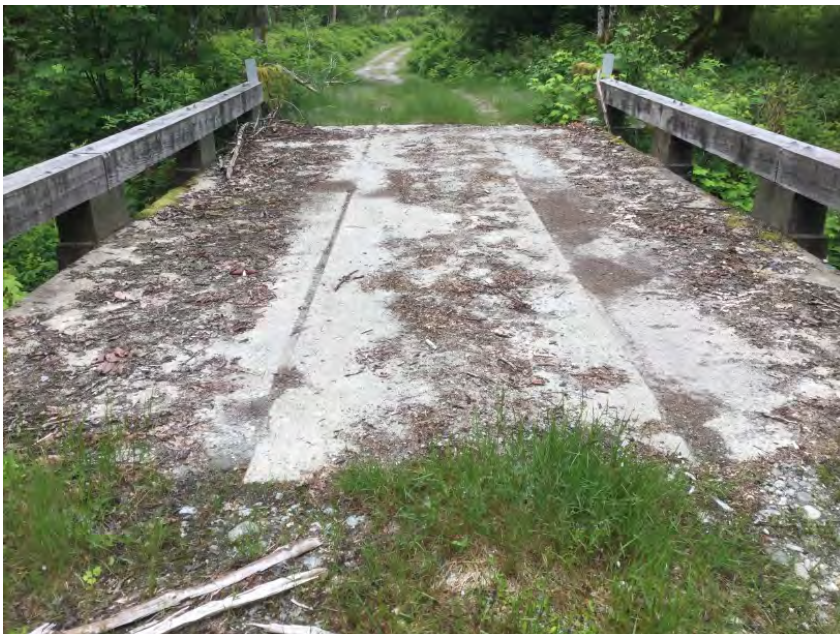
Concrete Deck      **Fair**      Some damage noted

Overall Deck Condition      **Fair**

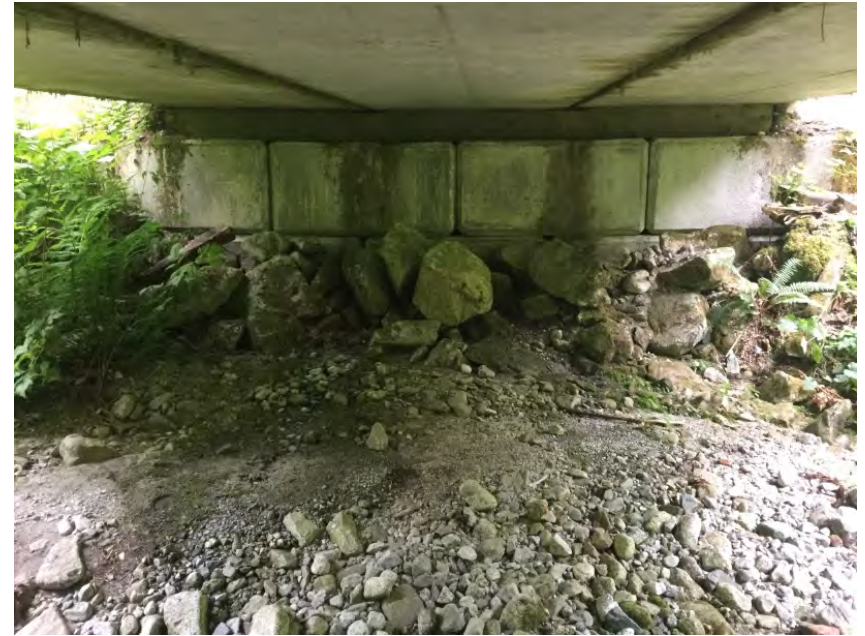
Left Bank Abutment when facing downstream

Concrete Good 2x lock blocks

Caps or Sills Good Treated timber

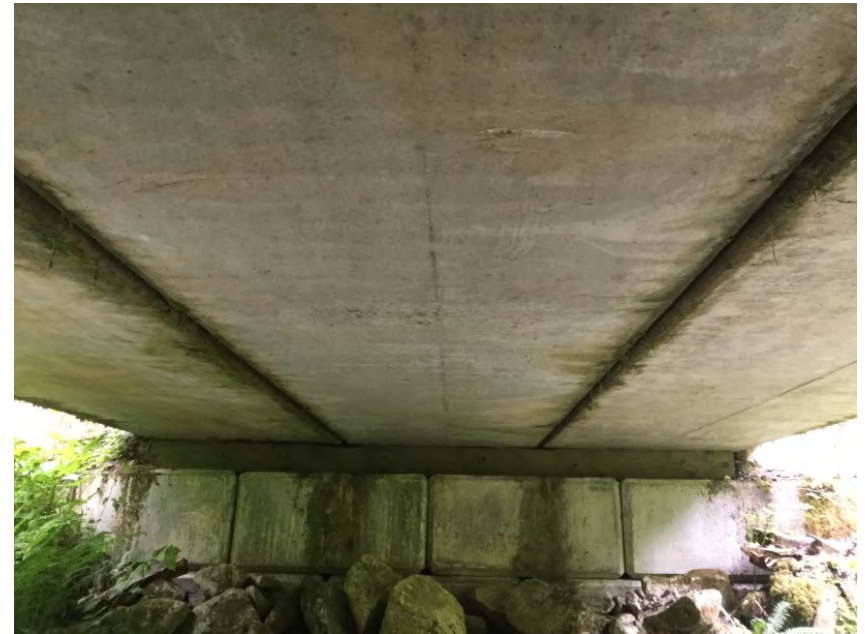
Superstructure

Girders Good 3 concrete slabs
