CK-2353

WINSLOW 1.9km

2018 Inspection

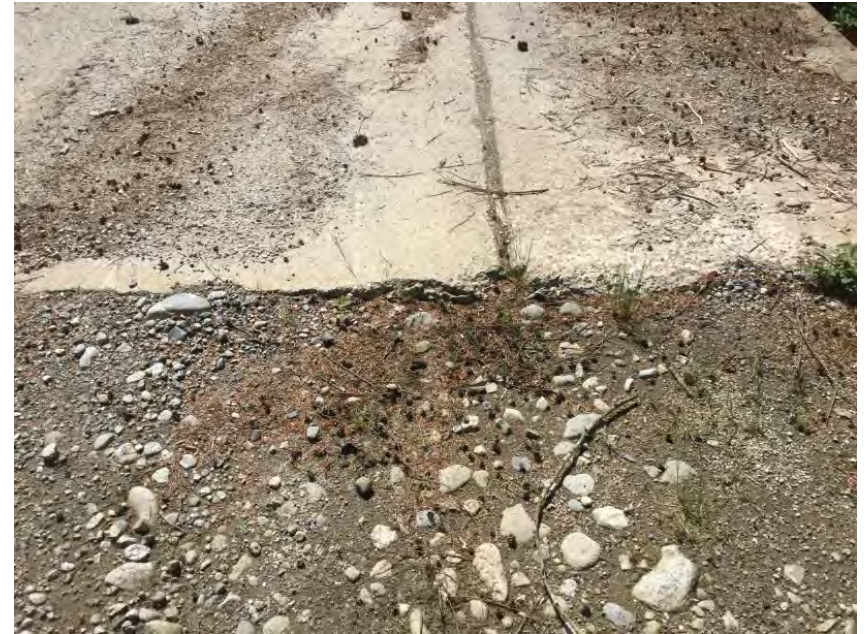
| Concrete Deck | Fair | Minor damage noted |

Minor damage noted at right approach

Repair damage to girder ends; add gravel to both approaches and grade in; brush approaches and post bridge ahead signs. Present load rating of L75 or 68 tonnes to continue.

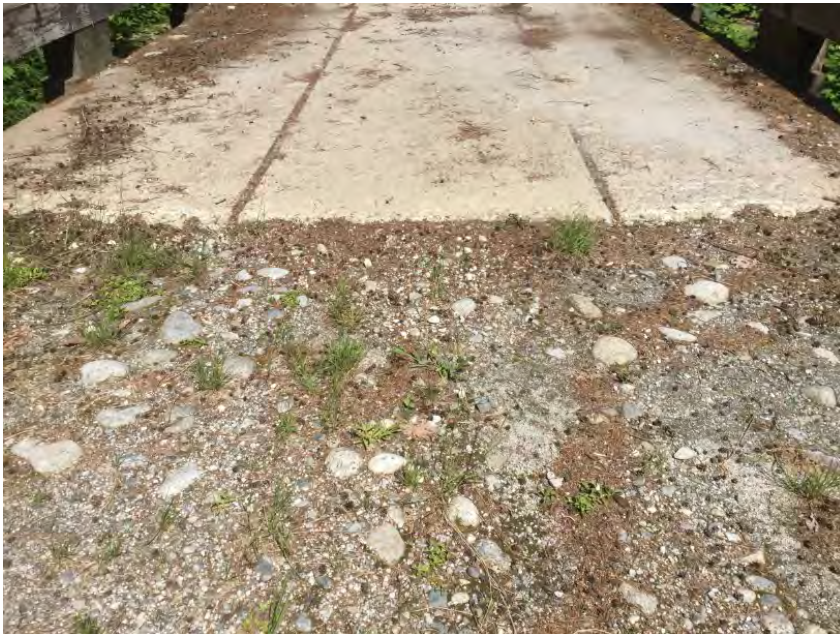
| Running Surface | Fair | Requires gravel at approaches |

Left approach requires 150mm gravel depth

| Repair Item | Priority | Repair Description |
|---|---|---|
| 1 | Medium | Add gravel at both approaches so level with bridge |
