CK-2354

HARRISON EAST 16.4km

2018 Inspection

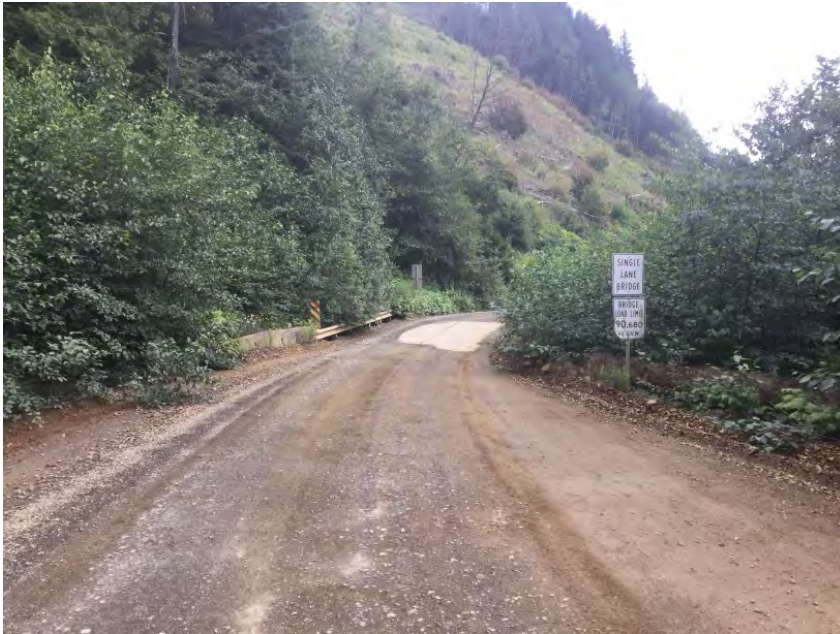
Approach from Right Bank when facing downstream

HC both approaches

| 1 | High | Brush approaches |

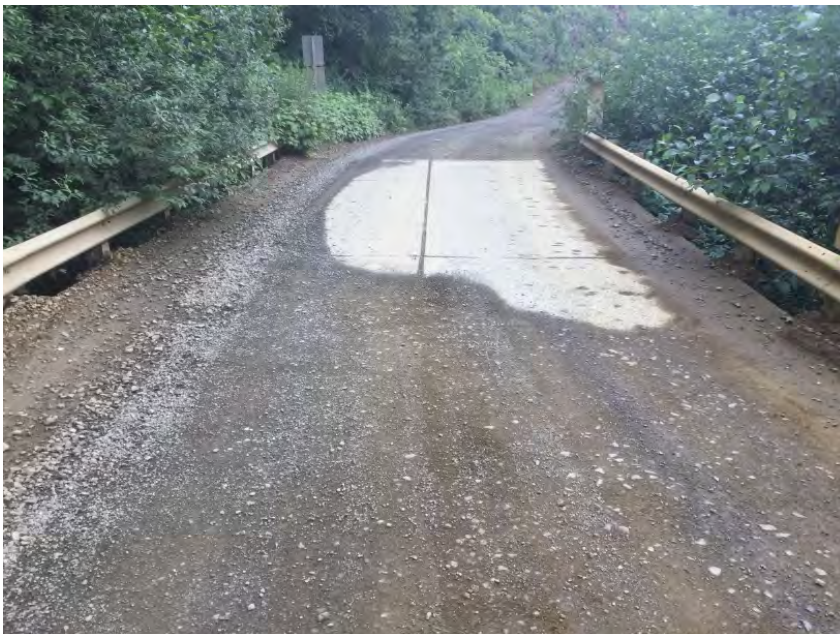
Deck Joints      Fair      Hairline cracks throughout

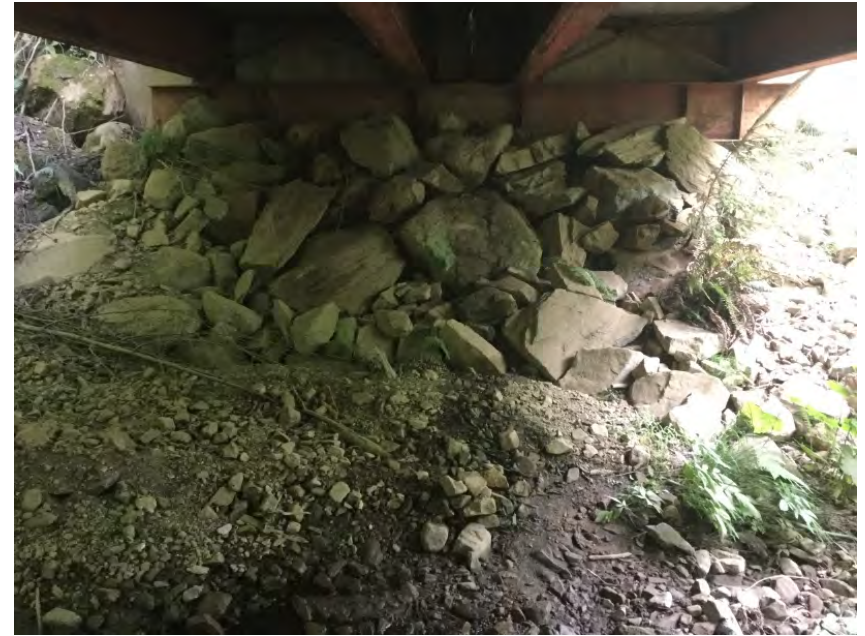
Left Bank Abutment when facing downstream

Caps or Sills Fair Painted steel cap with minor corrosion

Piles or Posts Fair Small diameter and only 1 set

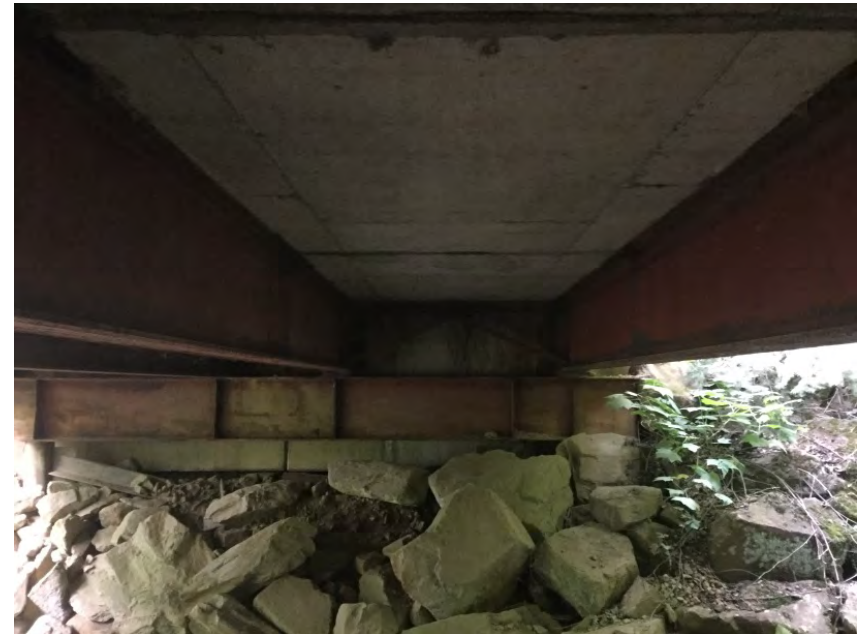
Upstream girders

Girders Fair 2 sets, painted with minor corrosion

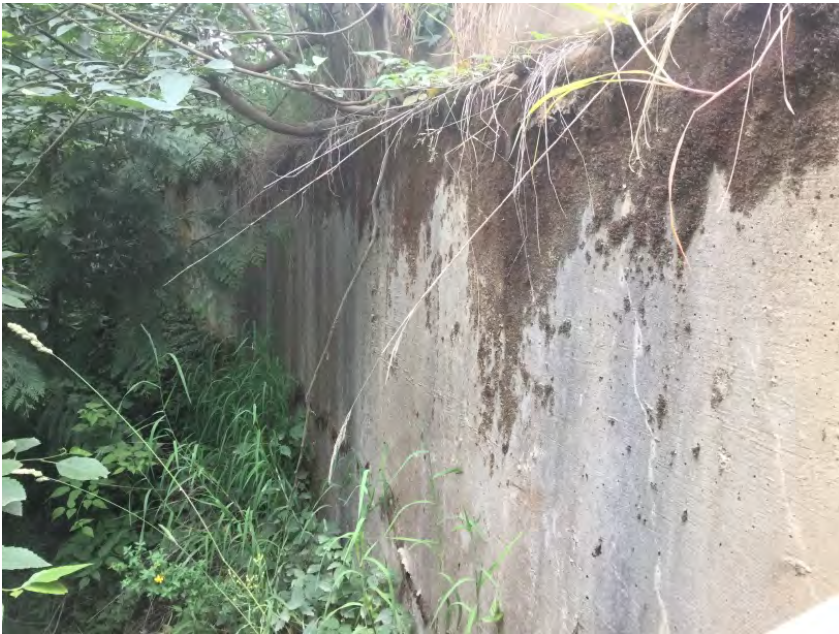
Wingwall

Wing Wall Good Only downstream right bank
