CK-2357

CANTELON 11000 0.1km

2018 Inspection

| Crossing Name | Cantelon Creek | | |

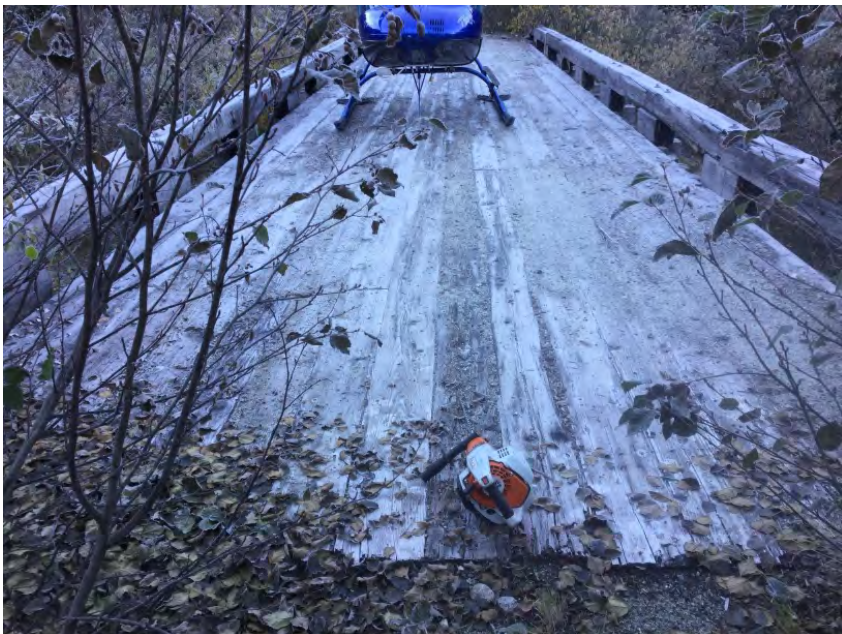
Overall Deck Condition

Poor

Due to entire timber deck condition

| Item | Priority | Repair Description |
|---|---|---|
| 1 | High | Replace ties, planks, guardrail, risers, delineators, and timber shims at left bank |

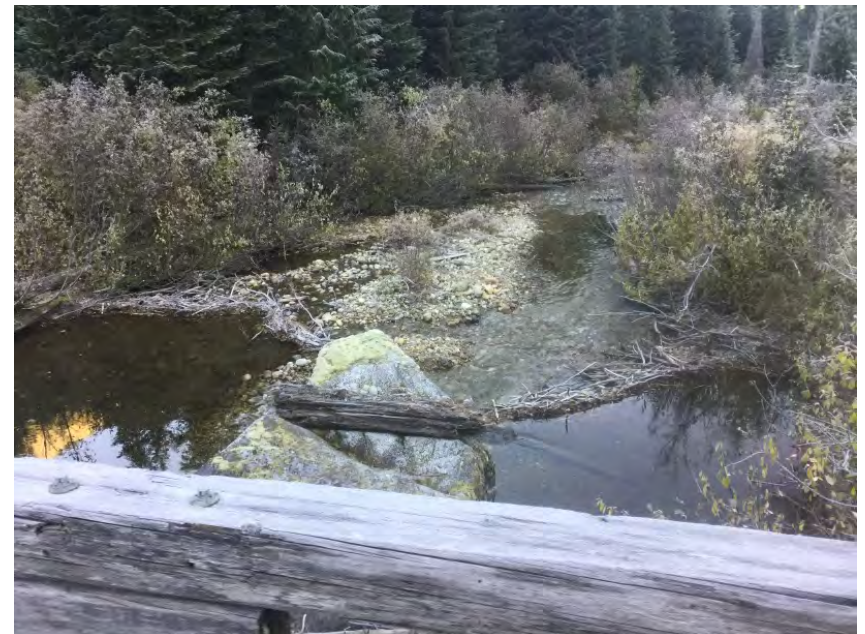
Downstream from Crossing

| Estimated Present Water Level Depth (m) | 1.0 | High Water | <input type="checkbox"/> | Debris | <input checked="" type="checkbox"/> |

| Item | Priority | Repair Description |
|---|---|---|
| 3 | Medium | Remove debris accumulation located immediately downstream from bridge location |

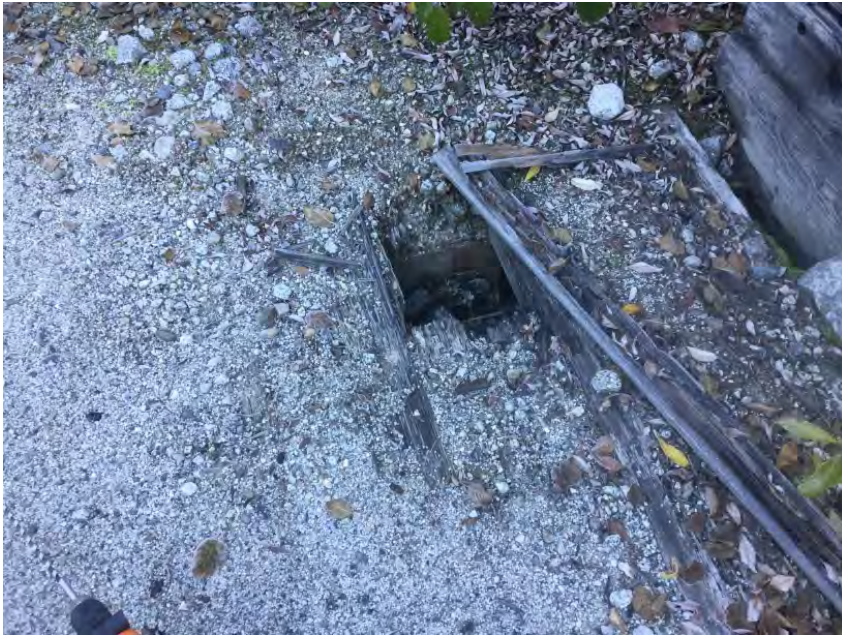
Running Planks

Poor

Rotten

Deck condition

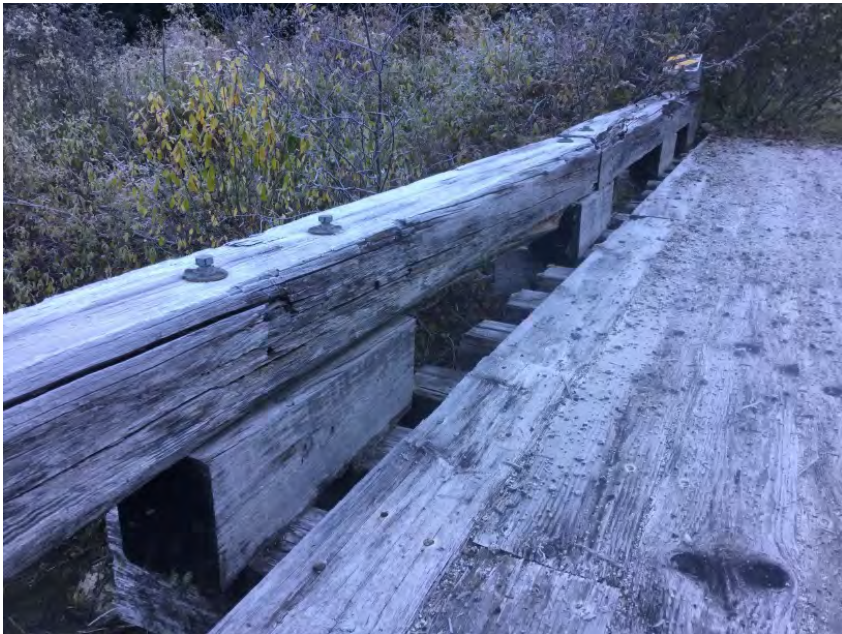
Guard Rail

Curb Rail/Blocks/Posts

Poor

Rotten

Hardware

Loose rail bolts

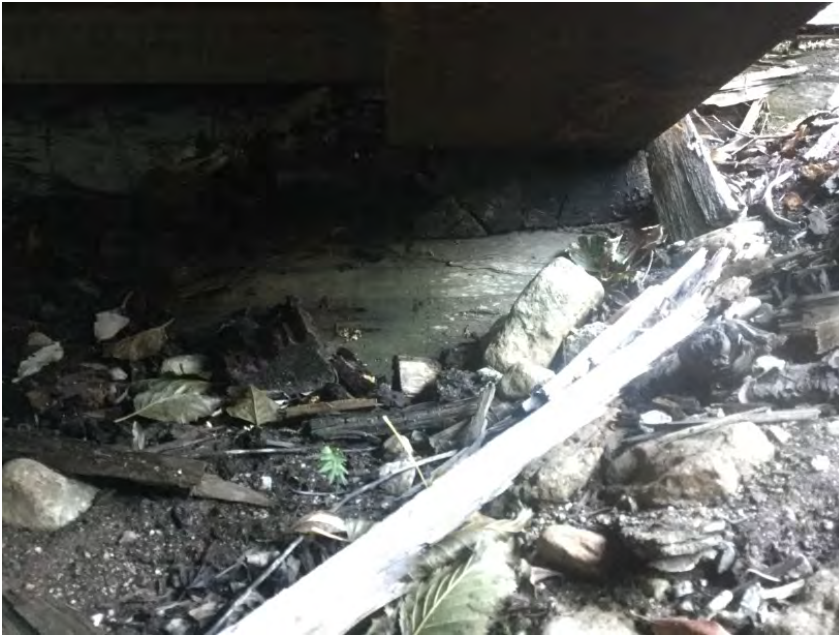
Caps or Sills Fair Single log sills both banks, with timber shims at left bank (rotten)

Bearings Poor Timber shims rotten and girders settling

Left bank timber shims rotten

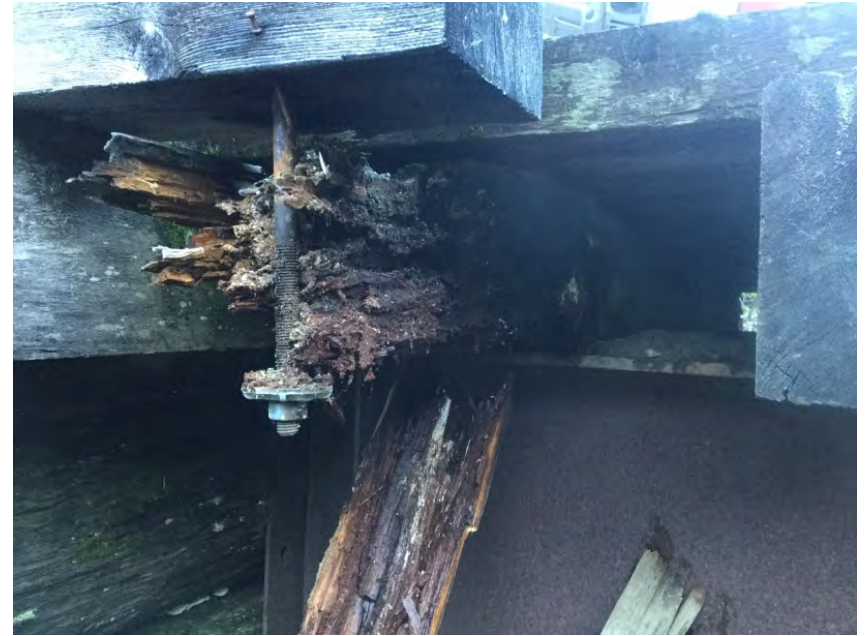
Ties

Poor

Rotten

Random Tie condition

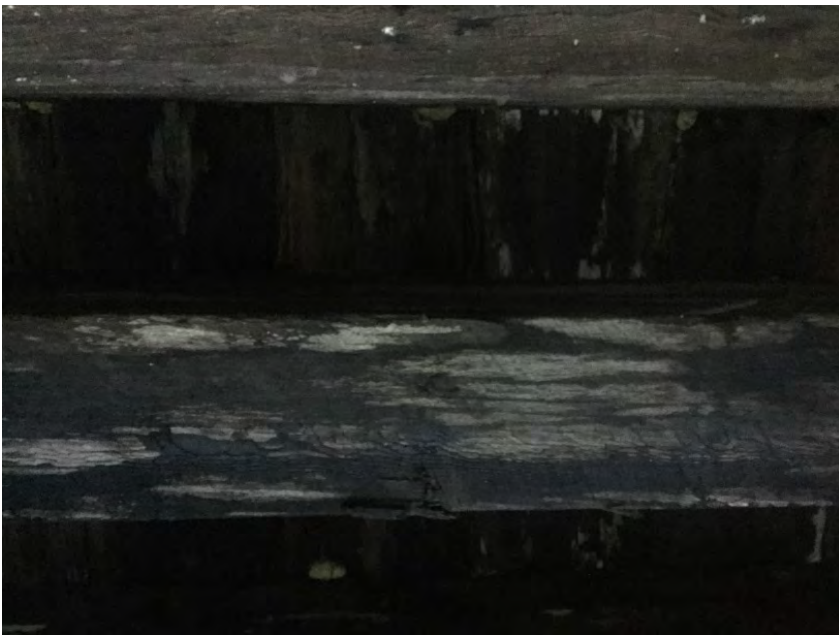
Rotten deck

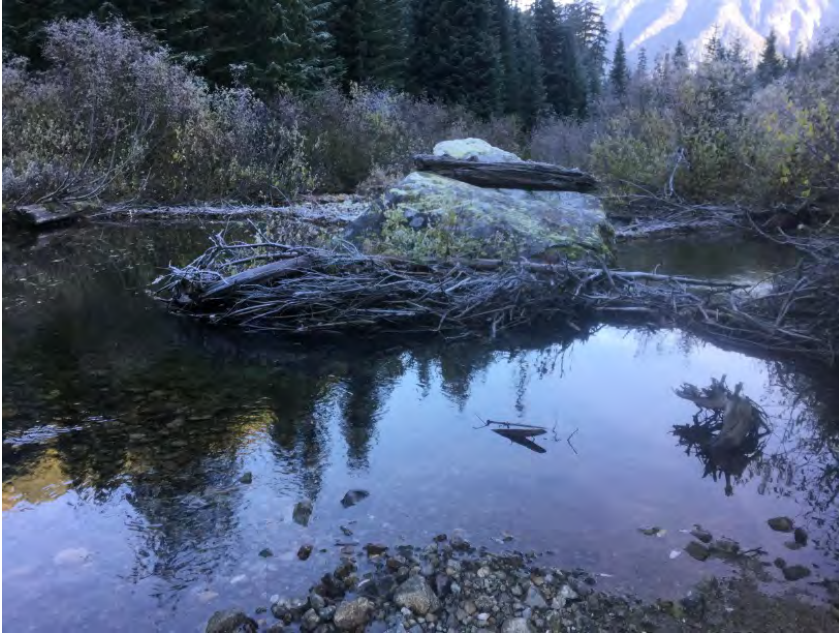
Debris accumulation immediately downstream
