CK-2360

KOOKIPI WEST 400 3.8km

2018 Inspection

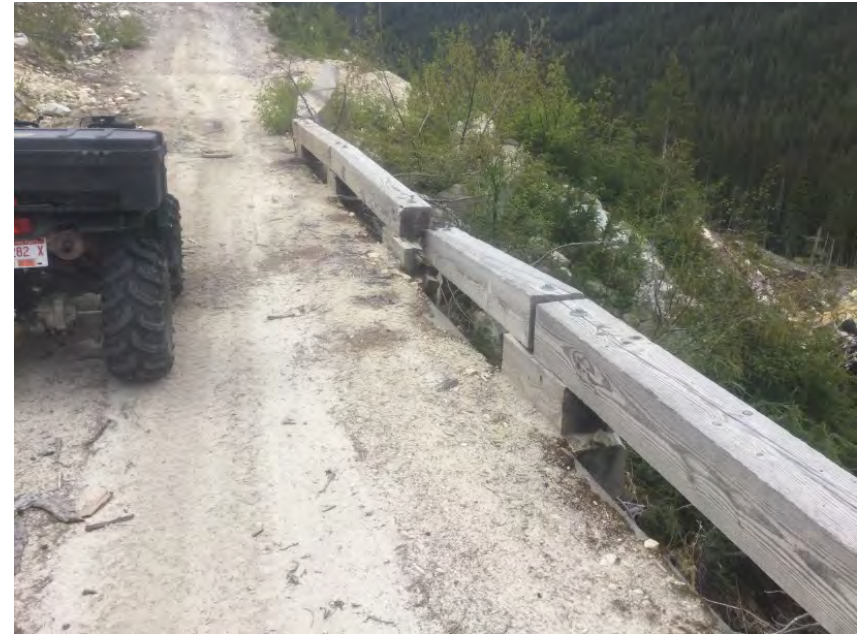
Guard Rail

| Curb Rail/Blocks/Posts | Poor | Rotten |

| Hardware | Poor | Loose rail bolts |

| Repair Item | Priority | Repair Description |
|---|---|---|
| 1 | High | Replace guardrail, risers and blocks |

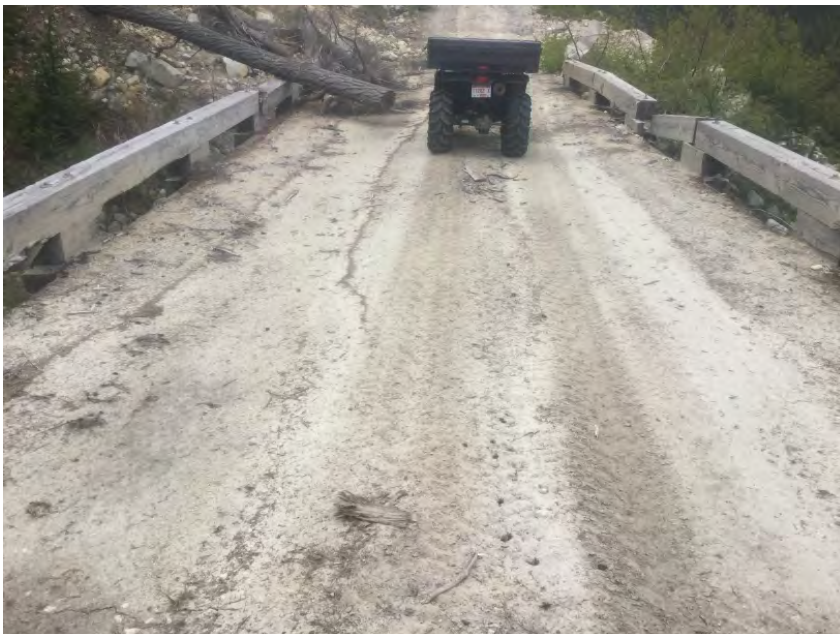
| Running Surface | Poor | Sediment and debris on deck |

| Overall Deck Condition | Poor | Due to debris on deck and rail condition |

| Repair Item | Priority | Repair Description |
|---|---|---|
| 3 | Medium | Post bridge ahead signs and clean sediment and debris from the deck |

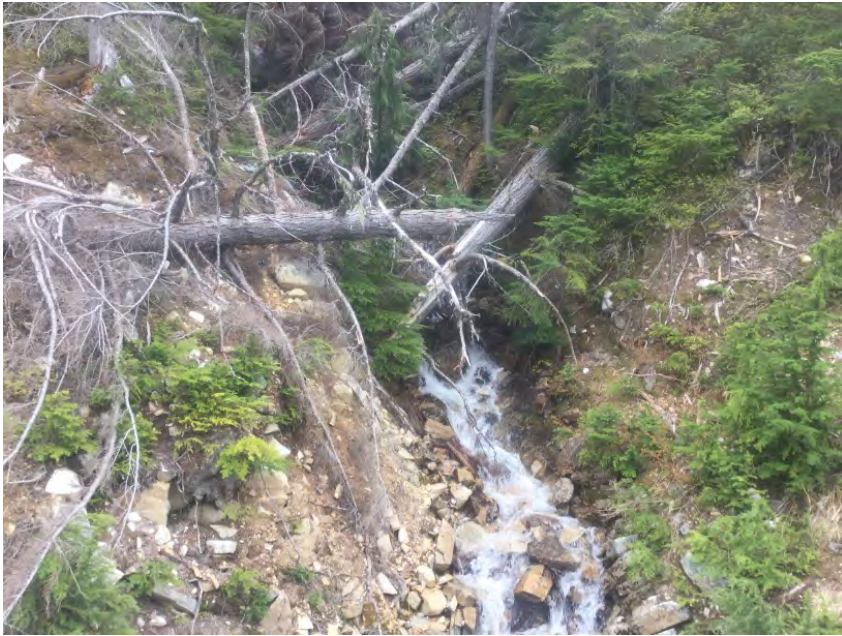
Upstream from Crossing

Comments Windfalls noted across stream above and below bridge

| Repair Item | Priority | Repair Description |
|---|---|---|
| 2 | Medium | Clear upstream left approach ravelled material and debris in stream above bridge |

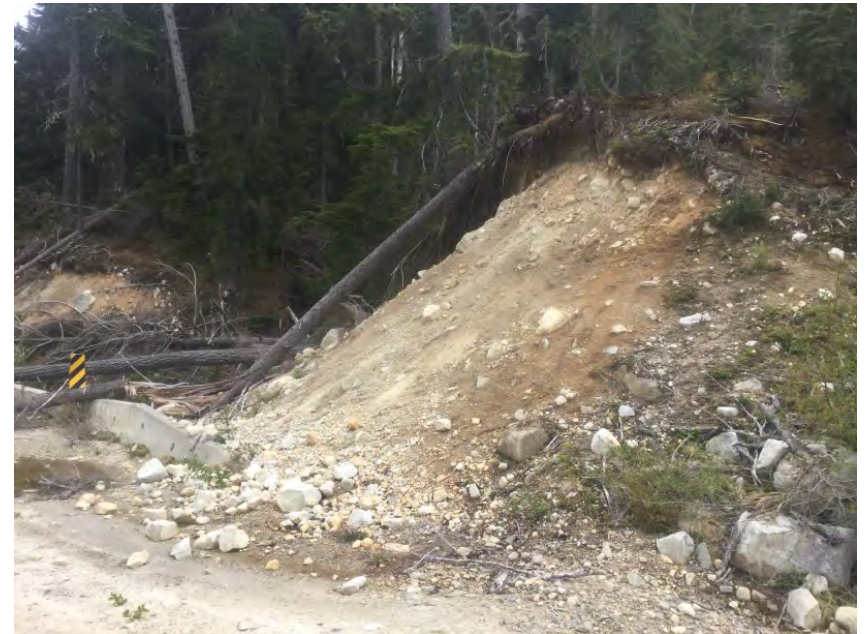
Ravelling cutslope upstream left approach

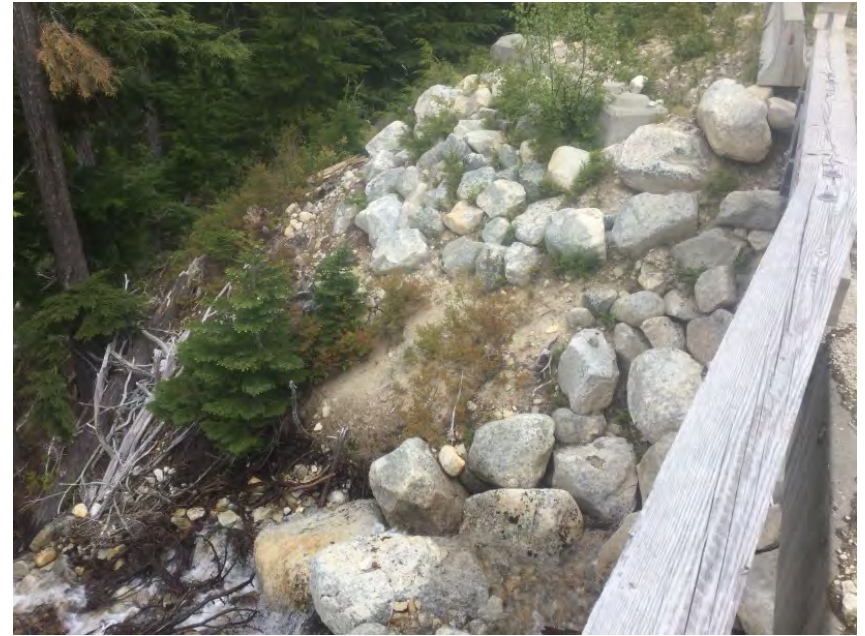
Fill Fair monitor fill and riprap stability at downstream right approach

Downstream right bank lack of riprap

| Item | Monitor Description | Frequency |
|---|---|---|
| 1 | Downstream right bank erosion | Routine Inspection |
