CK-2361

KOOKIPI WEST 400 4.9km

2018 Inspection

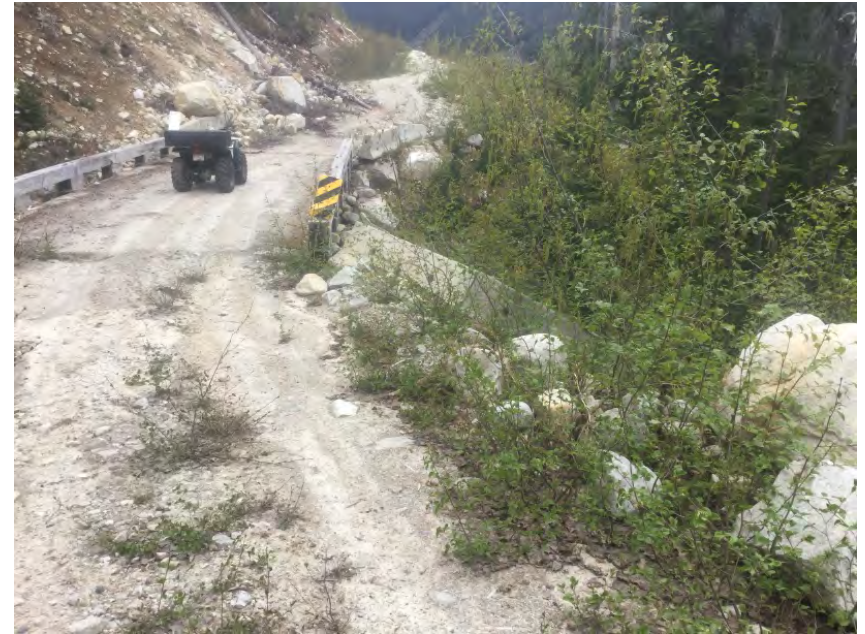
Concrete no post barriers but need to be reset

Failed no post barriers at downstream right approach

| Item | Priority | Repair Description |
|---|---|---|
| 2 | Medium | Repair failing downstream road fills by placing riprap and resetting all concrete no post barriers |

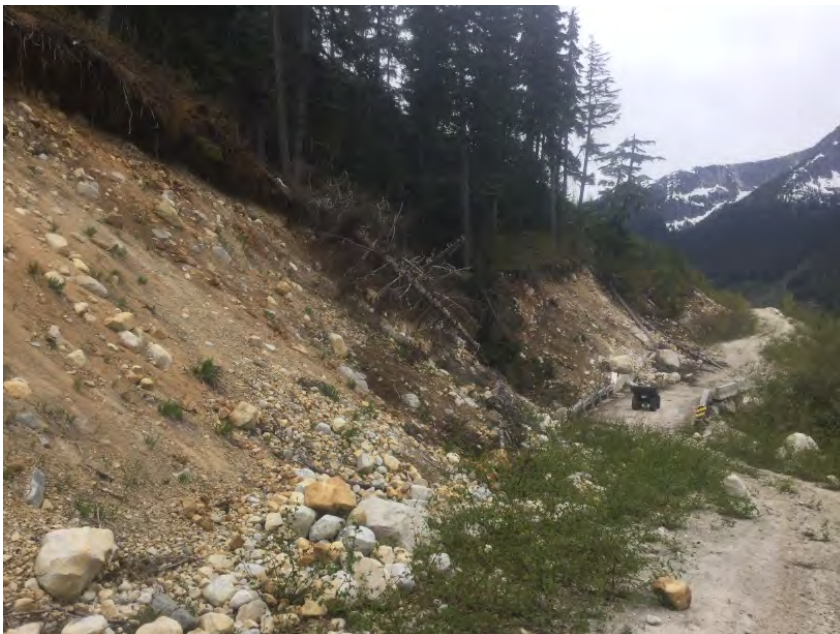
Ravelling cutslope sat both approaches

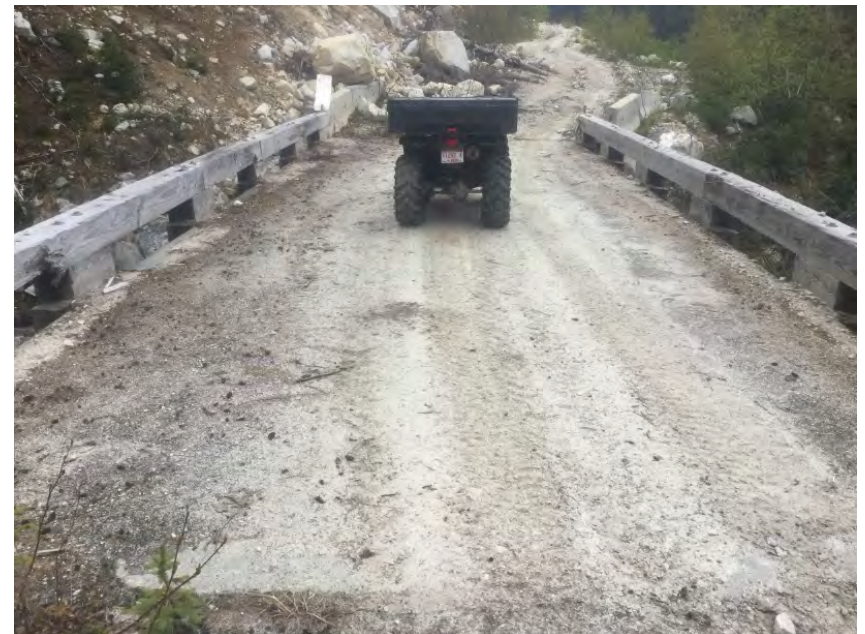
| Curb Rail/Blocks/Posts | Poor | Rotting |

| Hardware | Poor | Loose rail bolts |

| Overall Deck Condition | Poor | Due to rail condition |

| Item | Priority | Repair Description |
|---|---|---|
| 1 | Medium | Replace guardrail, risers and blocks; replace delineators and post bridge ahead signs |

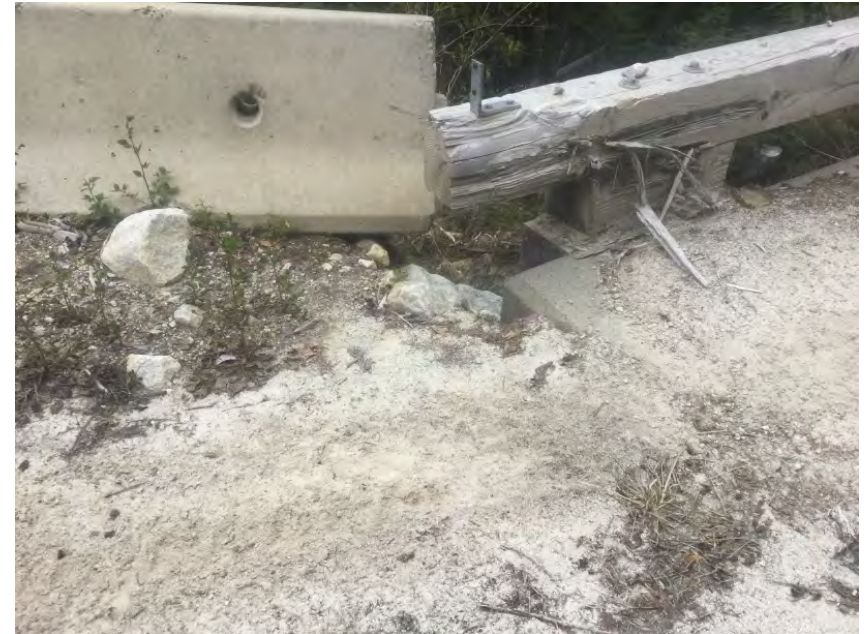
Failing at both downstream approaches

Loosing fill at downstream left approach

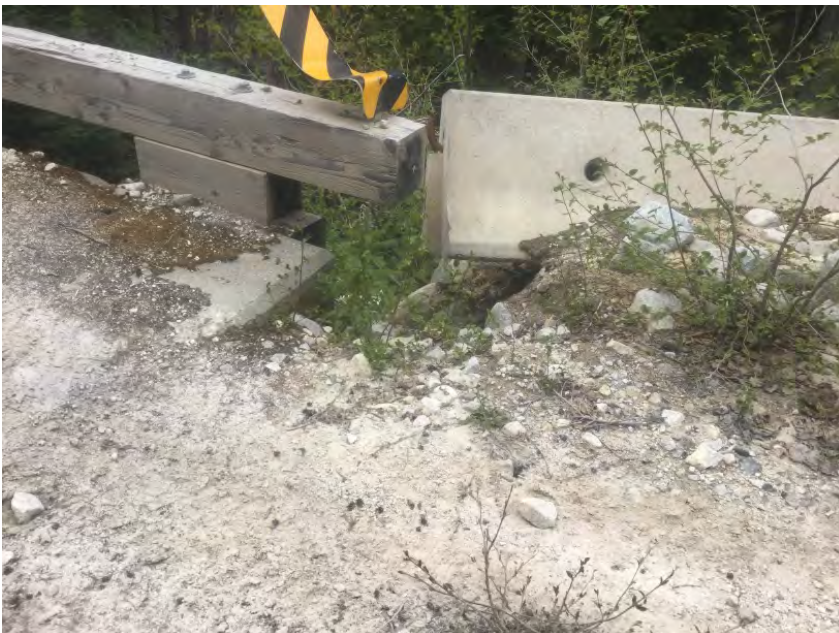
Loosing fill at downstream right approach
