CK-2362

KOOKIPI WEST 400 6.5km

2018 Inspection

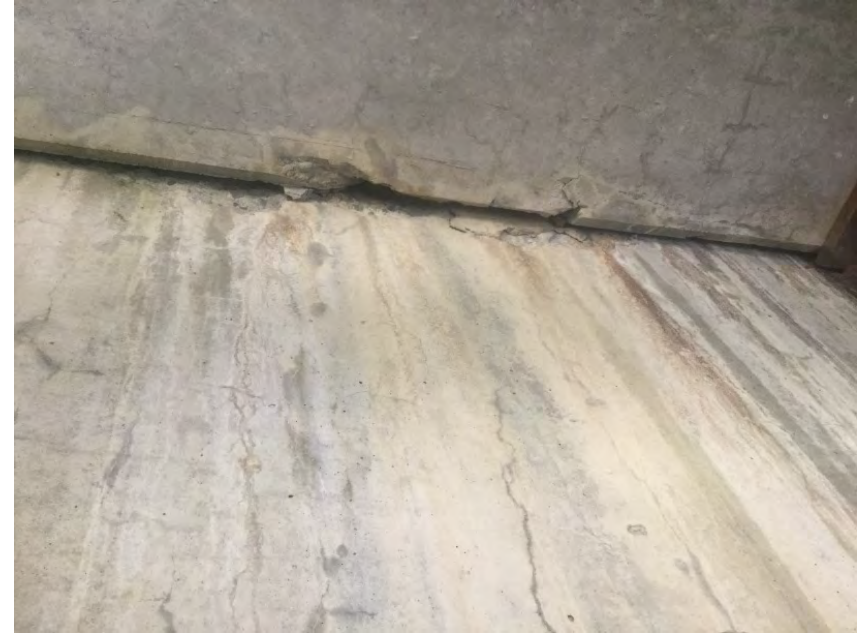
Minor spalling noted on left bank wall and panel 1

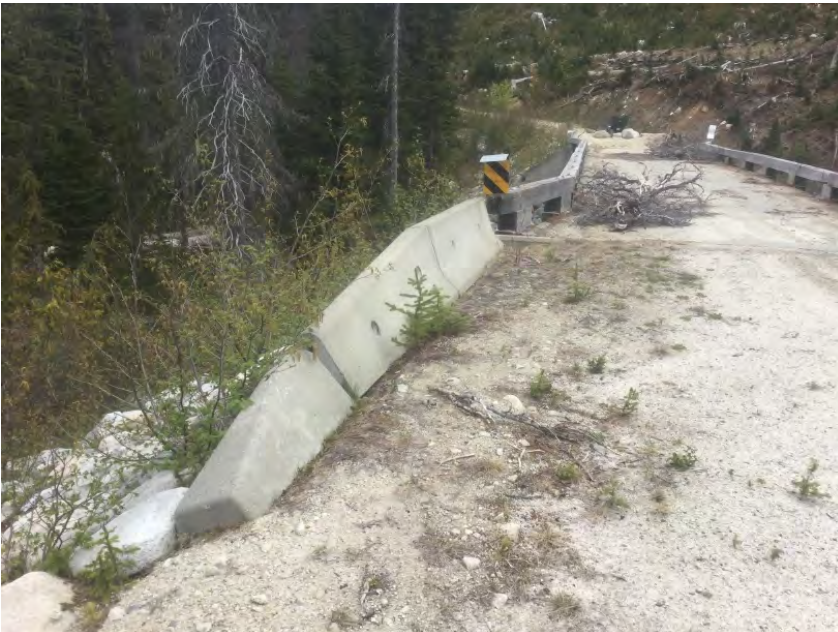
| Curb Rail/Blocks/Posts | Poor | Rotten |

| Hardware | Poor | Loose rail bolts |

Downstream left approach barriers failing

| 1 | Medium | Replace guardrail, risers and blocks |

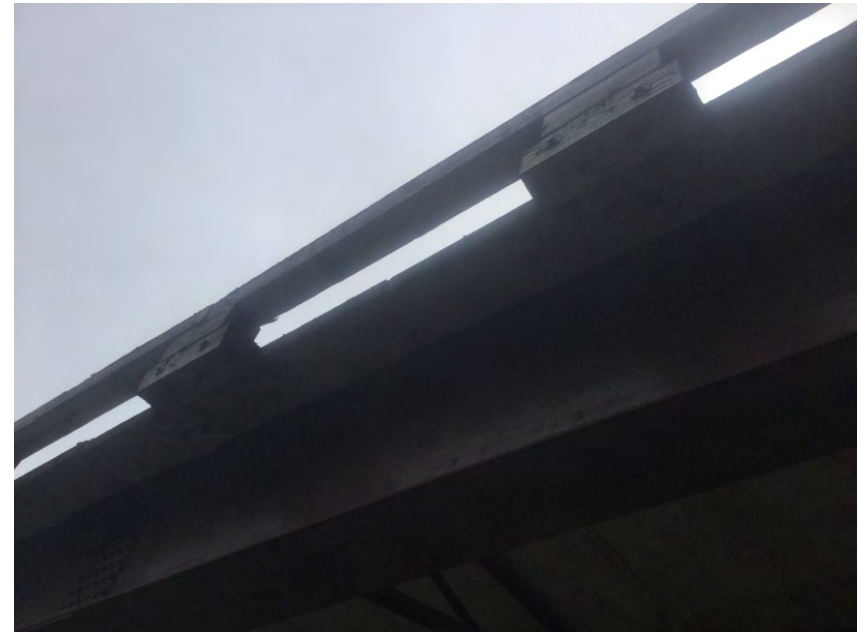
| Concrete Deck | Fair | Damage noted to underside of 2 panels on downstream ends |

Damage noted under 2 panels with rebar showing

| 2 | Medium | Repair damage noted to 2 panels on downstream ends |
