CK-2378

STAVE 7.7km

2018 Inspection

| Crossing Name | Winslow Side Channel | | |

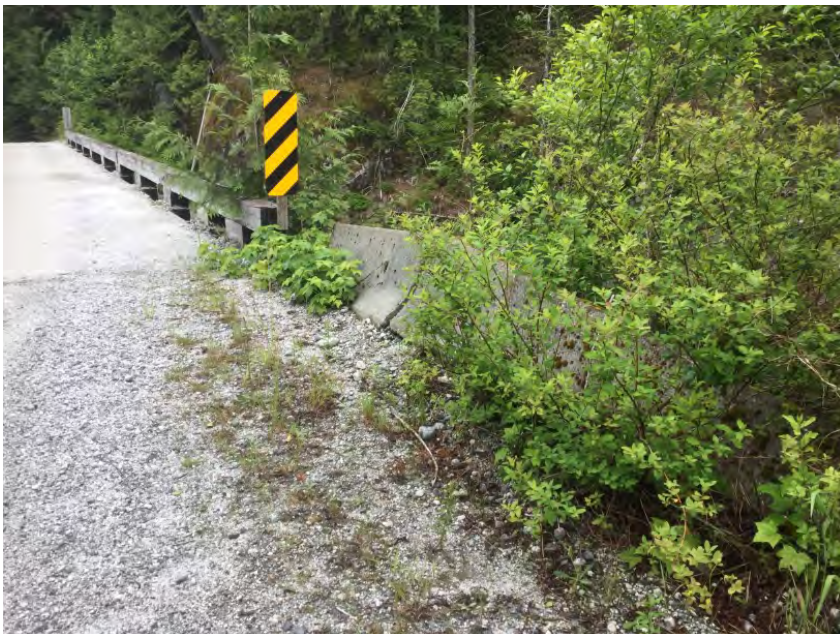
Upstream left approach no posts

| Repair Item | Priority | Repair Description |
|---|---|---|
| 2 | Medium | Replace all guardrail, risers and blocks and add road support and realign all concrete barriers |

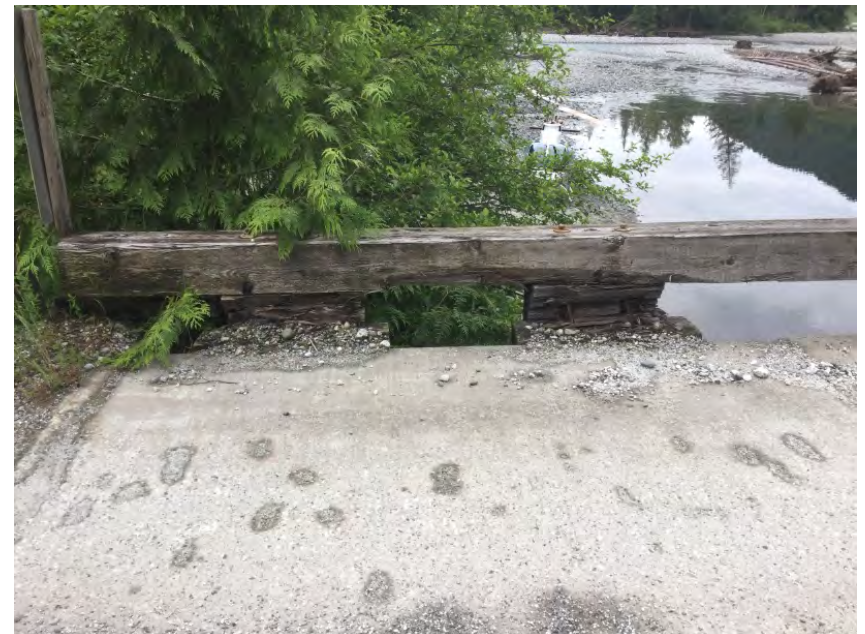
Curb Rail/Blocks/Posts Poor Rotten

Hardware Poor Loose rail bolts

Guardrail condition

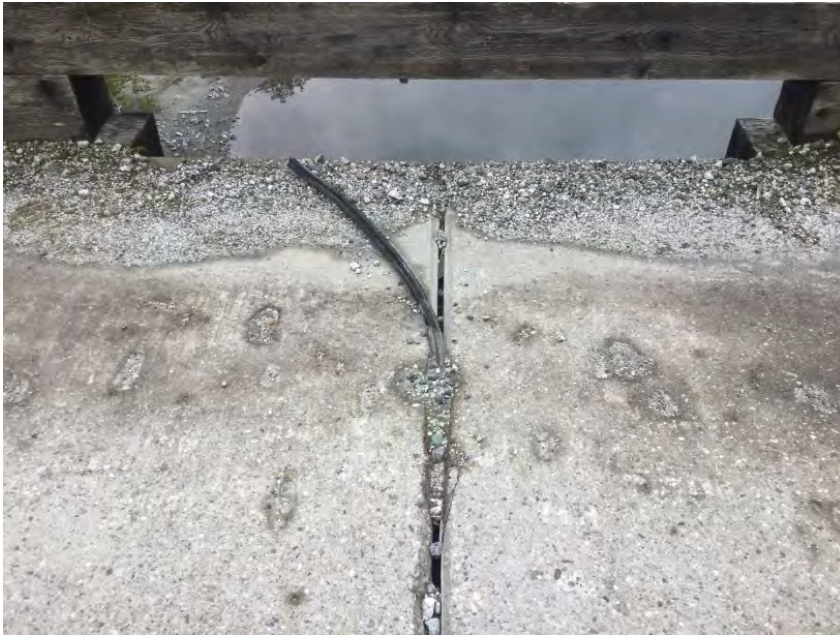
Deck Joints Poor Most compression seals have failed

Seals between deck panels failing throughout

| Repair Item | Priority | Repair Description |
|---|---|---|
| 3 | Medium | Repair damage to ballast wall and replace all compression seals |

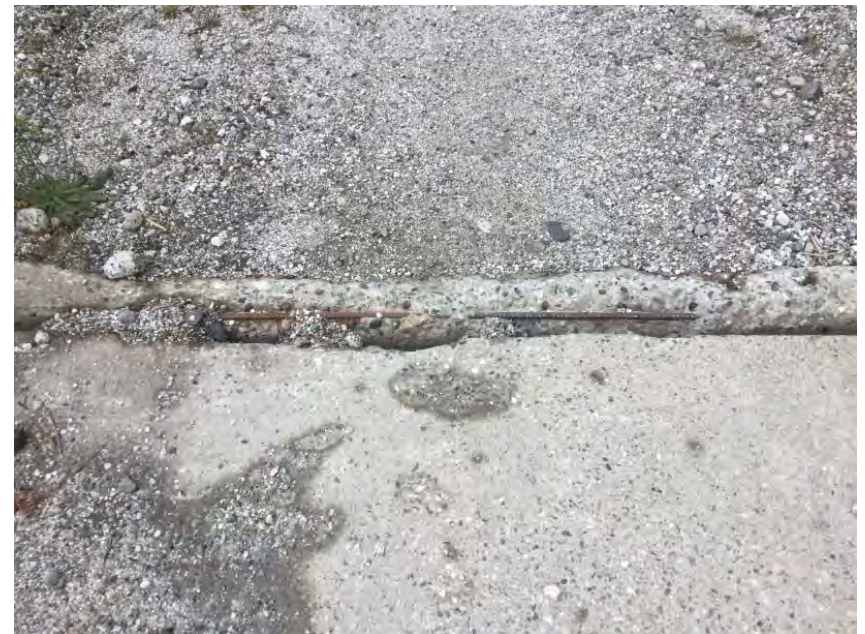
Ballast Wall Fair Damage noted to top right bank with rebar exposed

Right bank ballast wall damage

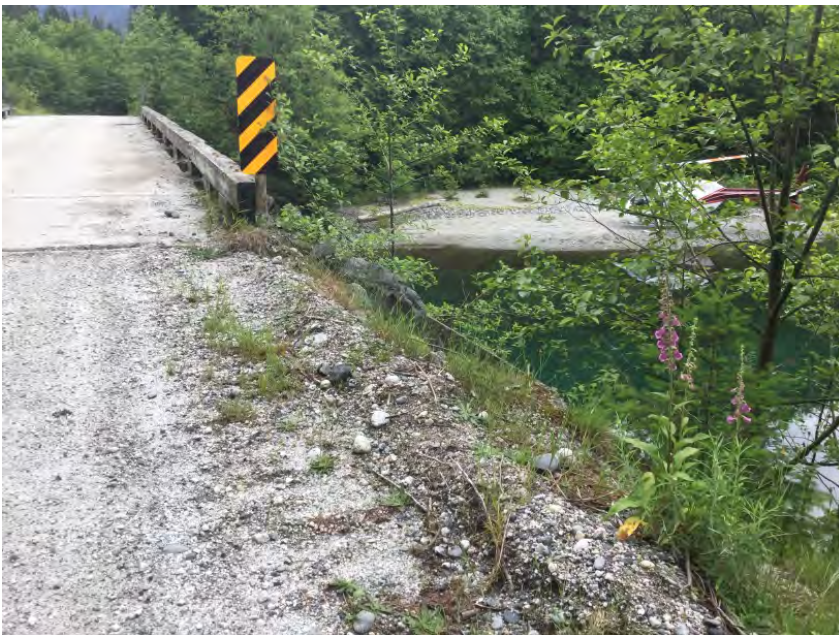
Missing no post barriers

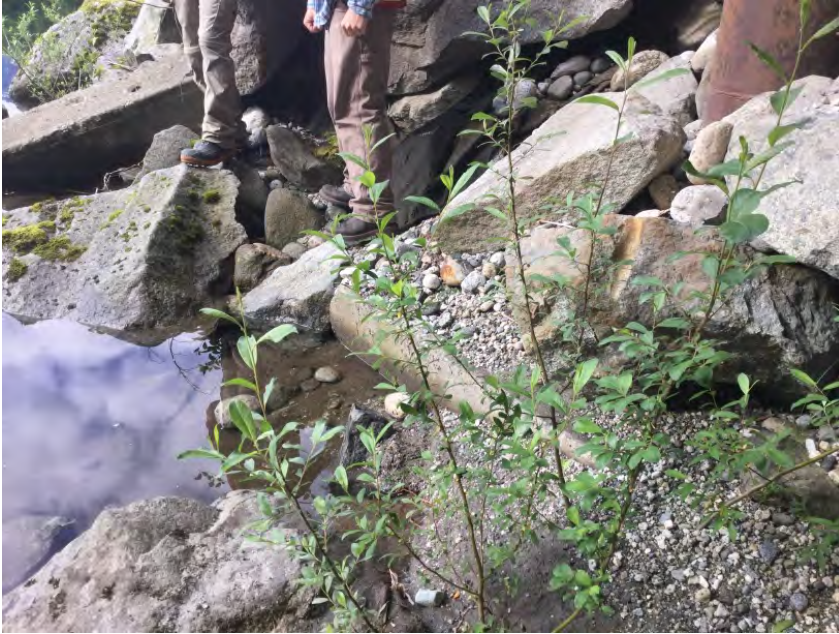
No settlement apparent due to scoured footing

Concrete Fair Downstream right pad scoured 300mm

Downstream right footing exposed

| Repair Item | Priority | Repair Description |
|---|---|---|
| 1 | High | Reinstate complete bearing under the downstream right bank precast footing and add riprap for protection |

| Item | Monitor Description | Frequency |
|---|---|---|
| 1 | Scour under the downstream right bank footing and riprap scour | Annually |

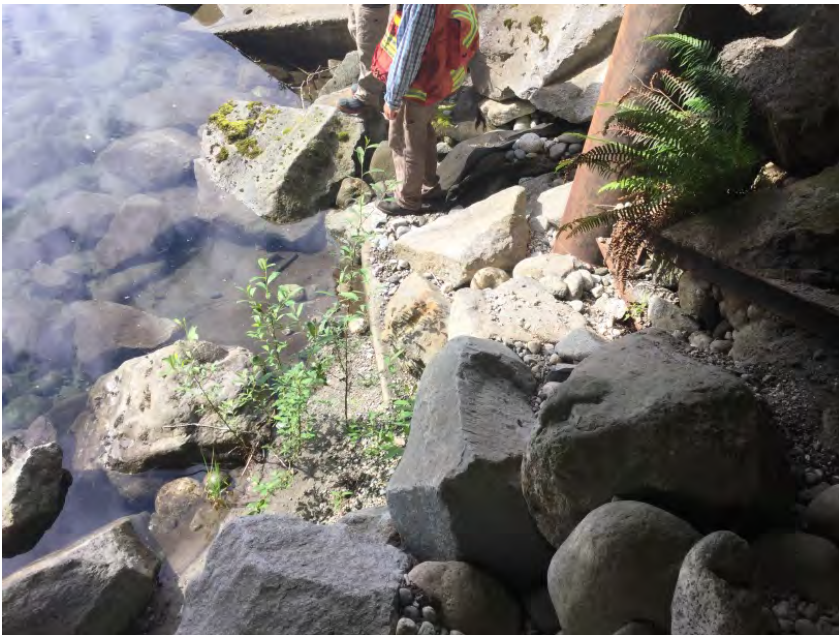
Riprap Poor Due to downstream right bank scour

Scoured riprap

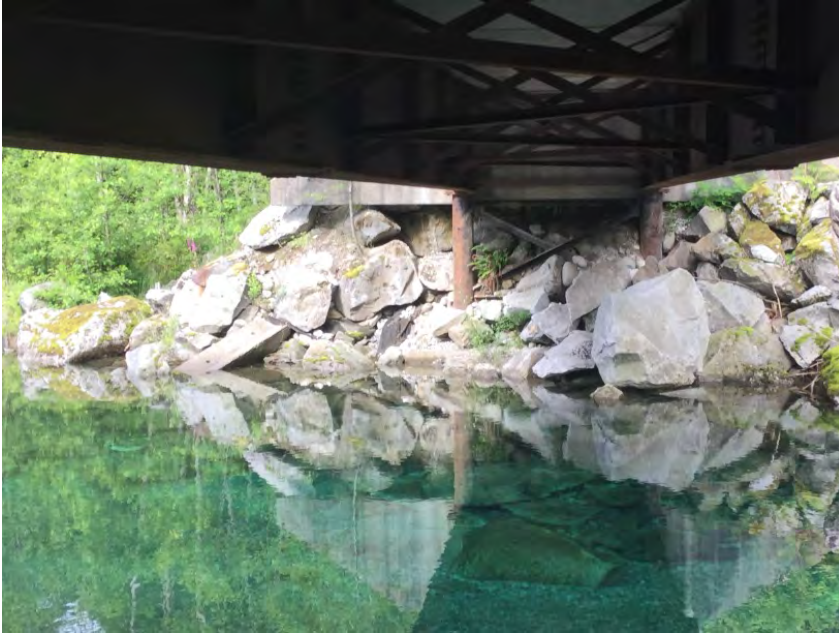
Fill Poor Failed downstream right bank

Downstream right bank riprap scour
