CK-2379

LEASE 0.7km

2018 Inspection

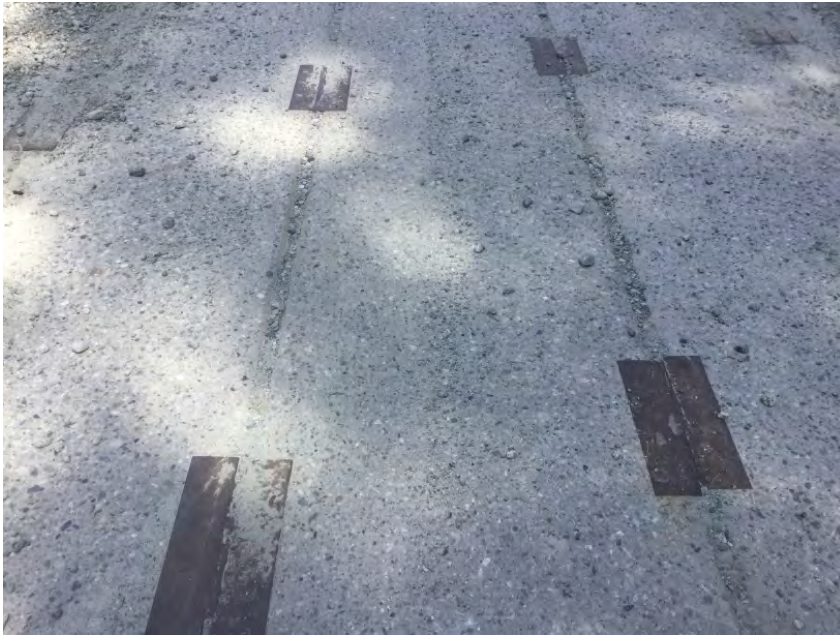
Welded shear connectors - typical

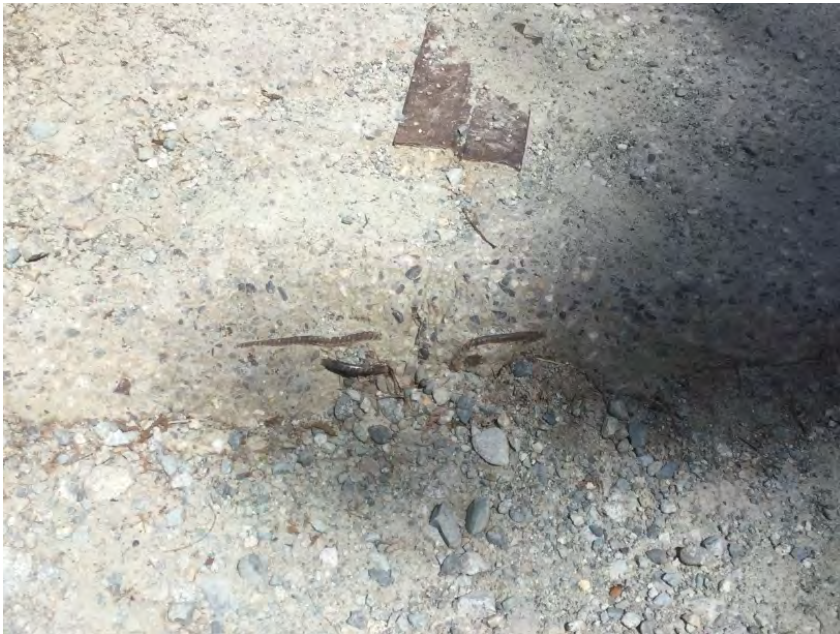
7 slabs with damage noted at ends on wheel path

Damage to slabs noted at left bank

Replace damage noted to slab ends. Replace guardrail, risers and blocks; clean sediment from deck and grade approaches. Present load rating of CL-625 or 63 tonnes to continue.

| Repair Item | Priority | Repair Description |
|---|---|---|
| 1 | Medium | Repair damage to concrete slabs |

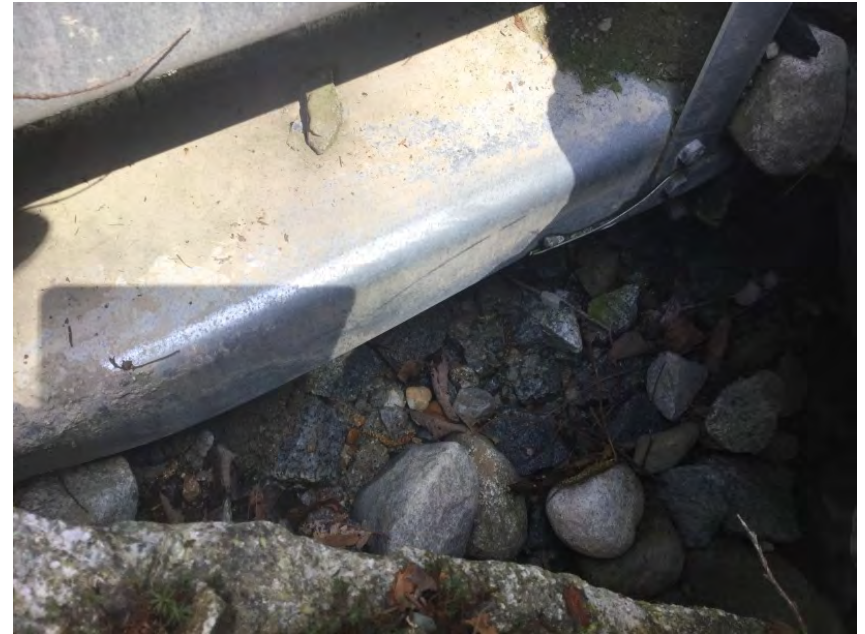
Minor installation damage noted and material starting to erode from under upstream right bank

Material under upstream right abutment binwall eroding

| Item | Monitor Description | Frequency |
|---|---|---|
| 1 | Material eroding from upstream right bin wall | Routine Inspection |

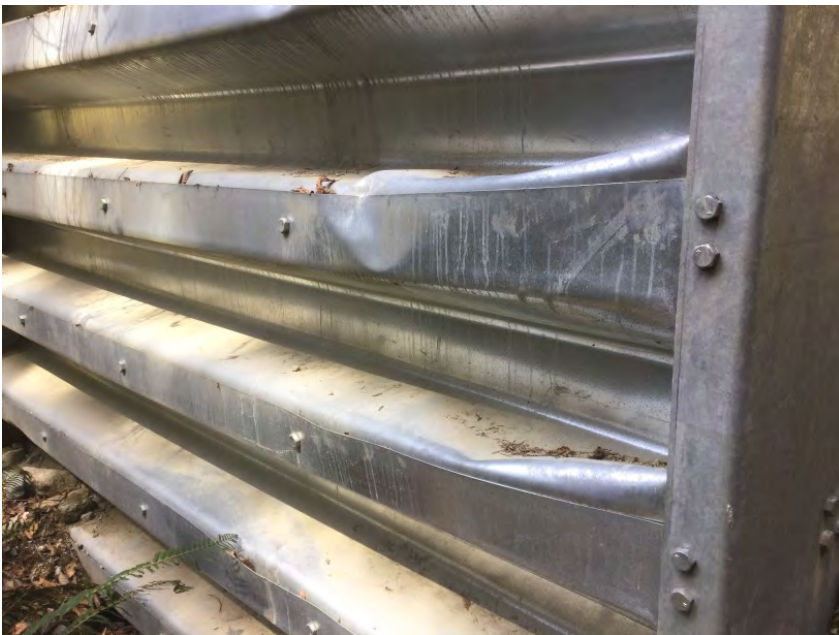
Minor damage noted at few location on bin wall - typical
