CK-2390

CEDARFLAT 4.6km

2018 Inspection

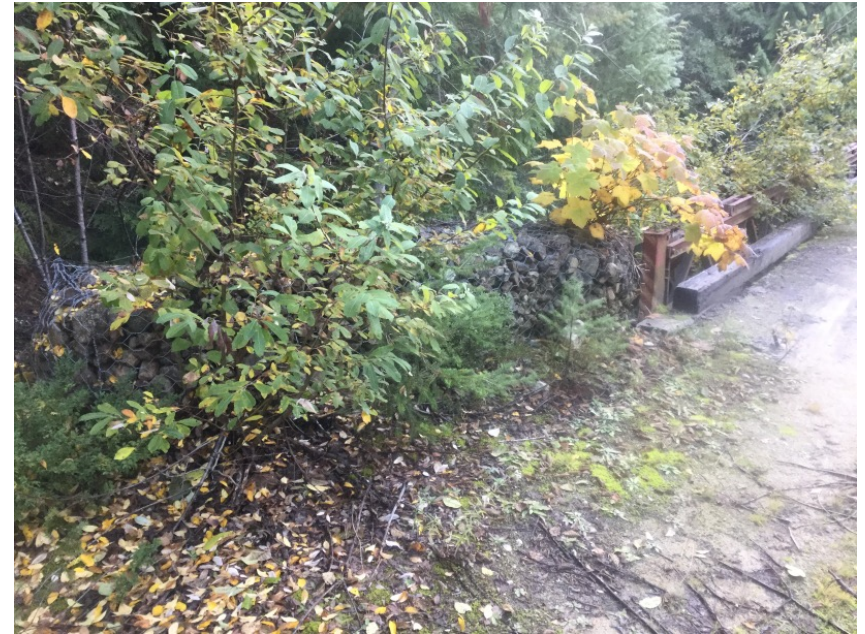
Fenders

Fender Condition Fair

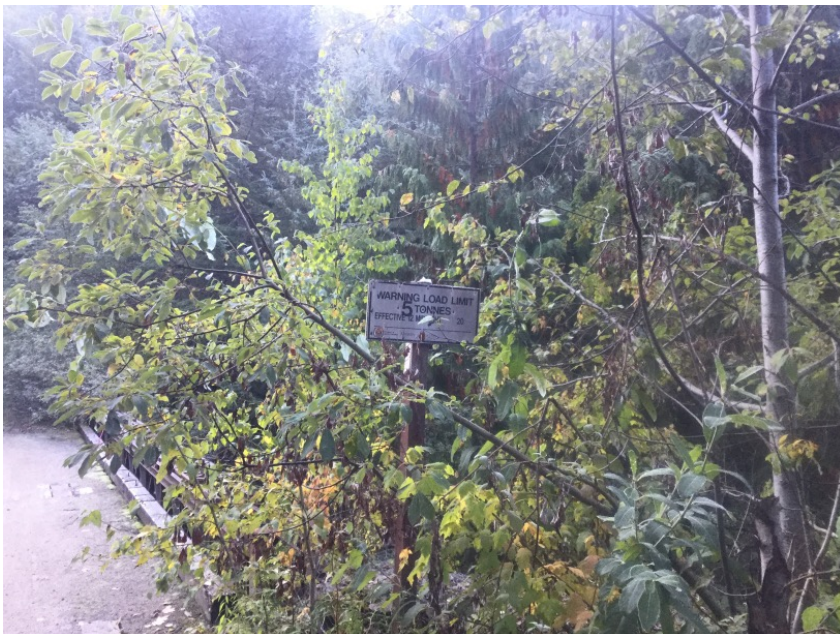
Load Rating Sign

Posted Load Rating 5

| 2 | High | Update load rating sign |

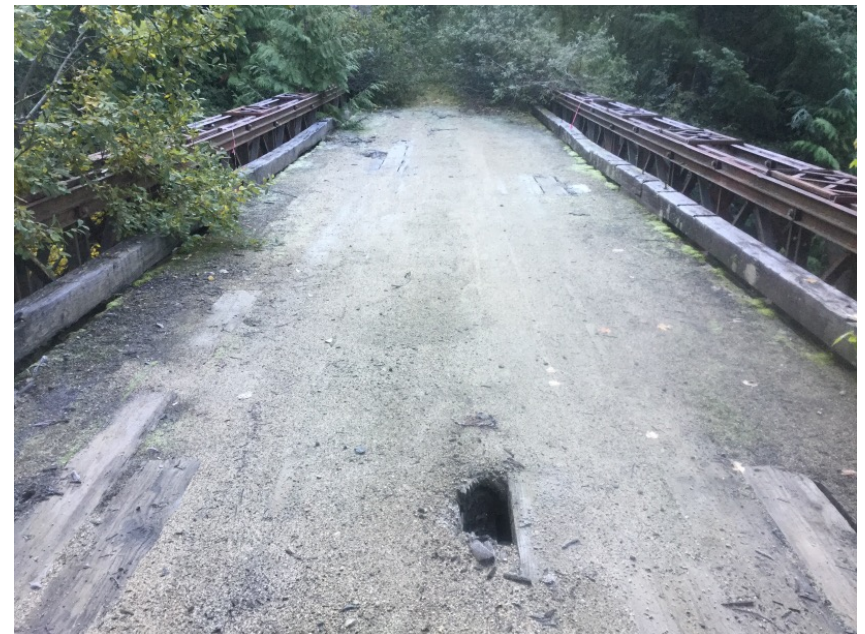
| Running Planks | Poor | Rotten and holes |

| Ties | Poor | Rotten |

| Overall Deck Condition | Poor | Rotten timbers |

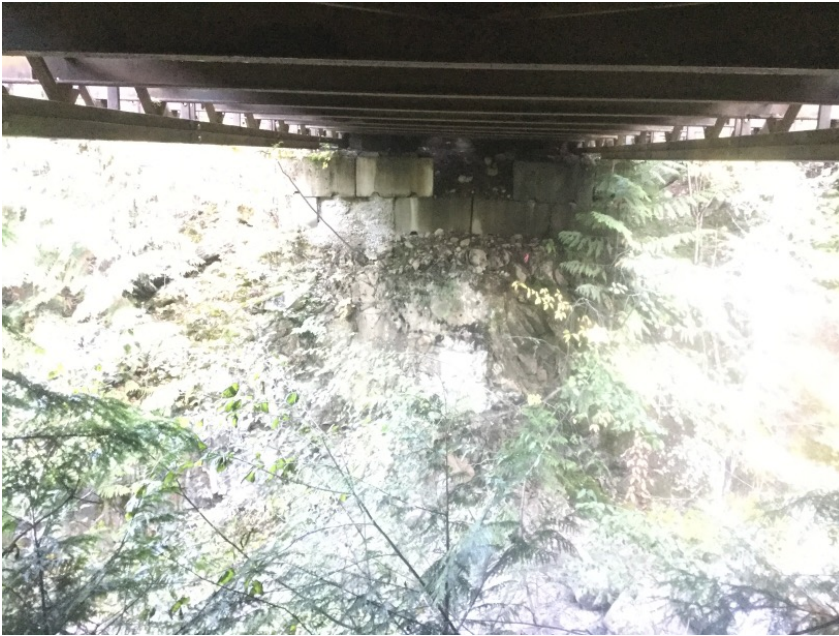
Right Bank Abutment when facing downstream

2 rows high lock blocks, spalling and rotating on right bank

Missing a lock block at the right abutment and fill failing into stream

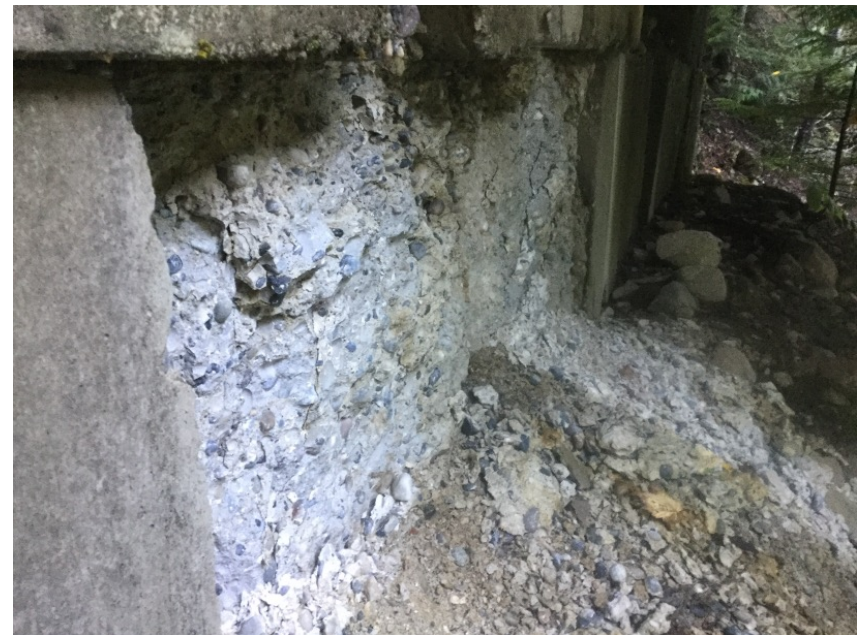
Lock block condition at right bank

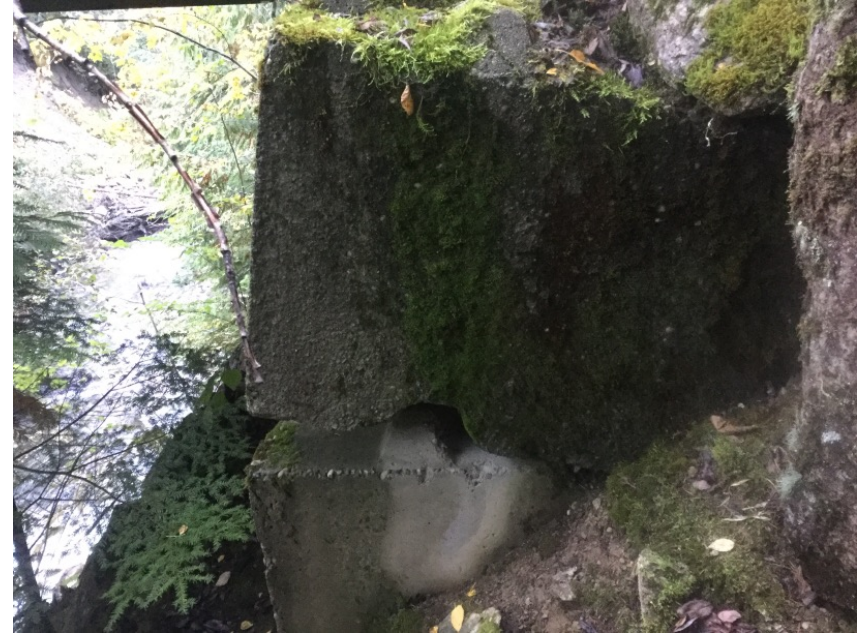
Upstream right bearing location appears to be settling

Upstream right bank lock block condition

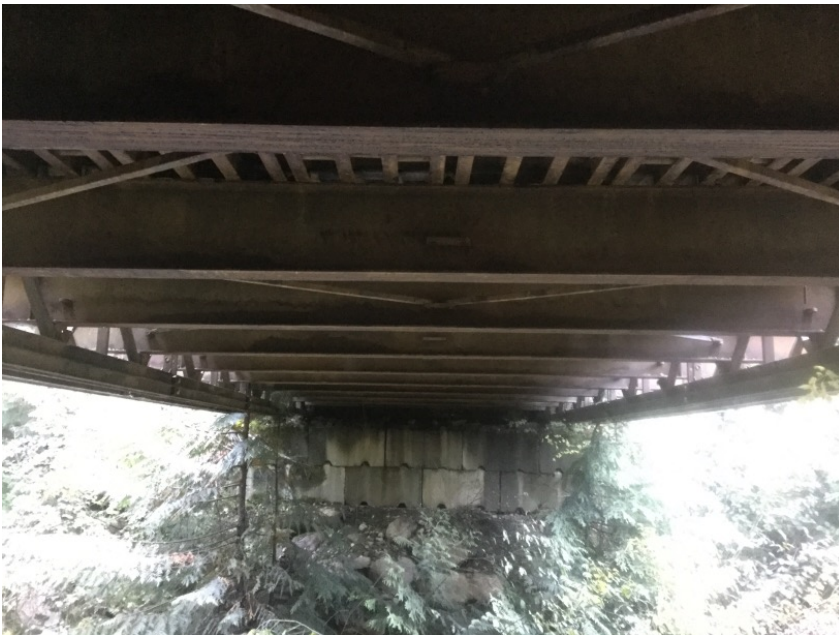
Superstructure

Girders Poor 6 panel - Double single reinforced bailey

Diaphragms Poor Rusting

Bracing Poor Rusting

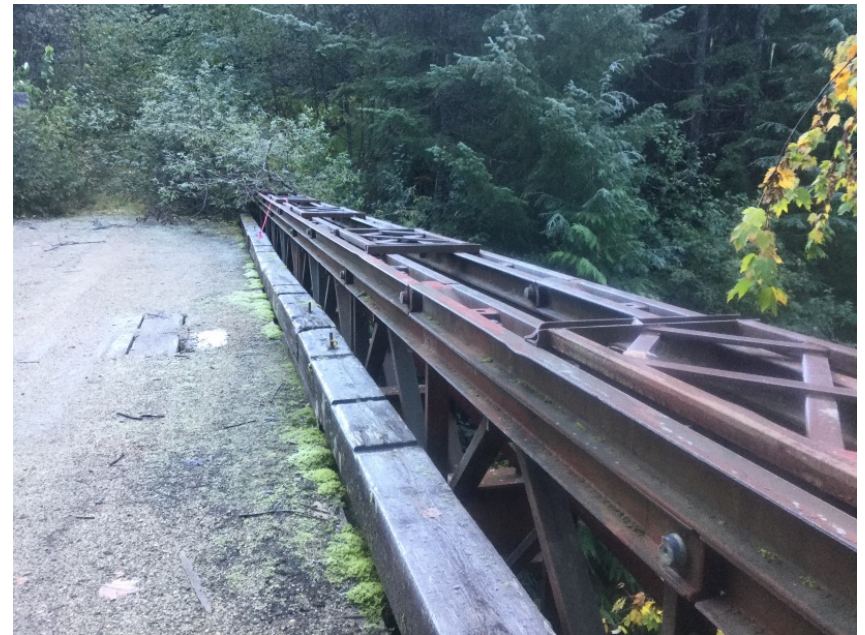
Steel components are aged with damage to some of the bracing frames and end posts.

Superstructure condition

| 1 | High | Replace prior to activity |
