CK-2443

NORRISH CREEK 11km

2018 Inspection

| Crossing Name | Hansen Creek | | |

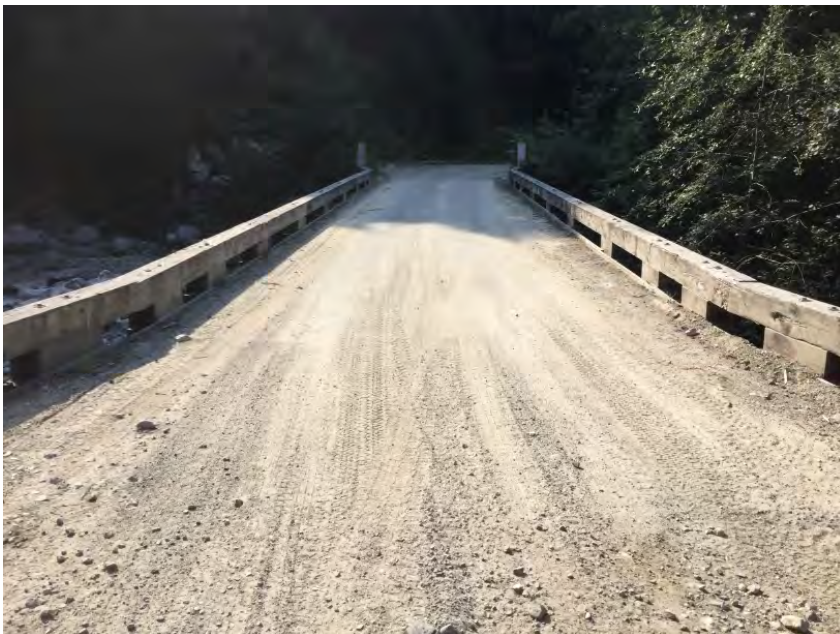
Curb Rail/Blocks/Posts      **Poor**      Up to 50% rot in blocks

Hardware      **Poor**      Loose rail boltsOverall Deck Condition      **Poor**      Due to rail condition

| Repair Item | Priority | Repair Description |
|---|---|---|
| 2 | Medium | Replace guardrail, risers and blocks |

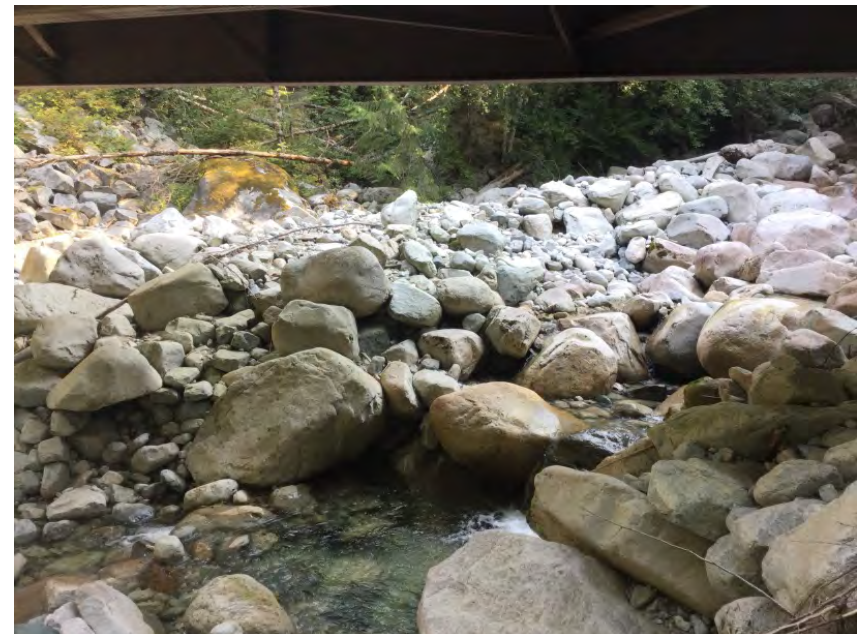
Comments Stream is aggrading at center of channel. Only 2.2m from top of stream channel to underside of girder. Recommend removing material from inlet of stream.

Stream aggradation

| Repair Item | Priority | Repair Description |
|---|---|---|
| 3 | High | Remove bedload from inlet of structure |

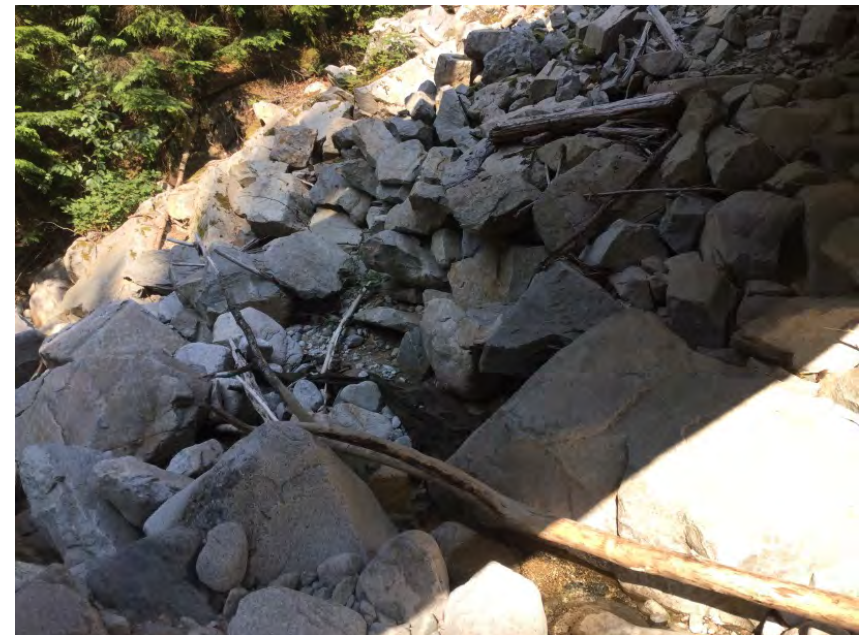
Riprap Fair small scour noted downstream right bank

Riprap scour downstream right bank

| Item | Monitor Description | Frequency |
|---|---|---|
| 2 | Riprap scour | Routine Inspection |
