CK-2444

NORRISH CREEK 12.9km

2018 Inspection

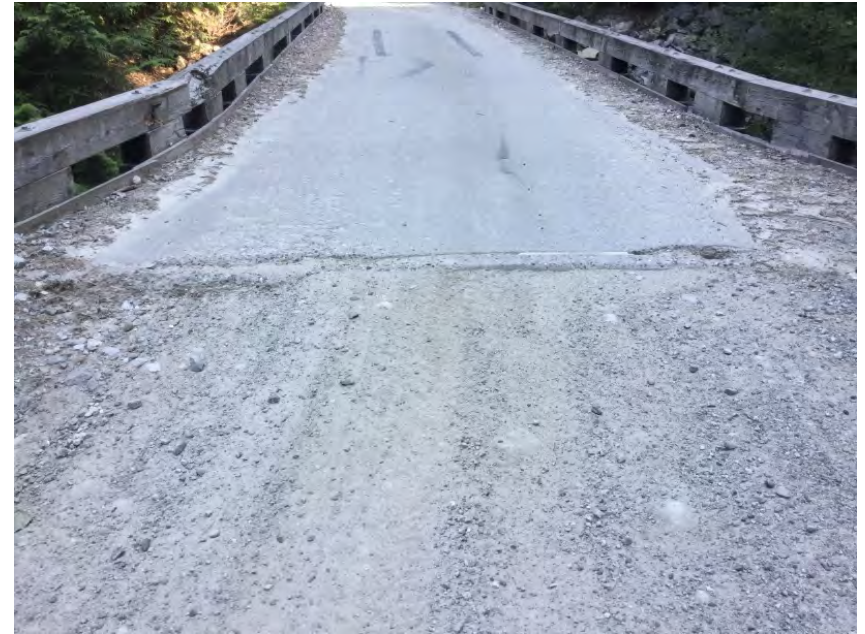
| Concrete Deck | Fair | Damage at both ends and along wheel path, most likely due to tracked machinery |

Left approach ballast wall and deck damage

Replace the guardrail, risers and blocks. Repair damage to the deck panels consistent with the Concrete Repair Guide for Concrete Bridge Components (MFLNRO, 2017) and replace the paraseal at both ballast walls and deck panel interfaces. Brush approaches. Current load rating of L100 or 91 tonnes to continue.

| Item | Priority | Repair Description |
|---|---|---|
| 1 | Medium | Repair damaged concrete at both approaches, and replace paraseal |

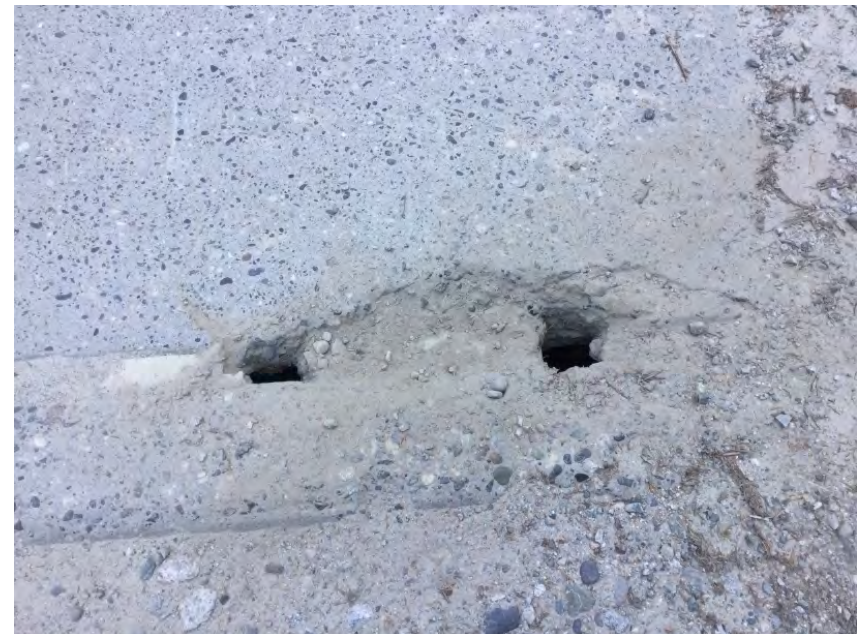
Left approach concrete damage

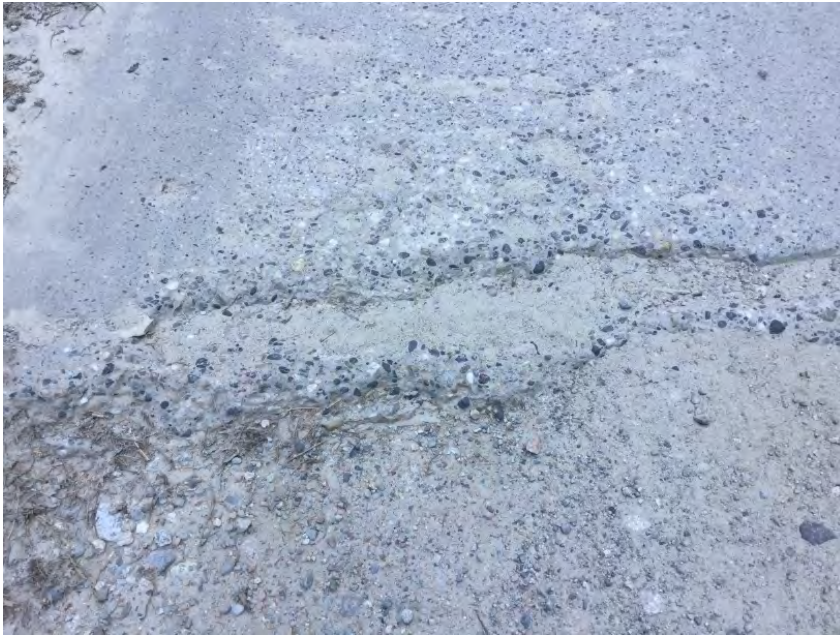
Left approach concrete damage

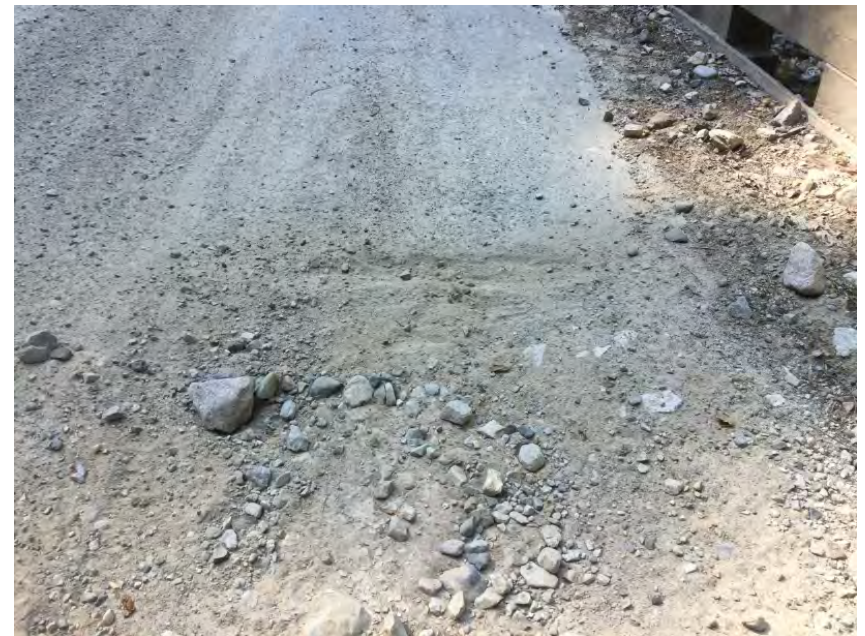
Right approach concrete damage

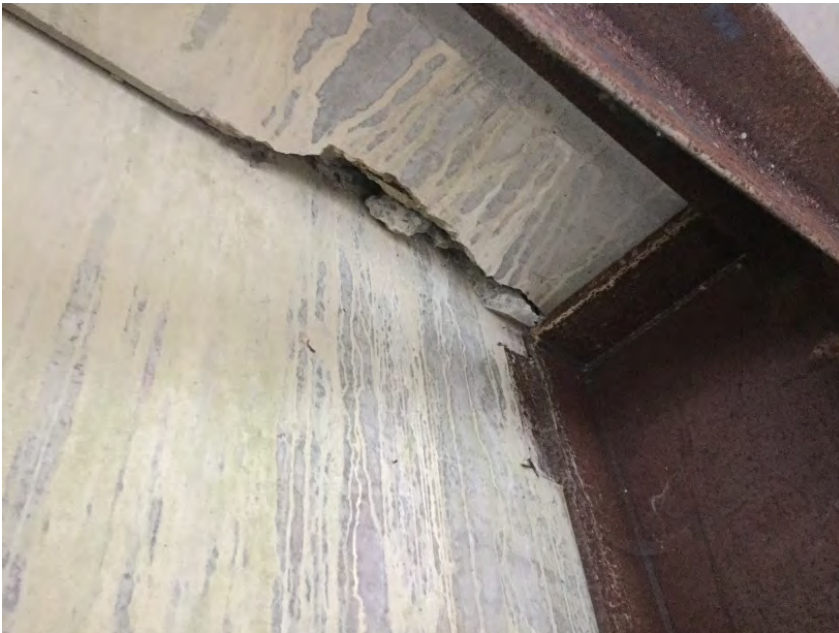
Right approach deck panel damage

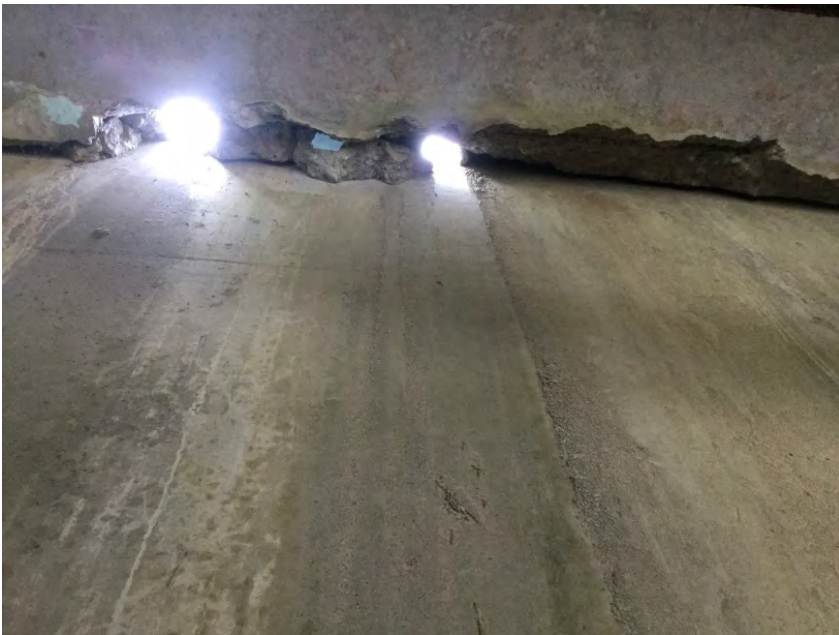
Left approach deck panel damage
