CK-2445

NORRISH CREEK 16km

2018 Inspection

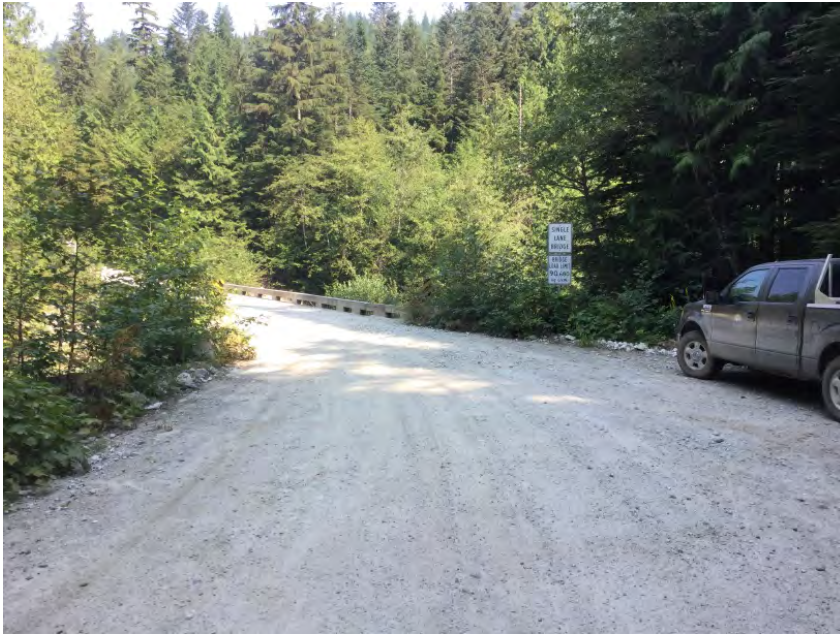
Approach from Left Bank when facing downstream

HC left approach

| 2 | Medium | Brush approaches |

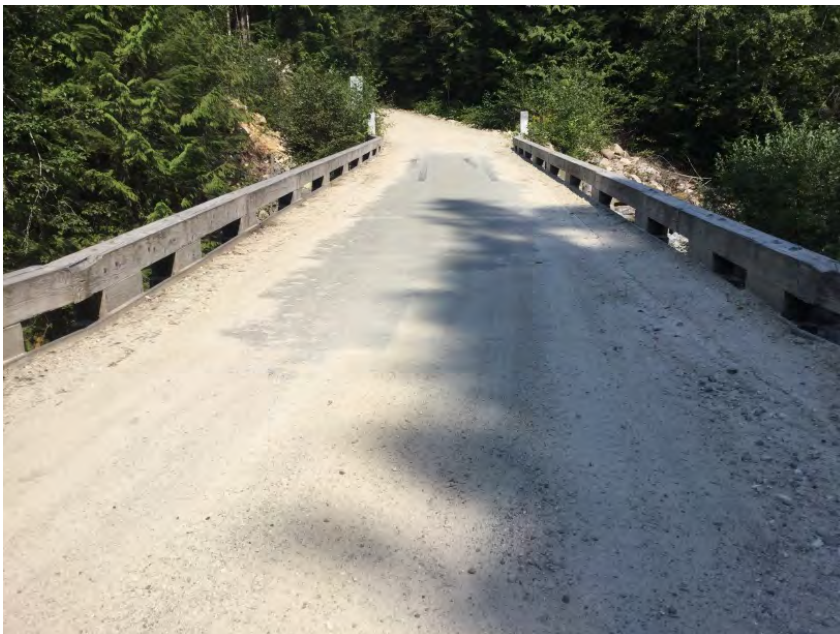
Curb Rail/Blocks/Posts      **Poor**      Blocks up to 50% rotten

Hardware      **Poor**      Loose rail boltsOverall Deck Condition      **Poor**      Due to rail condition

| 1 | Medium | Replace guardrail, risers and blocks |
