CK-2447

NORRISH 18km

2018 Inspection

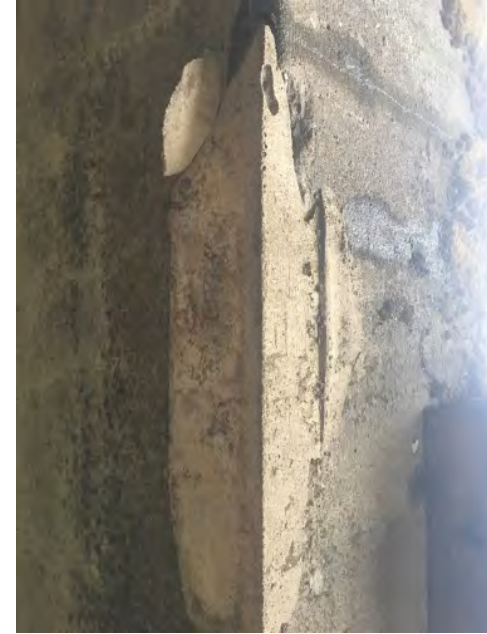
6 slabs with damage noted at surface of right approach

Previous concrete repair

Repair the damage to the concrete girders consistent with the Concrete Repair Guide for Concrete Bridge Components (MFLNRO, 2017). Brush and grade approaches. Current load rating of L165 to 150 tonnes to continue.

| 1 | Medium | Repair damage to girder ends |

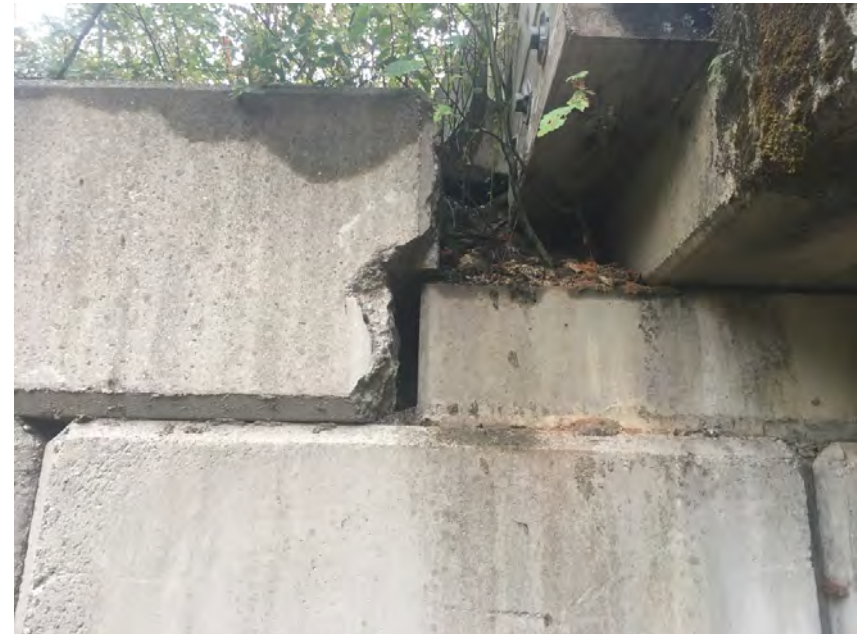
Lock blocks had to shaped around concrete cap at all corners
