CK-2450

NORRISH CREEK 5.1km

2018 Inspection

| Structure Class | Major Culvert |

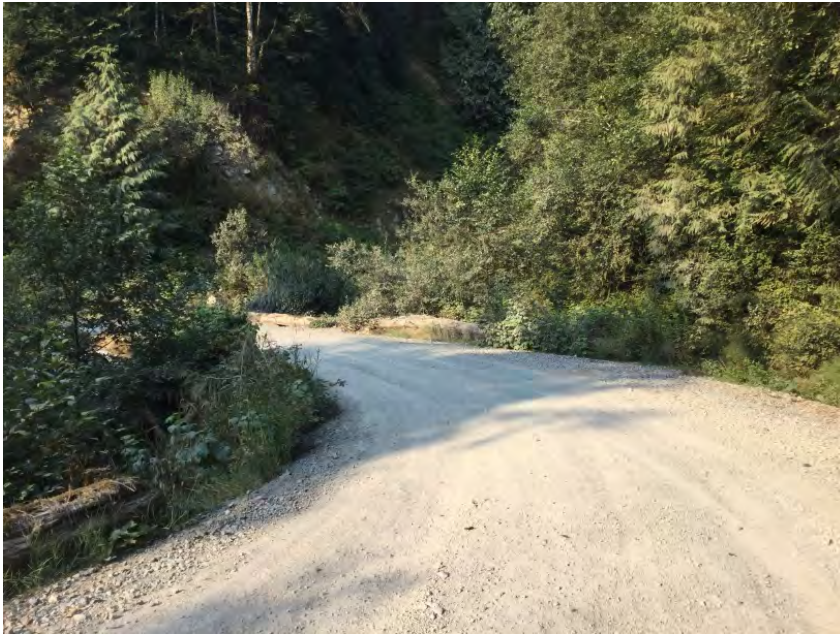
Approach from Left Bank when facing downstream

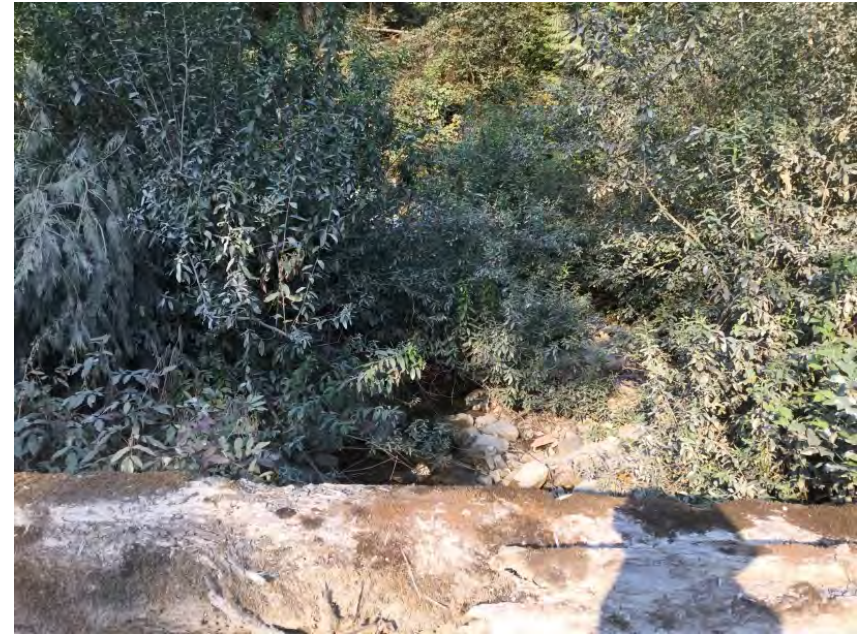
Looking upstream from road

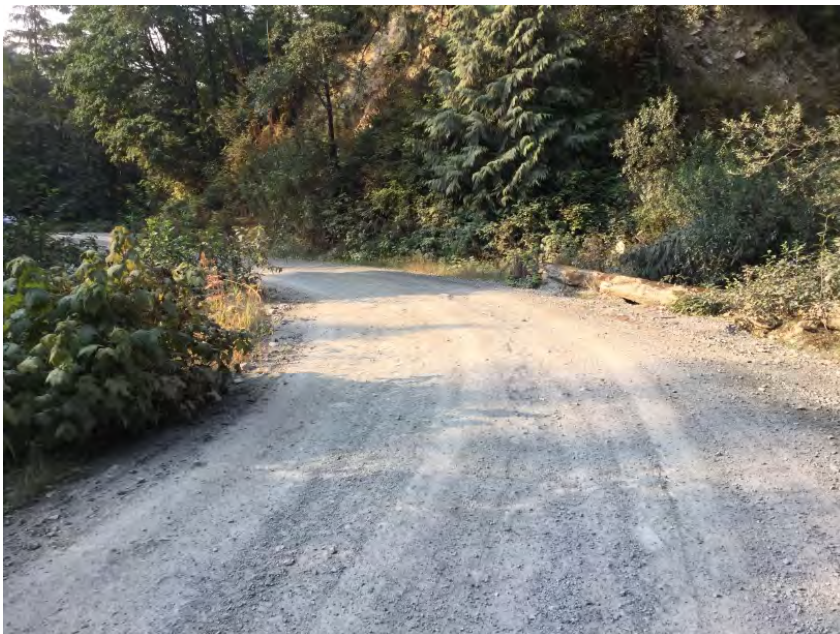
Approach from Left Bank when facing downstream

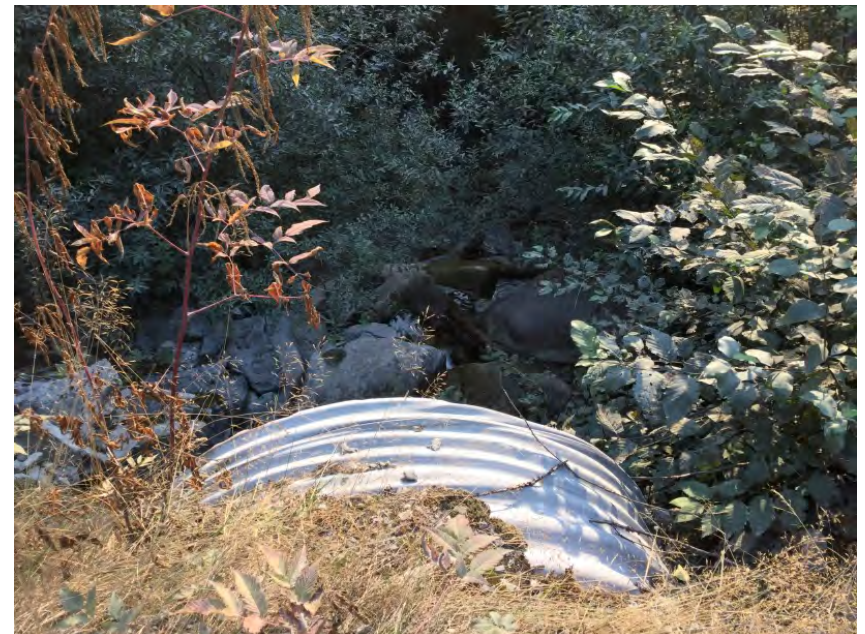
Looking downstream from road

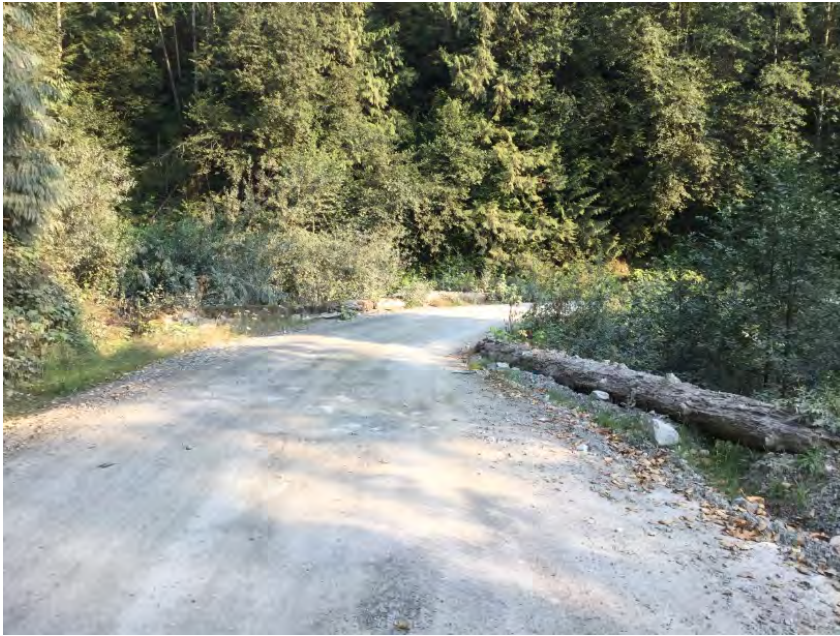
Approach from Right Bank when facing downstream

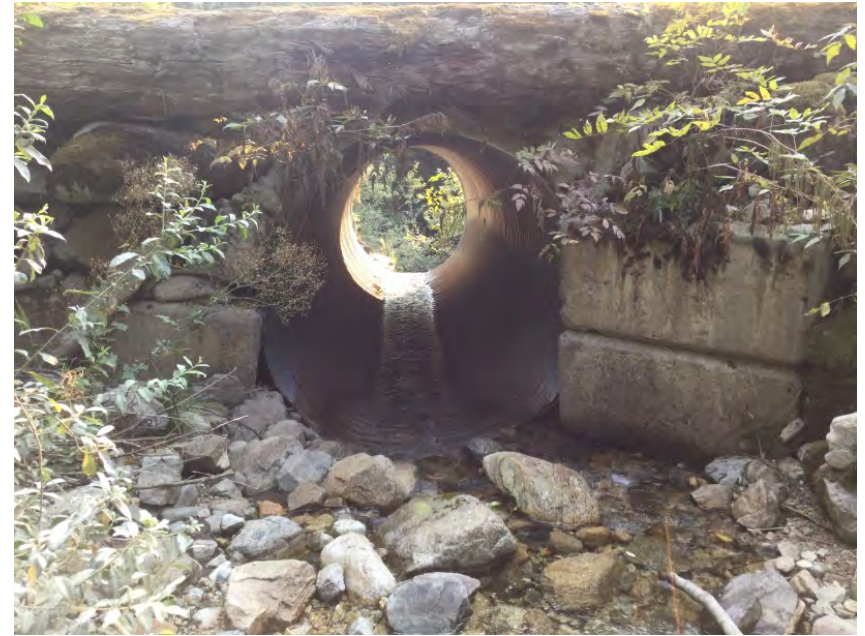
Inlet

Fair

Lock blocks and riprap

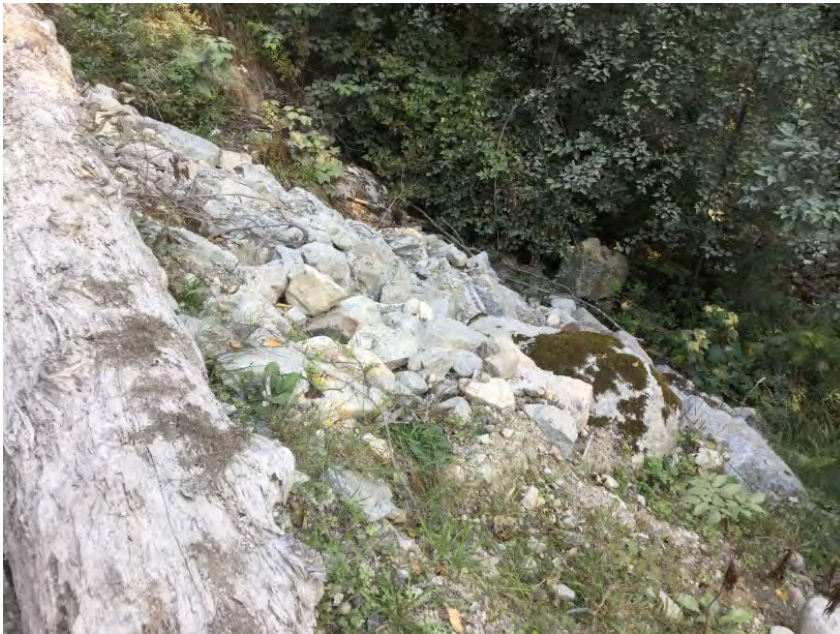
There aren't any indications that that the riprap slope at downstream right bank has moved since last inspection. No indication that the large log retaining fill has moved either. Continue to monitor.

Downstream right approach fill slope repair

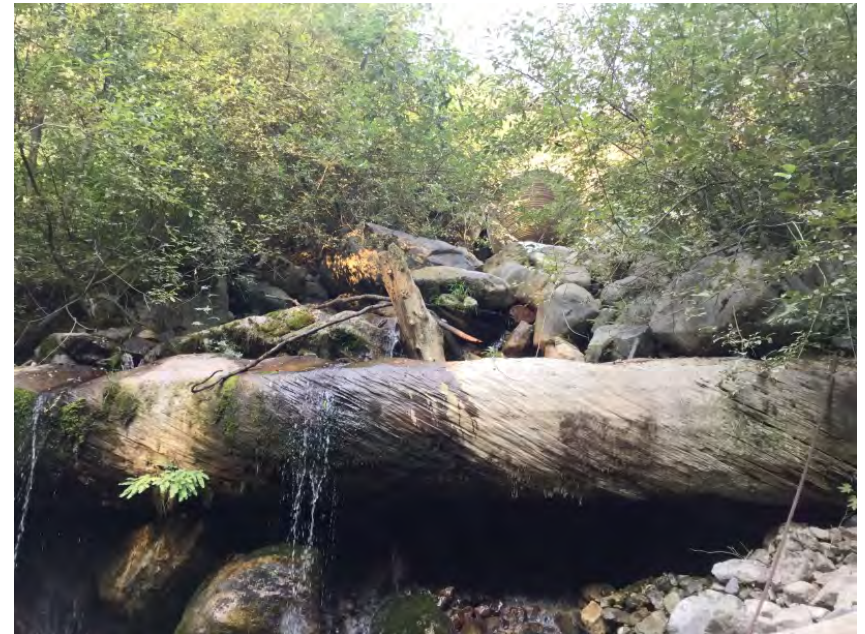
Outlet

Fair

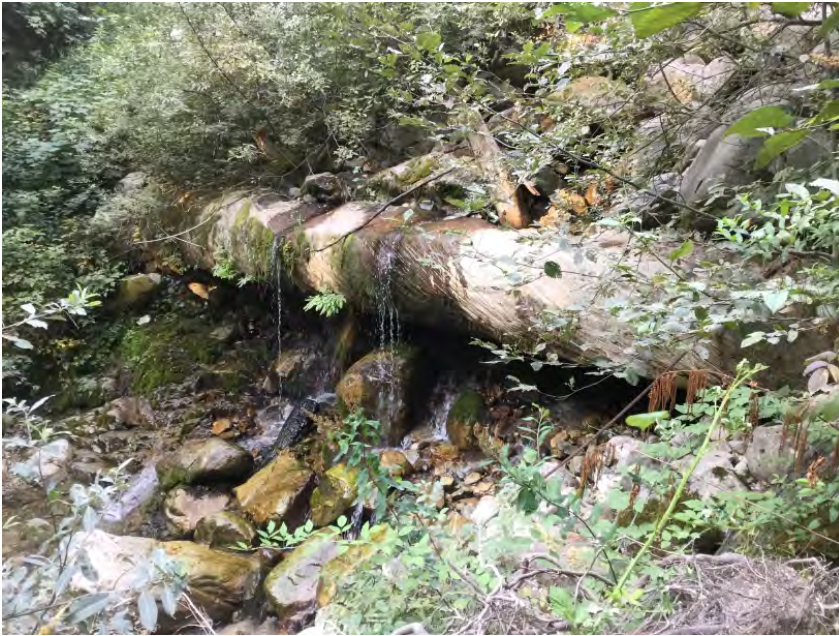
Fair to poor as the fill slope below culvert is held in place by large log

Log retaining much of the fill below culvert

Continue to monitor the log retaining the road fill below the outlet of the culvert. Consider replacing the fill retaining log with permanent materials or replace the entire structure. Current load rating of BCL-625 or 63 tonnes to continue.

1 Large log retaining fill

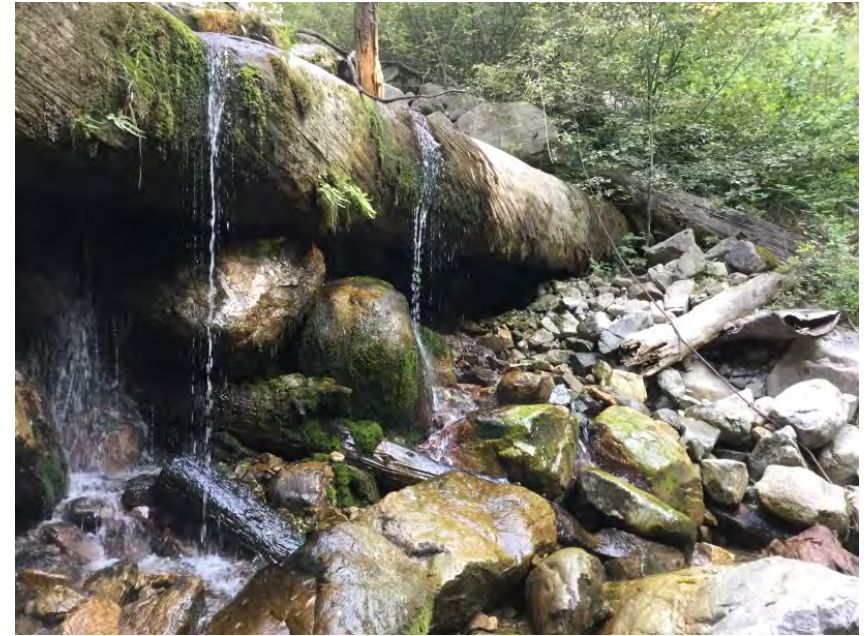
Log retaining fill anchored in middle (approx) and left bank

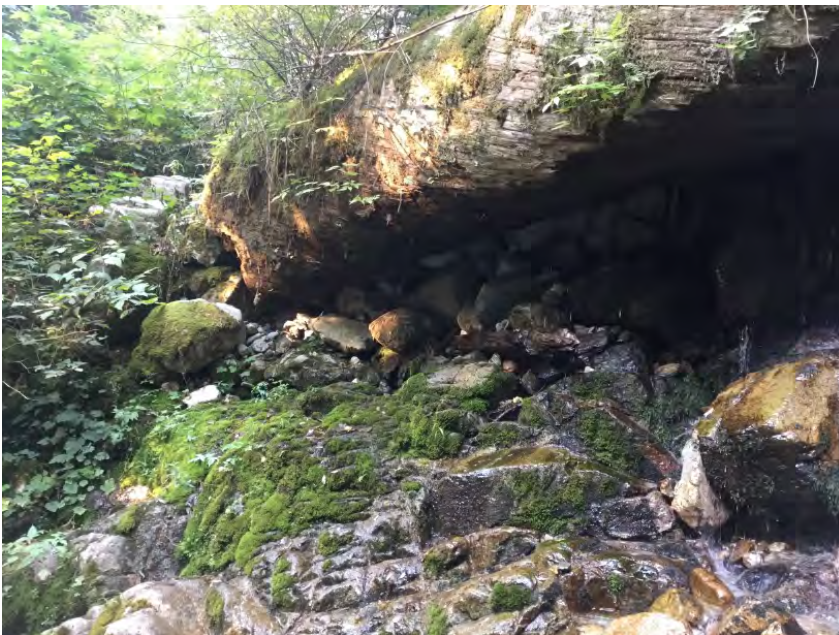
Log retaining fill not anchored on right bank

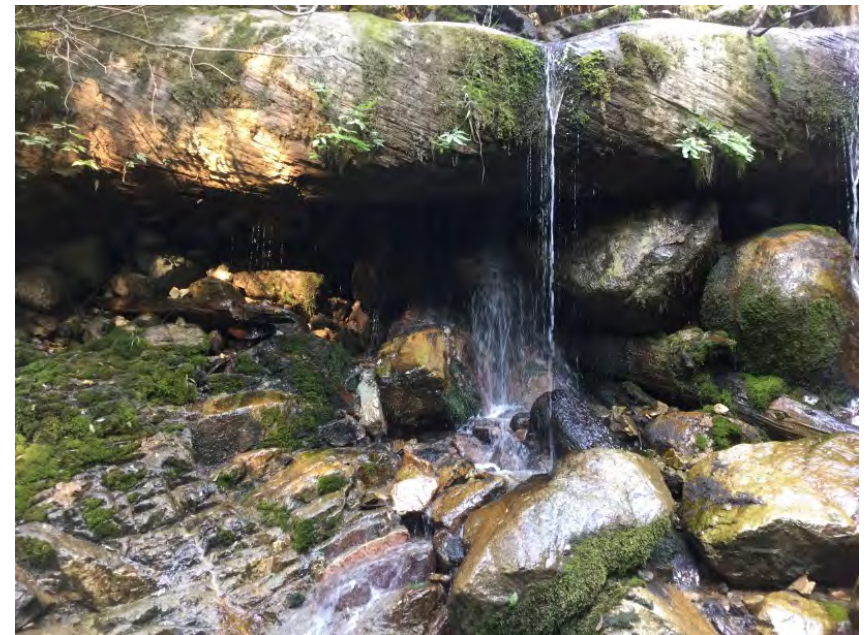
Bedrock, boulders, stones, gravel and organics in fill

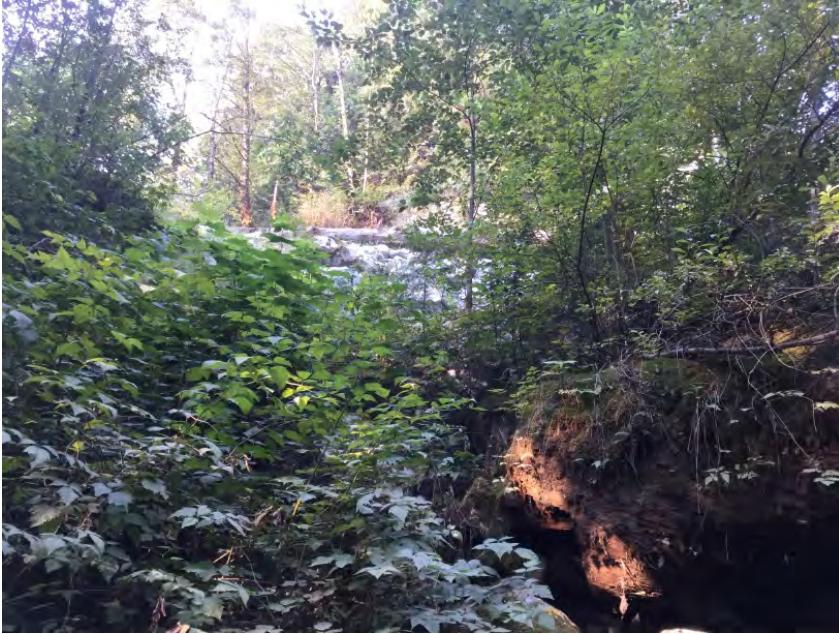
Downstream right bank fill repair immediately above large log retaining fill
