CK-2451

NORRISH CREEK 5.6km

2018 Inspection

| Structure Class | Major Culvert | | |

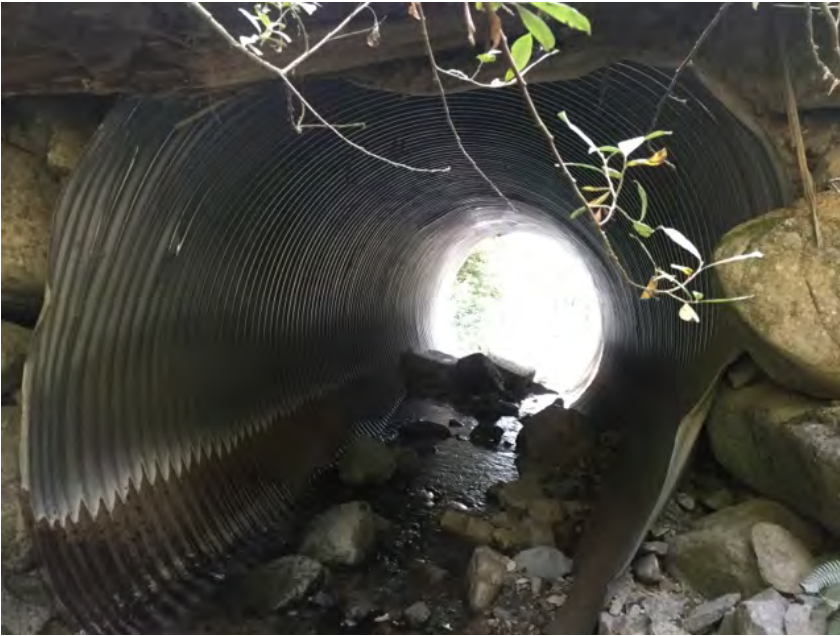
Inlet Fair

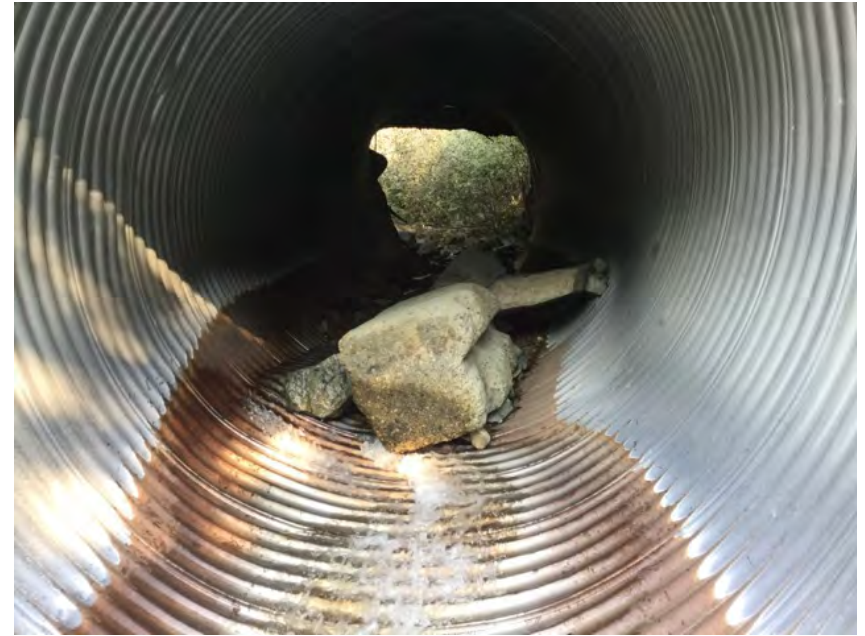
Comments    Material is being transported into the culvert and should be cleaned, no change from last inspection

Material being washed into the culvert

Remove material from within culvert and consider digging a sump at inlet. Monitor both the material buildup within the culvert and the overall culvert shape as there is damage to both the inlet and floor. Current load rating of BCL 625 or 63 tonnes to continue.

| Item | Priority | Repair Description |
|---|---|---|
| 1 | Medium | Remove material from within the culvert and dig sump |

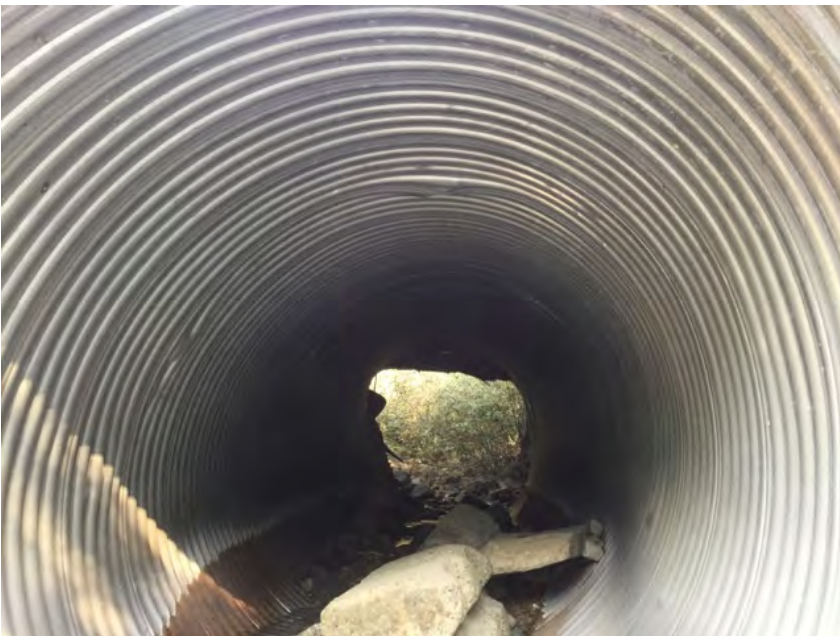
Roof Fair Damaged but finctional

Roof damage

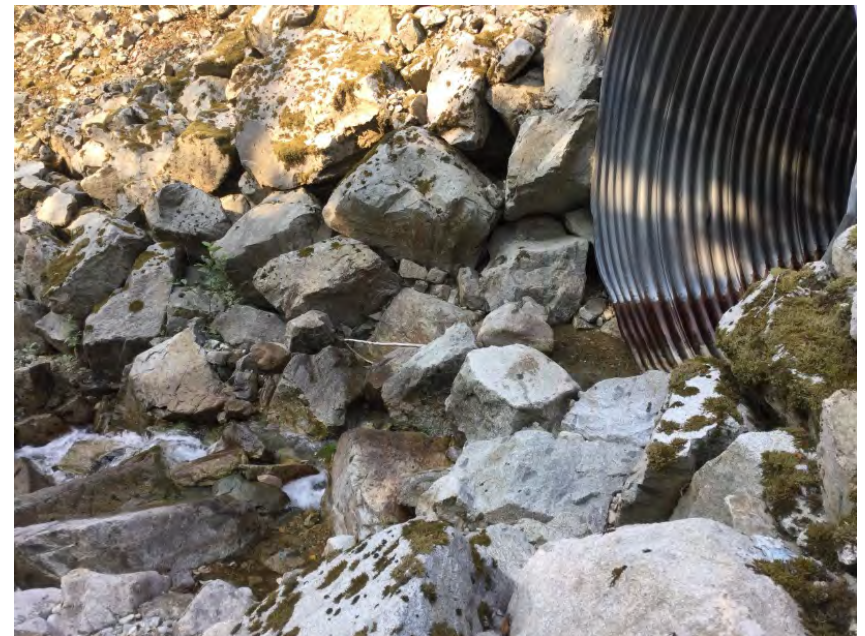
Outlet Fair

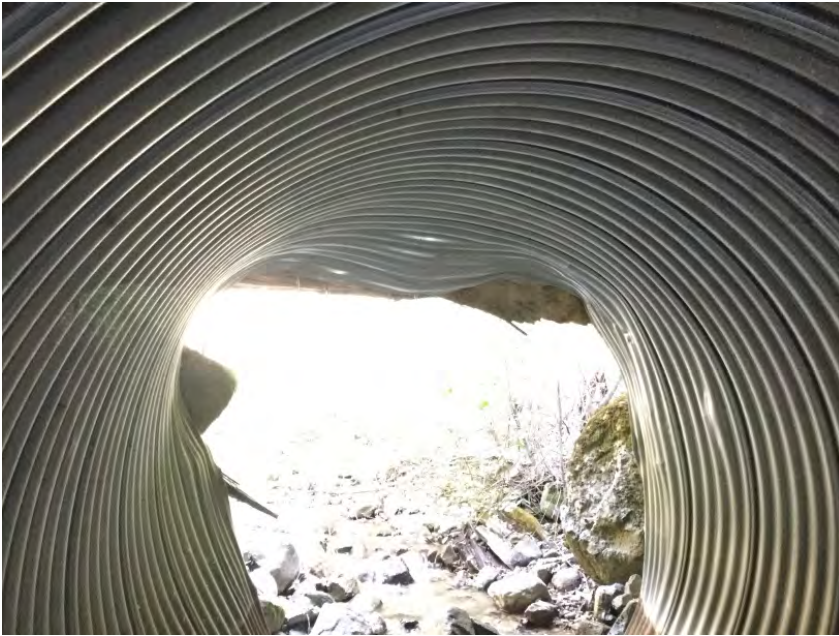
Damage to roof at inlet

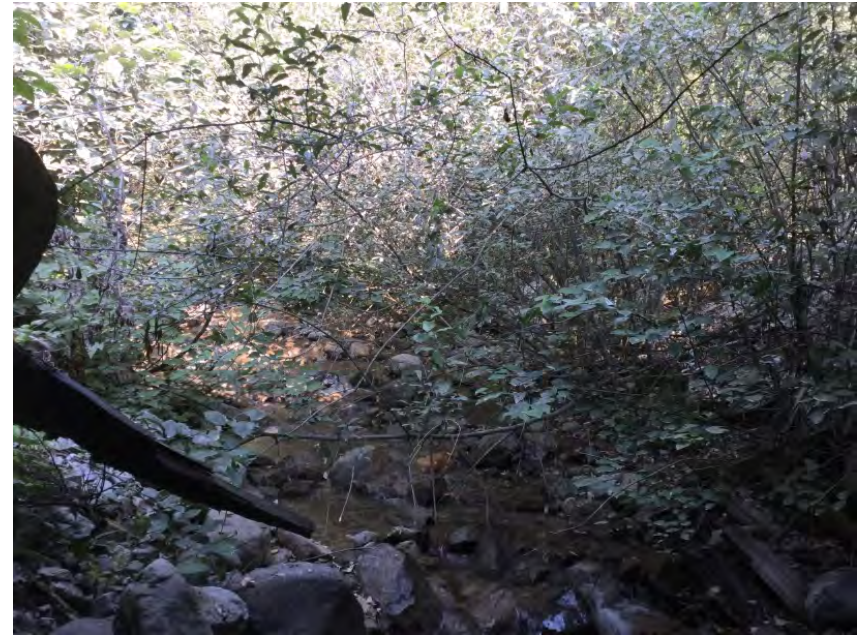
Inlet brush

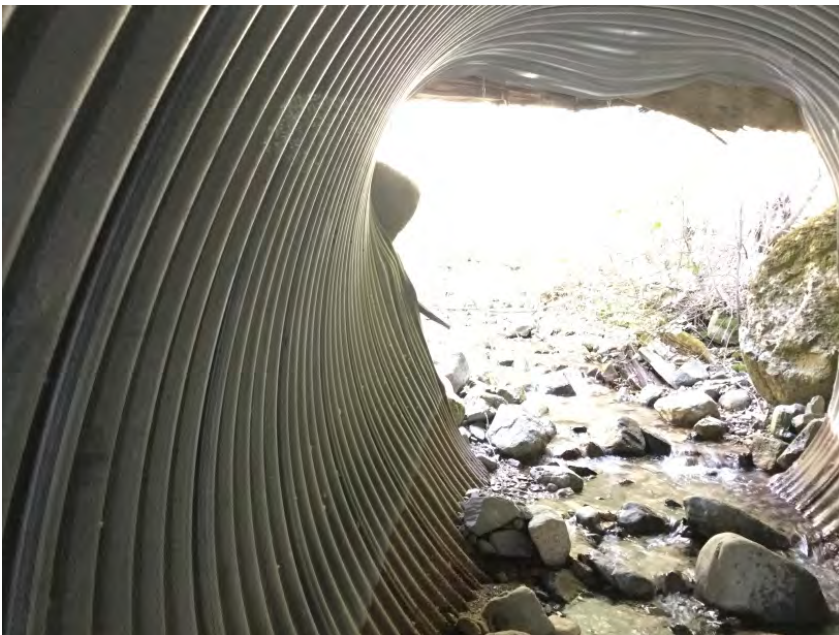
Sidewalls Fair Damaged but functional

Sidewall damage at inlet

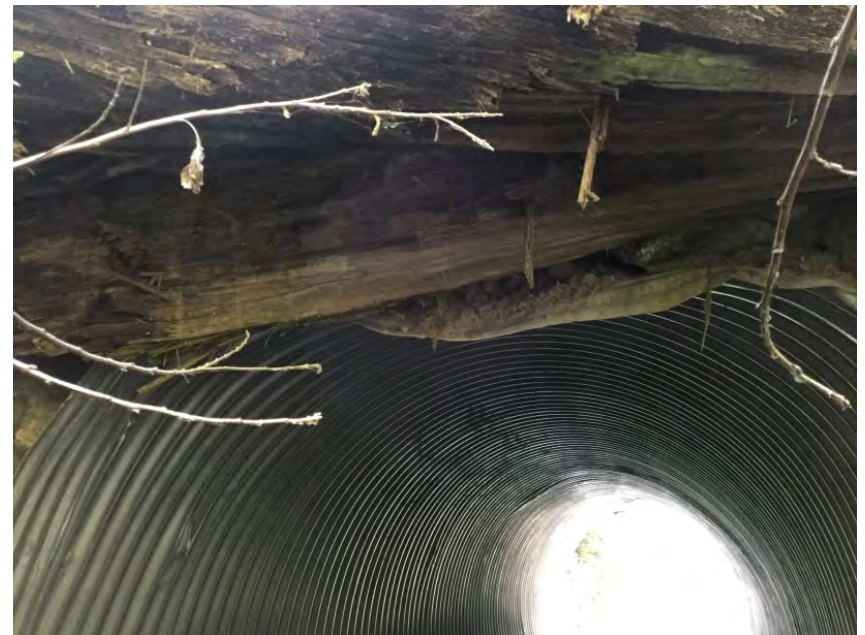
Damage to inlet from failing log fender
